Effects of the 2005 Muzaffarabad (Kashmir) earthquake on built environment

DURGESH C. RAI*
C. V. R. MURTY

*Department of Civil Engineering,
Indian Institute of Technology,
Kanpur 208 016, India*

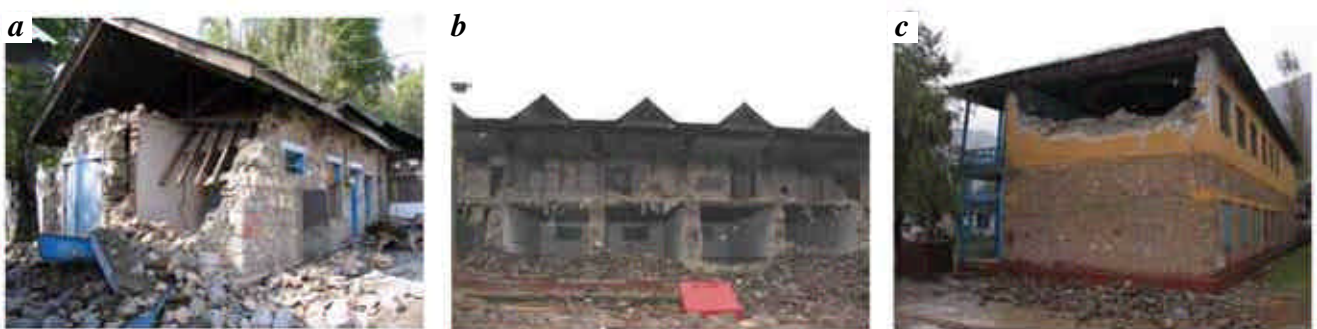
Figure 4. Out-of-plane collapse of stone masonry walls.

masonry construction are extremely vulnerable to earthquakes. Undressed stones are laid in mud or cement mortar and plastered in cement mortar to provide finished surface. Most of government buildings, hospitals, schools, jails, etc.,

built during the last 4 to 5 decades suffered heavy damage especially when the structure is old. This was primarily due to the fact that the walls could not maintain their integrity during the shaking. The collapsed walls of army buildings in

Uri and Kupwara are a few examples. Such out-of-plane failures arising from the dynamic instability of unsupported walls were also evident in collapsed tall slender end wall in brick masonry as well. Moreover, masonry walls are weakened

by openings for doors and windows (Figure 4).

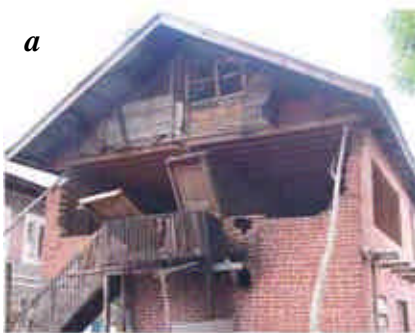
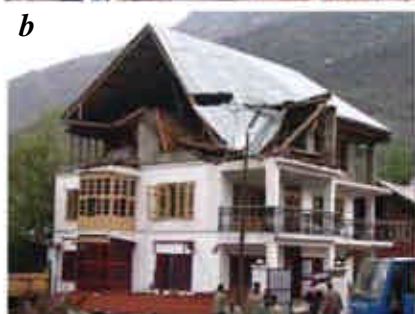
Deficiencies of stone masonry walls were more evident in R/R type masonry and were responsible for the majority of the observed damage in the earthquake-affected areas. Such deficiencies can render typical brick masonry buildings vulnerable to damage as shown in Figure 5. However, timber-laced masonry can maintain its integrity even when the supporting masonry walls in lower stories are severely damaged (Figure 6).

Figure 5. Damage to brick masonry buildings. *a*, Out-of-plane collapse of walls; *b*, In-plane failure of masonry walls in lower stories and out-of-plane collapse at uppermost storey.

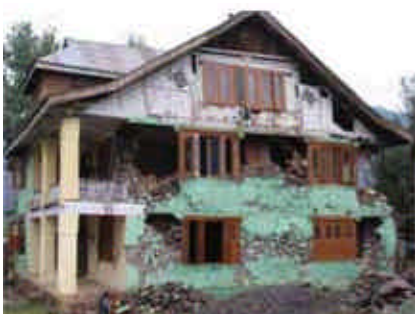
Figure 6. Timber-laced masonry in gable wall suffered little damage whereas extensive damage in stone masonry wall rendered the building unsafe at Uri.

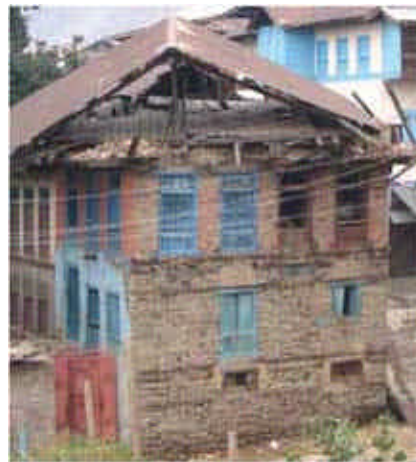
ing material. Corrugated Galvanized Iron (CGI) sheets have also been used as a roofing material in many cheaply built school buildings. These roofs are inherently weak in shear and cannot tie the walls together even when they are properly connected to them. Most of roof failures can be attributed to a combination of deficiencies such as loss of support of roof trusses and rafters due to failure of masonry walls and failure of roof truss itself due to failure of joints and/or members forming the truss or other roof supporting structure (Figure 7).

Figure 7. Failure of supporting walls for the roof in a traditional building using *Taq* system of masonry at Baramulla.

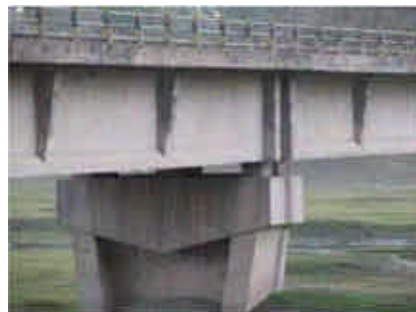
The area has a number of highways and pedestrian bridges over rivers, rivulets, and gorges. No serious damage to any of the highway bridges was noticed in the areas visited away from the epicenter. However, it has been reported that the Aman Setu at India-Pak border closer to the epicenter has suffered damage. Most of pedestrian bridges were of suspension types and no particular damage to the bridge structure or to the supporting pylons was noticed. The affected region which may experience ground shaking more than IX on MSK scale, has a number of major bridges which are simply supported prestressed concrete girder type with inadequate seating or no provision to prevent unseating (Figure 8).

Figure 8. Simply supported prestressed concrete girder bridge on NH1A in Zone V which lacks restrainers for preventing unseating during earthquakes.

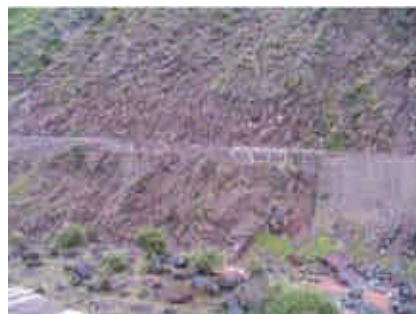
Roads closer to epicentral area in the mountainous region suffered extensive landslides which resulted in the closure of traffic for many days (Figure 9). The road to Tangadhar from Kupwara was not open even a week after the quake. Fissures on roads were noticed at places which were primarily due to ground movement across unstable slopes. Pipelines for drinking water supply broke at several places causing severe hardships. An overhead water tank on shaft supported staging in Traigaon suffered circumferential flexure tension and shear cracking which was empty at the time of earthquake (Figure 10). Such damages have been observed in many past earthquakes which highlight the inadequacy of current design methods of such tanks.

Figure 9. Landslide on NH1A near Uri disrupted the road traffic.

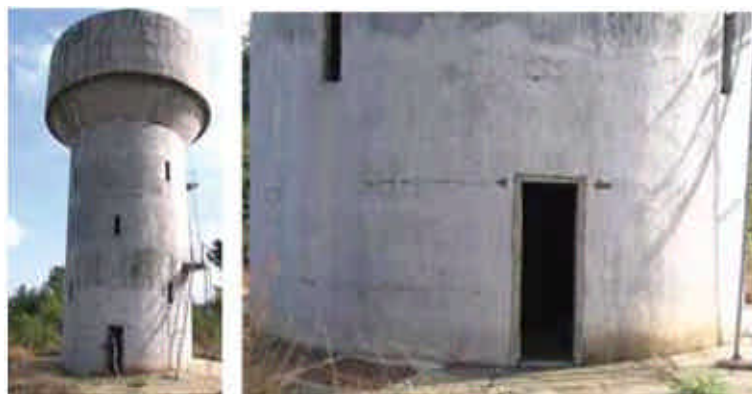
Figure 10. A 50000 gallon water tank at Traigaon developed flexure tension cracks in its supporting shaft rendering it unsafe for use.
