## Effects of *M*9 Sumatra earthquake and tsunami of 26 December 2004

This communication is based on a study organized by IIT Kanpur, in which a total of 13 investigators, divided into six groups carried out a reconnaissance investigation on the Indian Mainland coast and islands of Andaman and Nicobar during 1–13 January 2005.

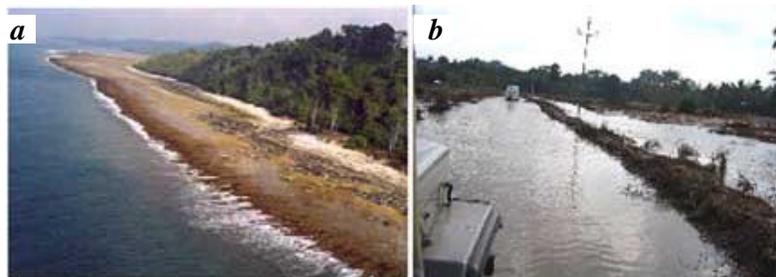
The earthquake occurred along the plate boundary marked by subduction zone between the Indian plate and the Burmese micro-plate. The subduction zone is characterized by NNW–SSE arcuate trench running parallel to the western side of the Sumatra and the Andaman–Nicobar Islands. As a result of this movement of tectonic plates, the Andaman and Nicobar Islands have experienced uplift and subsidence at different places as seen from the field evidence. At Port Blair, the sea water level has risen by about one meter, suggesting a subsidence of the landmass, whereas in Middle Andaman Islands emergence of new shallow coral beaches suggests uplift (Figure 1). The implications of rise in water level by 1 m with respect to the land are rather severe: the buildings and roads at lower elevations and the dry docks are being flooded during high tide, making them non-functional and disrupting normal activities even weeks after the event. In Middle Andaman Islands, at Baratang an older mud volcano became active again after the earthquake and also several new small mud volcanoes erupted

**Figure 1.** *a*, Up-throw of coral beds and rock strata due to uplift on the western coast of middle Andaman Island near Flat Island (Photo: Javed Malik). *b*, Seawater flooded Andaman Trunk Road at Sipi Ghat area near Port Blair during high tide, suggesting subsidence of the landmass. (Photo: Goutam Mondal).

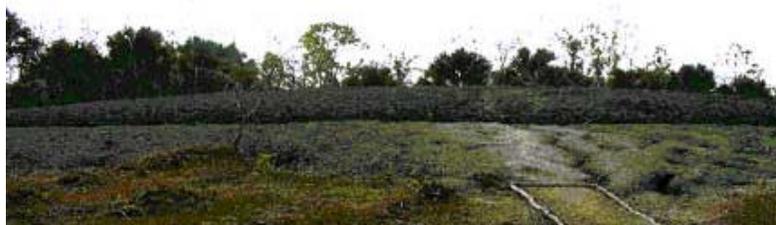
along with large ground deformation (Figure 2). Damages to buildings and other structures were primarily due to tsunami (as against due to ground shaking) on the mainland India, and in Little Andaman and other islands south of it (Figure 3); structural damage in islands north of Little Andaman was primarily due to ground shaking.

**Figure 2.** Eruption of a mud volcano near Jarawa Creek at Baratang Island in Middle Andaman, 105 km north of Port Blair (Photo: Durgesh C. Rai).

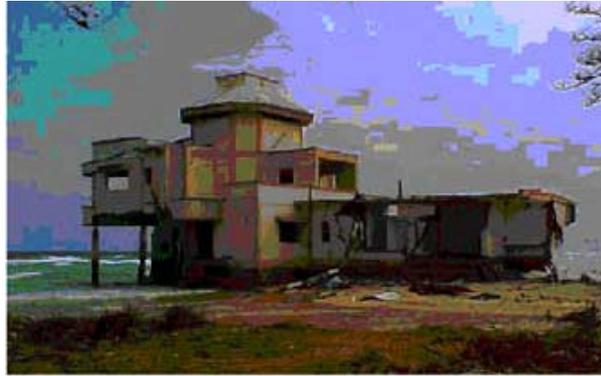
Tsunami created giant waves as high as 10–12 m; in several instances, objects were found on top of the trees after the tsunami. In the islands of Great Nicobar, Car Nicobar and Little Andaman, buildings constructed on the coast were washed away by the great waves, while those located on high grounds survived. When a number of rows of buildings existed on the coast, buildings in the first row from the sea suffered extensive damage, those in the rear rows did better due to the shielding provided by the front row. In general, constructions circular in plan (e.g., circular water tanks, light house) did better under the onslaught of tsunamis as the water could easily flow around such objects. At Car Nicobar about 100 personnel of air-

**Figure 3.** RC frame building (MES Inspection Bungalow) now stands in waters at the Military Residential Colony south of Malacca on the east coast of Car Nicobar Island. (Photo: C. V. R. Murty).

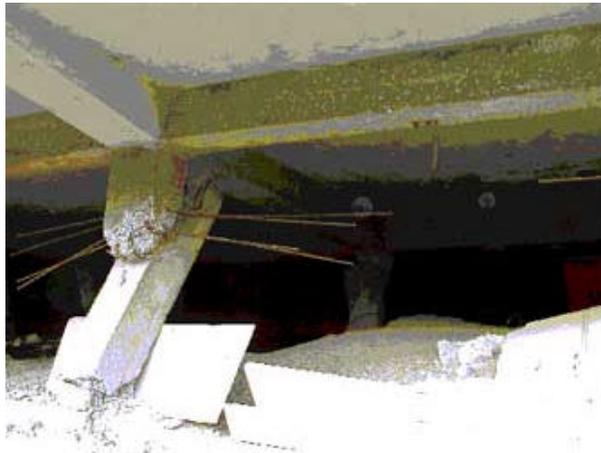
Due to the ground shaking, the wooden buildings suffered less damage compared to the more modern RC frame and concrete block masonry buildings. The latter sustained extensive damage when the seismic codes were not complied with. For instance, the Passenger Terminal Building at the Phoenix Bay in Port Blair was recently constructed but did not comply with the seismic codes. This rather expensive building has been irreparably damaged. A number of houses built by local people using reinforced concrete but without proper engineering supervision and seismic detailing collapsed. A three-storey apartment building in Port Blair on stilt columns, not complying with the codal requirements, collapsed (Figure 4). Similar damages were also observed in Rangat, and Mayabandar in northern islands as well.

**Figure 4.** Collapse of a three-storey reinforced concrete frame building at Port Blair (Photo: Sudhir K. Jain).

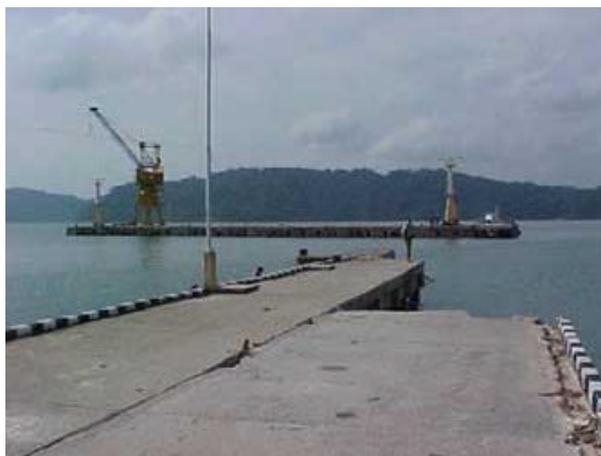
A number of jetties collapsed or were severely damaged in a number of islands

which severely affected the sea traffic and hence the relief operations (Figure 5). A new 268 m long bridge between North Andaman and Middle Andaman at Austen Strait had to be closed to even the light vehicles. The superstructure has moved on the substructure by a substantial amount and middle three spans fell off from the bearing (Figure 6a). Two of the authors had visited this region two years back after a moderate  $M6.5$  earthquake on 14 September 2002 and in their published report<sup>1</sup> had expressed concerns about this very bridge as follows:

**Figure 5.** Collapse of the 80 m segment of approach in Great Nicobar Island jetty at Campbell Bay. This has adversely affected the relief work. (Photo: C. V. R. Murty).

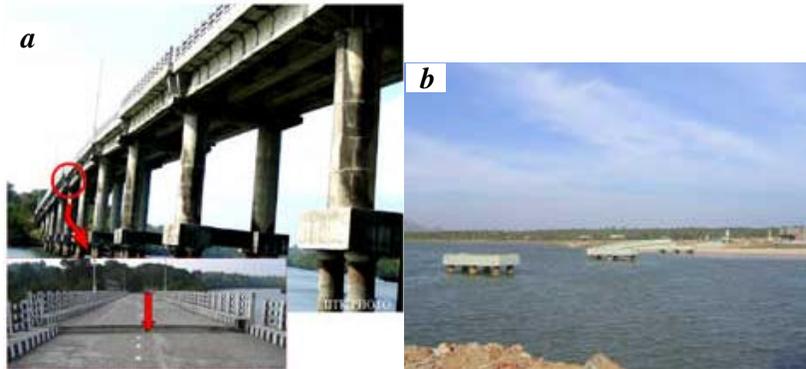
Inadequate seating of bridge deck over piers and abutments is a serious concern for its safety during a stronger earthquake in future. The bearings are simple neoprene pads which are far from satisfactory for a bridge located in seismic zone V. Bridge deck restrainers are the minimum that need to be provided to ensure that the spans are not dislodged from the piers in future earthquakes. (available at [http://www.nicee.org/EQ\\_Reports/Andaman/Andaman\\_report.htm](http://www.nicee.org/EQ_Reports/Andaman/Andaman_report.htm)).

**Figure 6.** *a*, Three middle spans of Chengappa Bridge over Austen Strait connecting Middle Andaman and North Andaman Islands, 230 km north of Port Blair fell off from the bearing due to ground shaking. (Photo: Durgesh C. Rai). *b*, Complete loss of spans of the four-span RC bridge at Melmannakudi due to tsunami. (Photo: Alpa Sheth).
