# Recent tsunami and earthquake devastation

The Indian Institute of Technology (IIT), Kanpur organised a reconnaissance study of the affected areas of the recent earthquake and the tsunami with a view to document the scientific, engineering and disaster management lessons from this tragedy. A total of 13 investigators were divided into six groups with independent responsibilities: each of the groups spent about eight days in the field, during January 1 to January 13, 2005, as per *Table 1*.

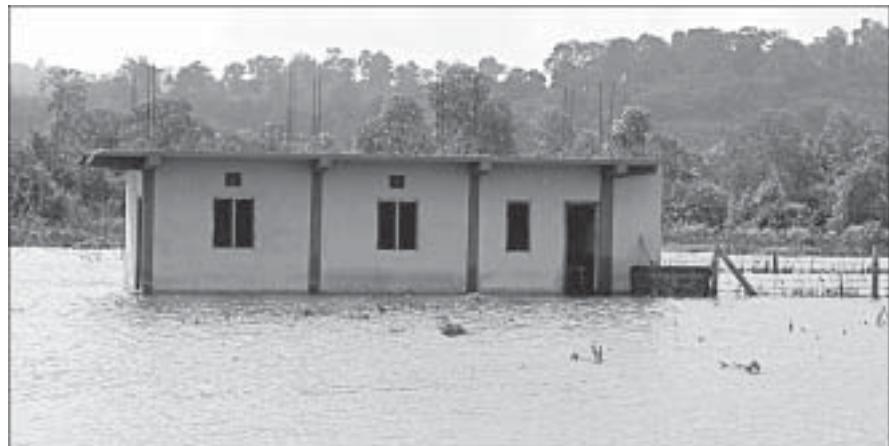
**Fig 1 Sea water level at Port Blair with respect to land has gone up by about 1 m. Hence many areas are now flooded during high tide** (Photo: Sudhir K Jain)

plate, the Andaman and Nicobar Islands experienced uplift on the western coast and subsidence on the eastern coast as seen from the field evidence. At Port Blair, located on the east coast, water level has risen by about 1 m, *Fig 1*. Western coast of the middle Andaman islands showed emergence of new shallow coral beaches suggesting an uplift.

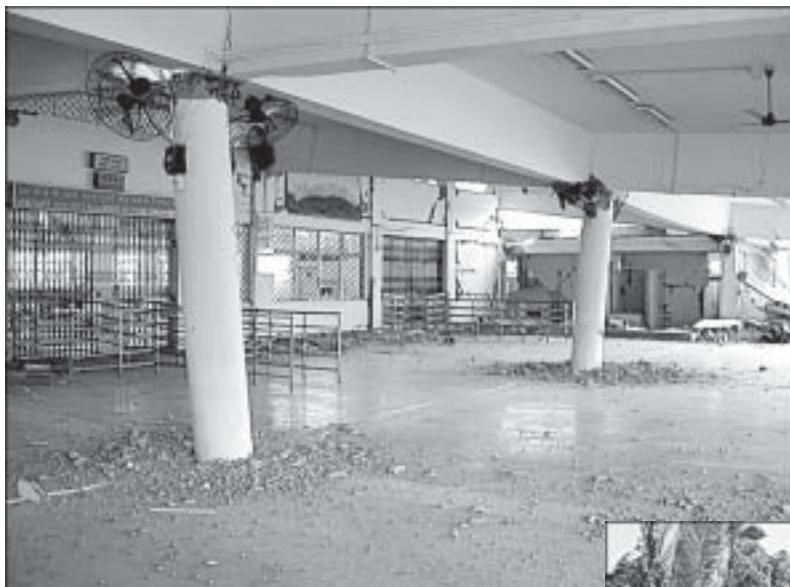
**Fig 2 Severe damage to Passenger Terminal Building at Port Blair** (Photo: Sudhir K Jain)

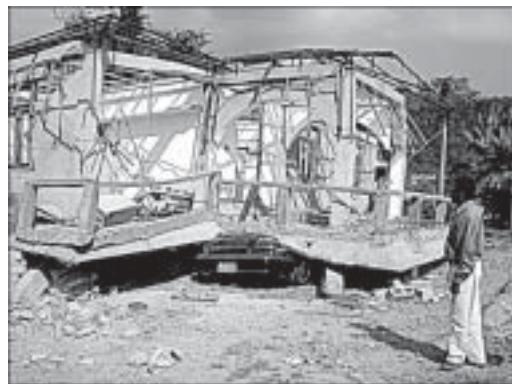
**Fig 3 Collapse of a stilt plus one-storey house in reinforced concrete near Port Blair** (Photo: Sudhir K Jain)

Due to the ground shaking, the wooden buildings have performed very well as compared to the more modern RC frame and concrete block masonry buildings. The latter sustained large damages wherever the seismic codes were not complied with. For instance, the passenger terminal building at the Phoenix Bay in Port Blair was recently constructed but did not comply with the seismic codes. This rather expensive building has been irreparably damaged, *Fig 2*. At least two houses built by local people using reinforced concrete but without proper engineering supervision and seismic detailing collapsed, *Figs 3 to 5*. A three-storey apartment building in Port Blair

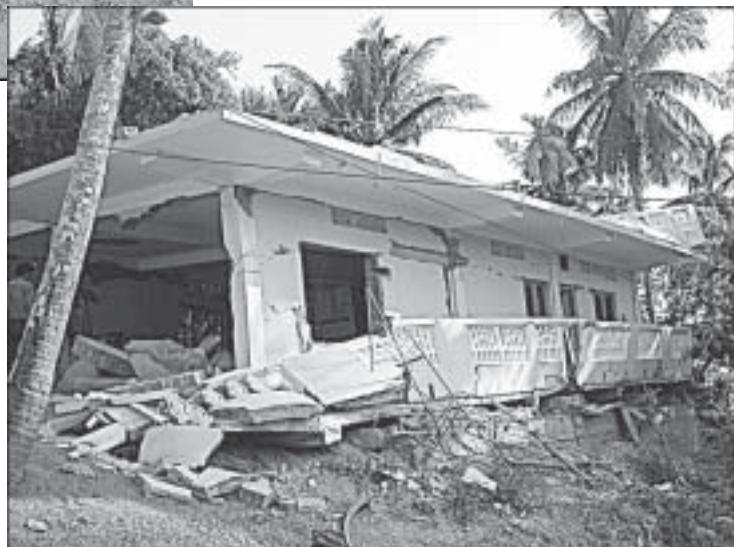
**Fig 4 Collapse of a stilt plus one-storey house in reinforced concrete near Port Blair** (Photo: Hemant Kaushik)

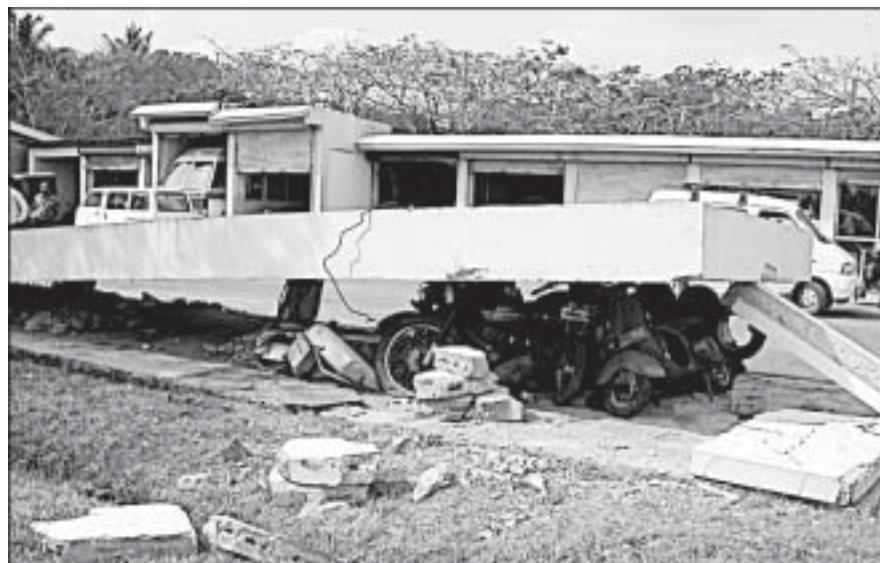
**Fig 5 Collapse of a reinforced concrete scooter stand at Port Management Board office in Port Blair** (Photo: Hemant Kaushik)

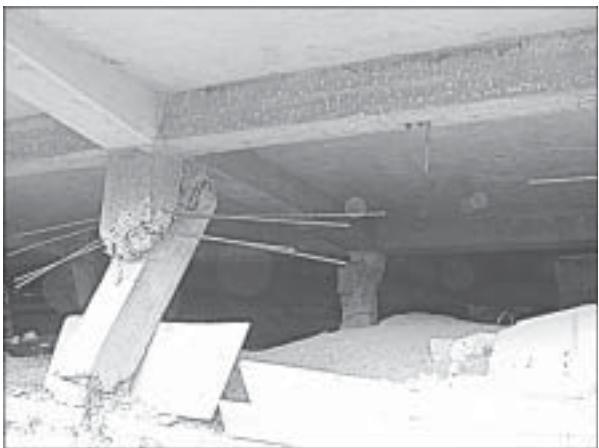
**Fig 6 Collapse of three-storey reinforced concrete frame building at Port Blair** (Photo: Sudhir K Jain)

on stilt columns, not complying with the codal requirements, collapsed, *Fig 6*.

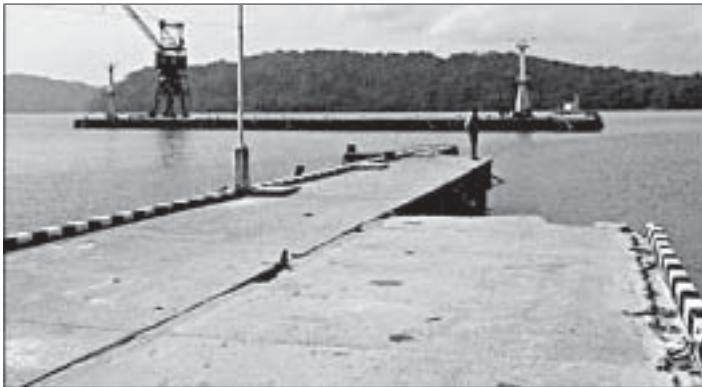
A number of jetties collapsed or were severely damaged in a number of islands, *Fig 7*. This has severely affected the sea traffic and hence the relief operations.

**Fig 7 Collapse of the 80-m segment of the approach to Great Nicobar island jetty at Cambell Bay. This has adversely affected the relief work** (Photo: CVR Murty )

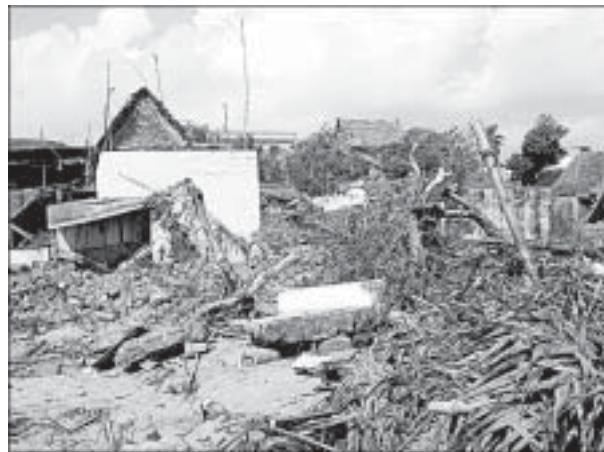
**Fig 8 Ravaged houses at Nagapattinam due to poor construction** (Photo: Alpa Sheth)

The fishing community living along the shore suffered the maximum damage: to its housing, to its boats and fishing equipment, and in terms of loss of life,

*Fig 8. Most houses along the coast had been non-engineered. In general, quality of construction had a major influence on the level of damage sustained by the buildings. Buildings with low foundation depth, those with poorer building materials, poor integrity and poor workmanship were worst sufferers, Fig 9.*

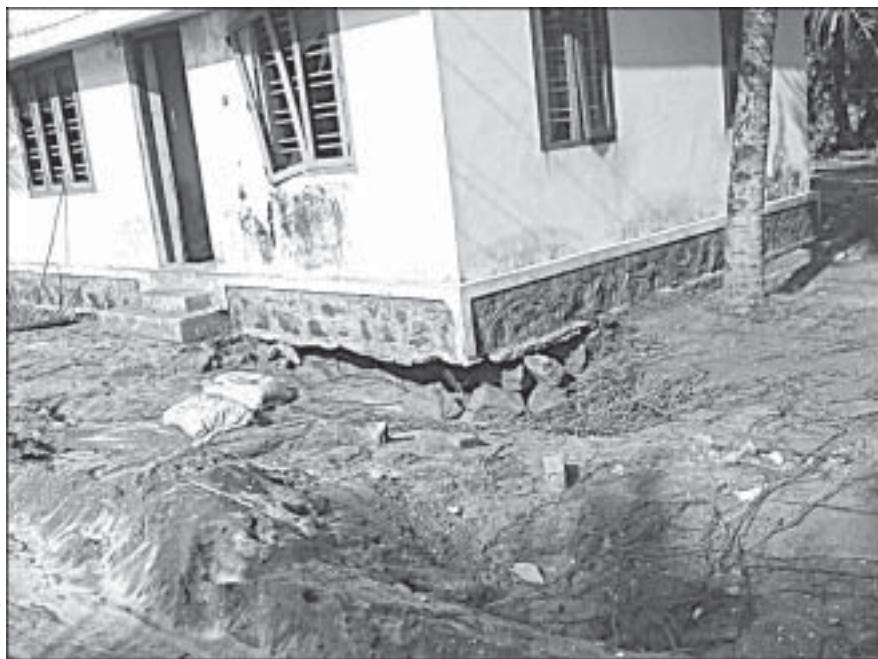
**Fig 9 Foundation failure in Kerala due to scouring of rather shallow foundation** (Photo: Alpa Sheth )

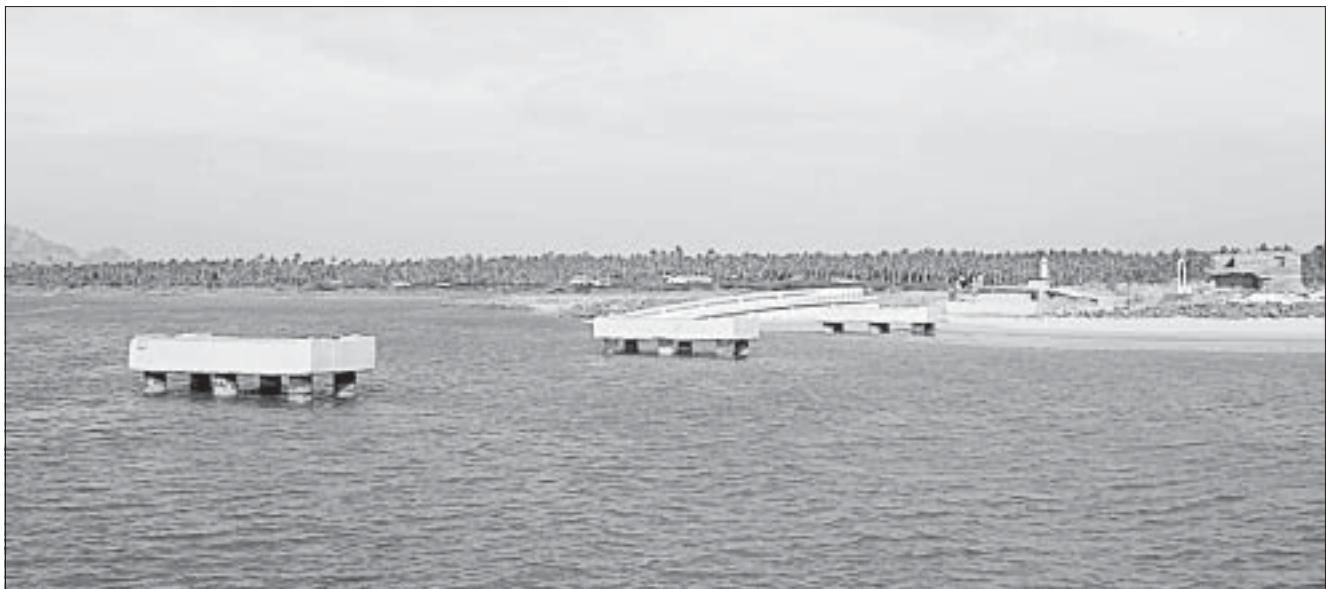
Fig 10 Complete loss of the four span of a RC bridge at Melmannakudi (Photo: Alpa Sheth)

Several bridges suffered serious damages. The superstructure of all four spans of a bridge at Melmanakuddi came off the sub structure and two of the spans washed away to large distances, *Fig 10*. A good connection between the superstructure and the substructure and the additional

provision of restraining upstands — recommended features for seismic design — would have helped these bridges. Infrastructure in Nagapattinam district was significantly affected: a railway line on the shore, telecommunication tower and control panel room were irreparably damaged. Compound walls upto 300 m inside the shoreline were very extensively damaged.

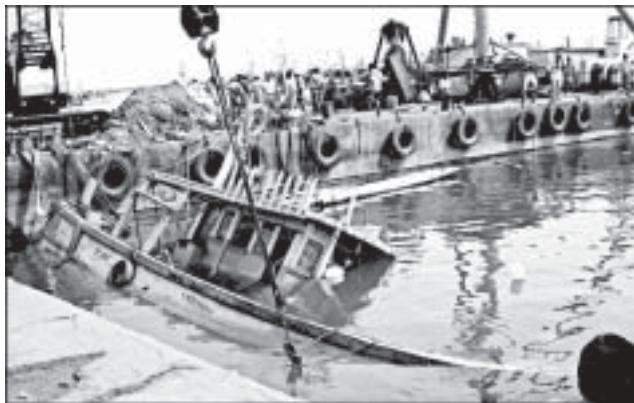
Fig 11 Small mechanised boat sunk into harbour basin being pulled out of water at Fishermen's Wharf, Chennai (Photo: Arvind Jaswal)

In ports and harbours, major disturbance was caused by vessels parting their ropes and becoming loose and hitting other vessels and causing damage. Small boats and ships were tossed astray onto the land by the incoming wave and thereby damaging them. Some boats were sunk to the basin due to the returning giant waves, *Fig 11*.
