## **Chamoli (Himalaya, India) Earthquake of 29 March 1999**

EERI Special Earthquake Report, EERI Newsletter Vol.33, No.7, July 1999

### ***Introduction***

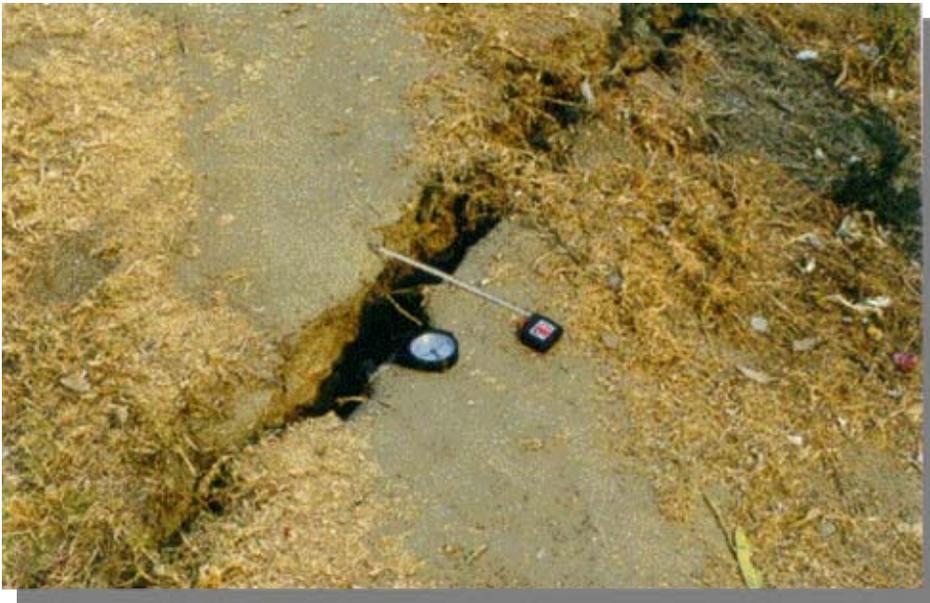
The Chamoli earthquake was accompanied by severe ground deformations. Development of ground fissures, landslides and changes in the groundwater flow were reported from several locations. Well-developed ground cracks trending roughly in the east-west direction and showing lateral movement of up to about 12 cm were observed in Gopeshwar, Chamoli and Bairagna. Attempts were made to make trenches across some of these ground fissures at the Telecom Hill, Gopeshwar (*Figure 5*). None of the trenches could be extended down more than a meter, as these were bottomed on the rubbles or boulders, which form part of debris. In one of these trenches, a poorly defined thrust plane was detected. Orientation of these ground fissures, although discontinuous, conforms to the strike of the thrust front (MCT-I). Majority of these east-west oriented fissures, particularly those developed in the well-consolidated debris, may be a manifestation of the fault movement.

*Figure 5:* Ground fissure at Telecom Hill near Gopeshwar

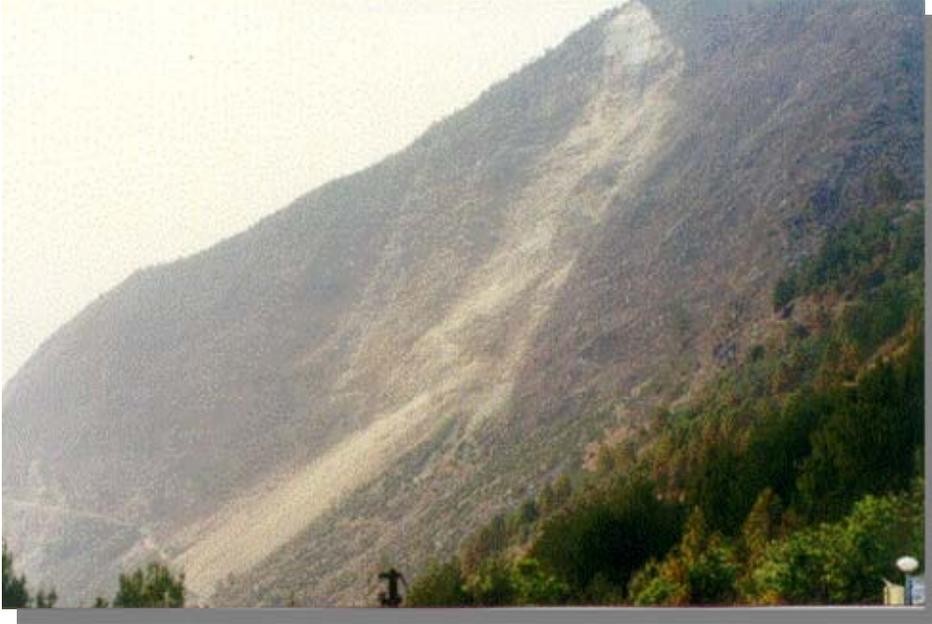
Ground cracks at several places also developed as part of slope failure and these pose threat to the down-slope settlements. Cracks were seen in asphalt roads at some locations, indicating the possibility of failure due to ground slippage. At several sites, large-scale earthquake-induced landslide/rock falls were observed (*Figure 6*). Those near Gopeshwar, Chamoli and Gadi continued

*Figure 6:* A major landslide about 1km north of Gopeshwar. It blocked the road traffic to Okhimath for a considerable period.

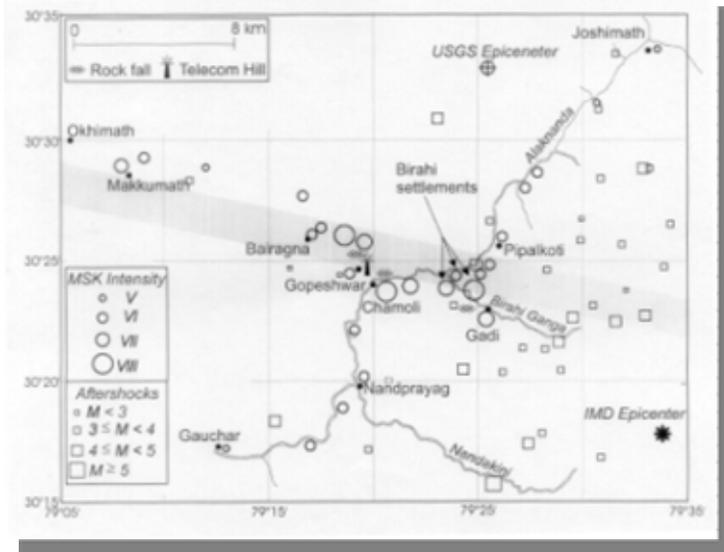
Figure 4 shows the intensity of shaking at some of the locations. The maximum intensity was VIII on MSK scale (at Upper and Lower Chamoli and at Upper Birahi). Intensity showed rather abrupt changes from one location to the other, because of the site effects on river terraces composed of alluvial deposits of sand and boulders. For instance, the right bank of the Birahi Ganga river has two settlements: Upper and Lower Birahi about 1 km apart. The intensity of shaking was VIII at Upper Birahi located on the river terrace at a higher elevation, whereas it was only VI at Lower Birahi on hard rock. A forest department check-post just across the river from Lower Birahi also showed higher intensity (VII) due to its location on the river terrace. The intensity at Lower and Upper Chamoli was VIII, and that at Gopeshwar, located only 2 km aerial distance

away, was only V. While Chamoli is located on the river terrace, Gopeshwar is at a higher elevation on the hill slopes. Intensity VII observed at Makkumath located also on a river terrace about 20 km aerial distance from the epicenter is another example of site amplification due to alluvial cover.

Figure 4: Intensity variation during the main shock and location of aftershocks in the affected area. Shaded portion shows the trend of the fault as per the fault-plane solution, which is consistent with the damage distribution.

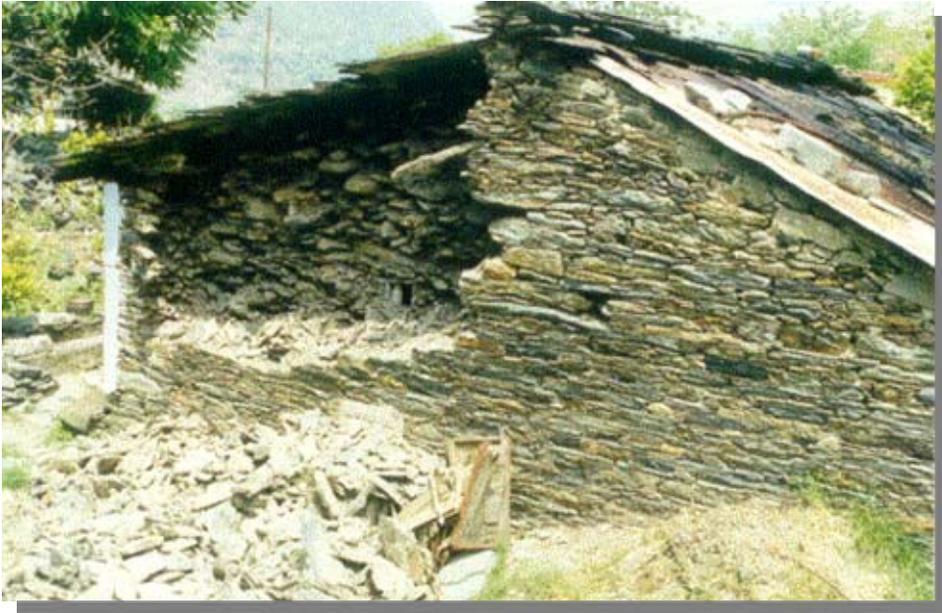
between. In carefully done walls of this type, the dressed stones appear at intervals of about 0.5m along the length and about 0.3m along the height, else they appear at random locations. Unlike in case of random rubble masonry, the rubble of small stones is not dumped in the middle region of the wall. Since none of the slate wafers is wide enough, this type of wall also has a tendency to split and buckle into two separate wythes due to lack of interlocking (*Figure 7*).

*Figure 7:* Collapse of one of the wythes in a traditional house in slate wafer masonry.

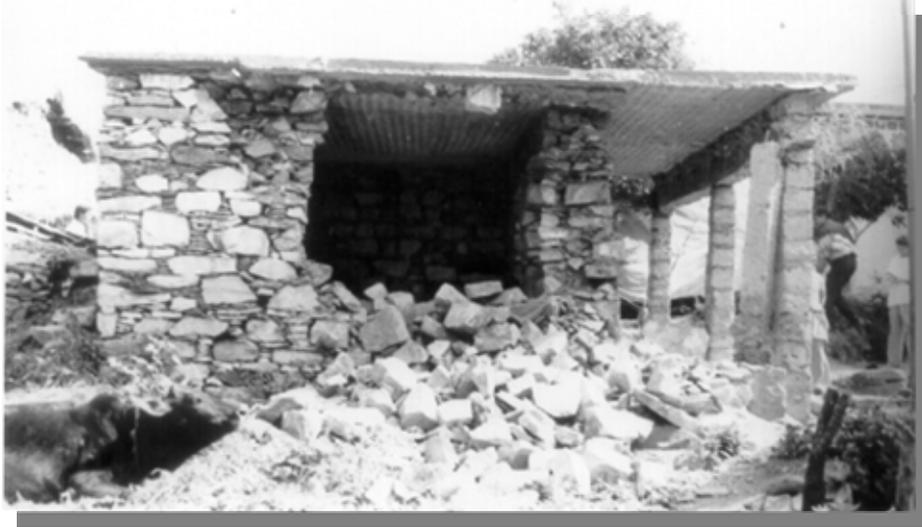
These dwellings have heavy roof mass and rather weak walls, and these performed poorly as expected (*Figure 8*). Most of the deaths and injuries occurred due to the collapses of such units. In fact, many older buildings owned by the government also fall in this category. The police lock-up at Upper Chamoli consisted of random rubble masonry in cement mortar; collapse of this building killed six inmates and injured about twelve persons. However, the dwellings with masonry walls in slate wafers performed better than those in random rubble masonry. The most common damage pattern was the separation of wythes following which the walls tended to buckle. Where wood rafter roofs were used, partial cave-in of the roof along with the wall was also frequently

observed. Most constructions using wooden post system for supporting roof were able to withstand the motion without collapse. However, the walls of these structures were extensively damaged, and the houses were left unfit for occupation.

Figure 8: Partial collapse in a random rubble stone masonry. Note that the front portion has RC beam supported on concrete block columns and roof consists of RC slab

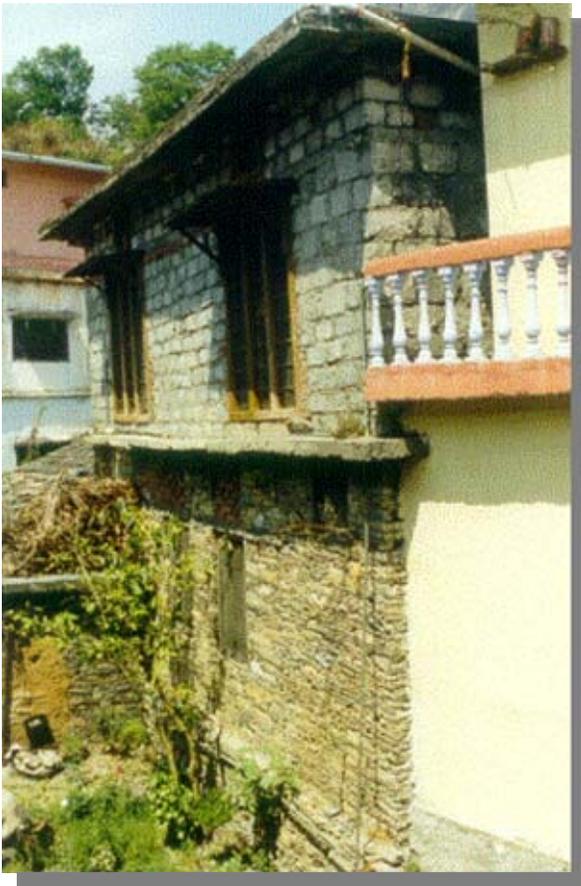
Numerous dwellings built in recent years in villages as well as in towns are provided with a reinforced concrete lintel band. These include both stone masonry buildings and brick/concrete block masonry buildings (*Figure 9*). Often the rooms are provided with a RC shelf (about 0.45 m wide) projecting from the wall at lintel level; it serves the dual purpose of a storage slab and a lintel band. Most houses with lintel band performed very well, even though the quality control in these dwellings may not have been very good. Some buildings with lintel band that sustained damage had serious flaws with continuity of the band (*Figure 10*).

*Figure 9:* Two-storey house at Pipalkoti with no damage. Ground storey in slate wafer masonry, upper storey added later in concrete block masonry. Both storeys have RC lintel band

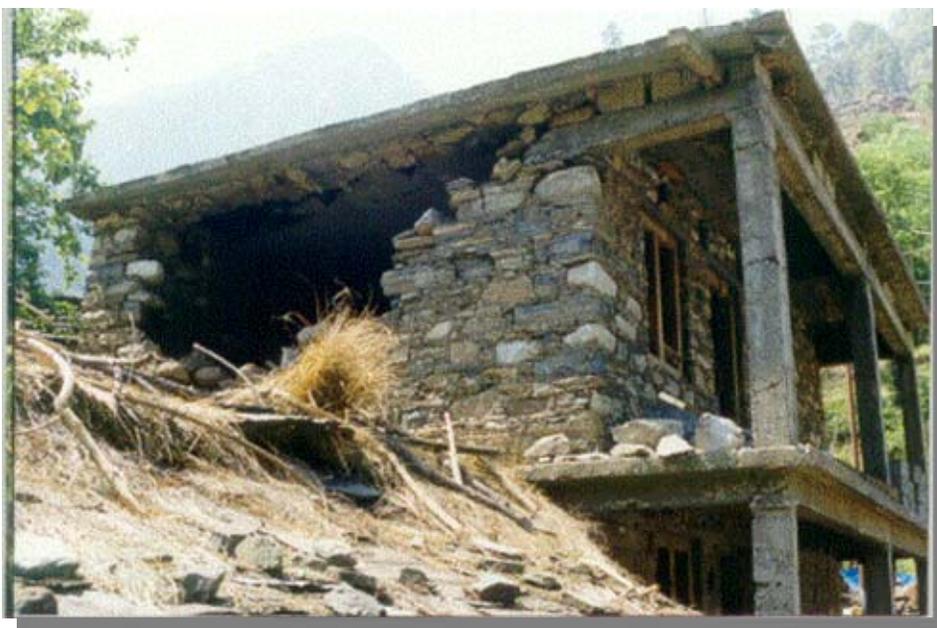
*Figure 10:* Partial collapse in a stone masonry house at Gadi village. Lintel band, present in the front portion, does not continue in the side wall

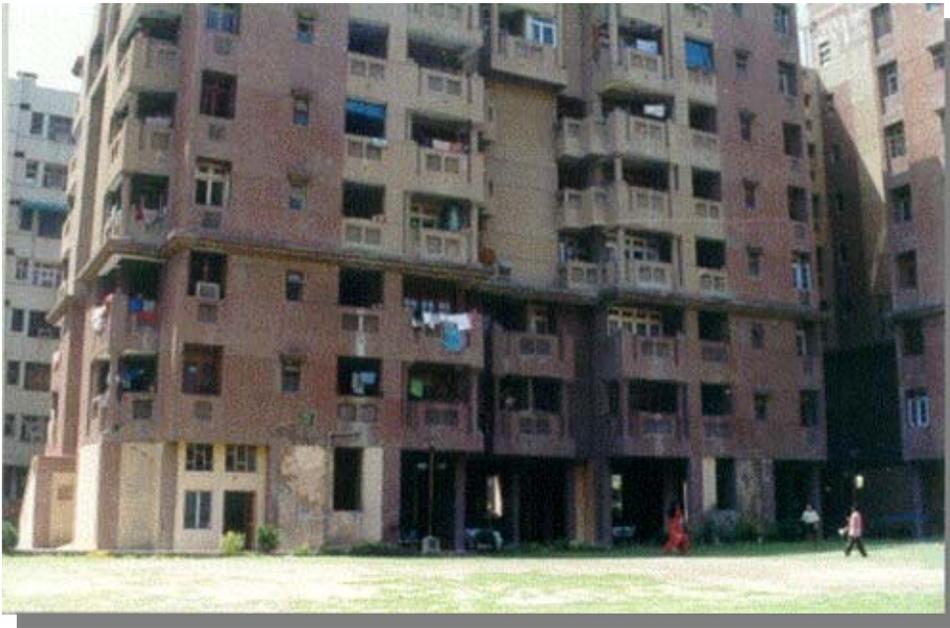
An interesting aspect of this earthquake was that a few buildings in Delhi (280 km aerial distance from epicenter) sustained some non-structural damage. For instance, Tarang Apartments (*Figure 11*), an eight-storey building with open ground storey, in Patpatganj area located on the banks of the Yamuna river, sustained cracks in infill walls and separation of infills from RC frame at the lowest storey. These damages, even though minor, underline the disaster potential of Delhi not only from the nearby damaging earthquakes, but also from the large events in the far-off Himalaya. Many buildings in Dehradun (125 km west of Chamoli town) sustained damage. For instance, some old buildings of the Survey of India sustained collapse of gable masonry, and severe cracking along the junctions between the pitched roof and the masonry walls.

*Figure 11:* Tarang Apartment in Delhi that sustained damage due to infill walls

- c) Non-structural damage to some buildings in far-off Delhi clearly underlines the potential for a major disaster in Delhi from not just nearby damaging earthquakes but also from large events in the Himalaya. Considering the political and other significance of such an eventuality, efforts should be directed for an effective earthquake disaster mitigation and management in the Indian capital.

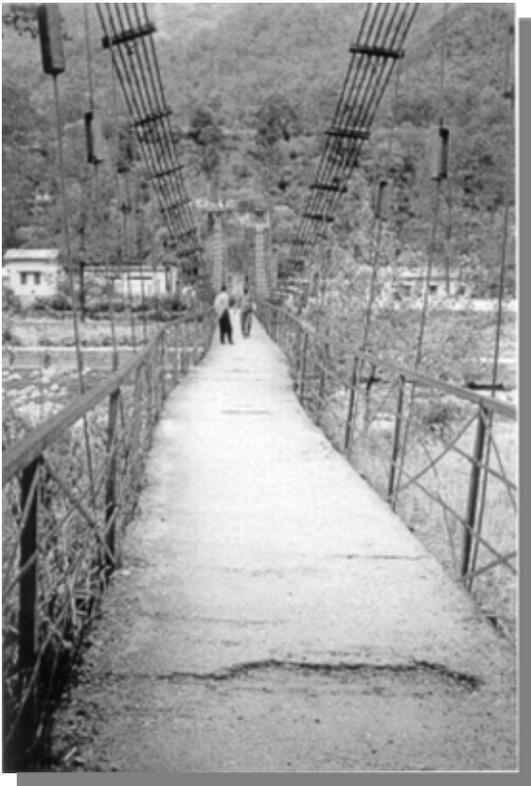
The area has numerous pedestrian bridges across the rivers; some of these are of suspension type with span ranging from 15m to 60m. Lateral buckling of the bridge deck was observed at one of the pedestrian suspension bridges located near Bairagna (*Figure 12*). The cables were found to have loosened, possibly due to shifting of the anchor block at one end due to slope instability.

*Figure 12: Lateral buckling of the deck of a suspension bridge at Bairagna*
