PRESS RELEASE

NICEE@IIT KANPUR RECONNAISSANCE SURVEY OF THE 2016 IMPHAL EARTHQUAKE OF JANUARY 04, 2016

National Information Center of Earthquake Engineering Indian Institute of Technology Kanpur, India

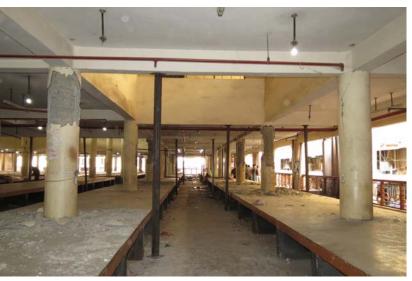
General damage to buildings and other structures agreed well with the intensity of ground shaking observed at various places, with the maximum of VI at Imphal and Tamenglong in Manipur on MSK scale. However, unexpected severe damage at an intensity of VI in Imphal was observed in buildings, such as, residential apartments of central agriculture university at Lamphelpat, a 3-storey building in Keishampat (Fig. 1), New Market and Laxmi Market in Imphal (Fig. 2), and a 4-storey building in Dewlahland.

Fig. 1. Collapse of a 3-storey building in Keishampat, Imphal
