Performance of structures during the Sikkim earthquake of 14 February 2006

Hemant B. Kaushik*, Kaustubh Dasgupta, Dipti R. Sahoo and Gayatri Kharel

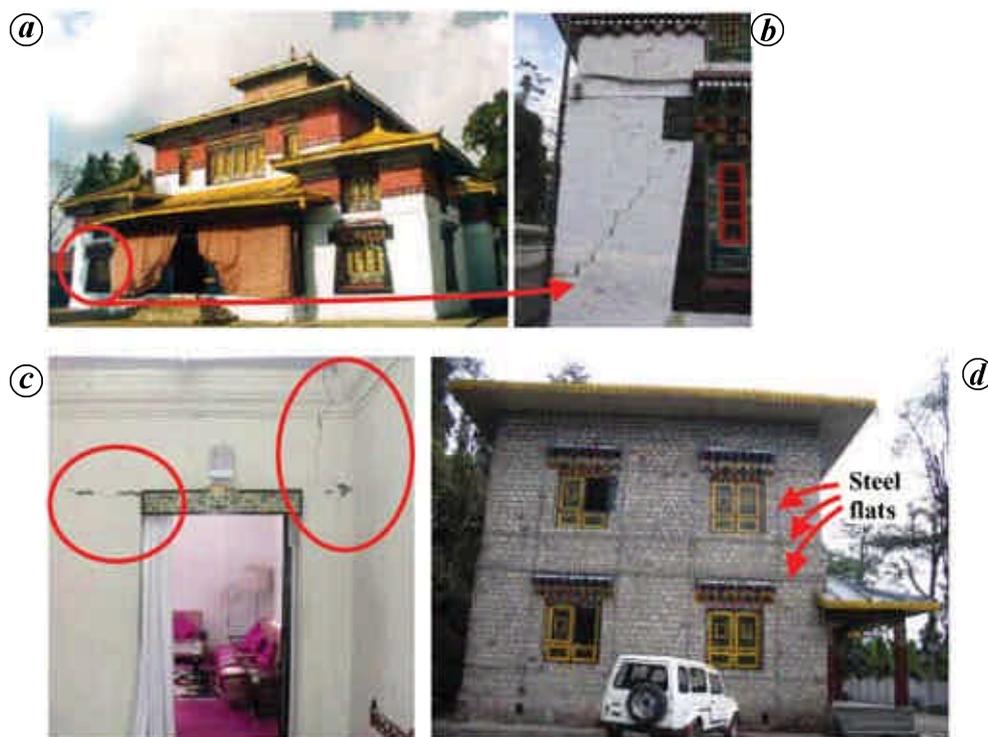
Figure 3. Performance of masonry structures at Gangtok. *a, b*, Wide shear and vertical cracks in masonry walls at corners and near openings in Enchey Monastery. *c*, Numerous cracks near door/window openings were observed at Raj Bhavan. *d*, Good performance shown by retrofitted Archive building (arrows show steel flats used to retrofit the building after the 1988 Bihar–Nepal earthquake).

Generally, stone-masonry structures in the area are of undressed stones with mud mortar. A few important structures have dressed stone masonry with mud and lime-based mortar (e.g. the Raj Bhavan). Stone-masonry buildings suffered damages primarily because of undressed stones used without proper bonding between adjacent courses of masonry, and also at the corners. The mud mortar used as bonding material in these buildings further aggravates their lateral strength capacity. Some of the important masonry buildings damaged during the earthquake are Enchey monastery (Figure 3 *a* and *b*) and the Raj Bhavan (Figure 3 *c*). These buildings were also damaged during the 1980 and 1988 earthquakes⁴. It seems that these buildings were only ‘repaired’ and not adequately retrofitted against future events. During the present earthquake, several masonry walls of these buildings suffered damages in the form of inclined shear cracks, and vertical cracks (Figure 3 *a–c*). These cracks were concentrated at the corners, and also at the location of window and door openings. The two-storey Archive building was previously the Legislative Assembly building at Gangtok, until it was damaged during the 1988 Bihar–Nepal earthquake. Subsequently, this masonry building was retrofitted by fixing horizontal and vertical steel flats of about 50 mm × 8 mm size on all the outer faces of the exterior walls in each storey (Figure

3 *d*). The building sustained no damage during the present earthquake. Clearly, sensible retrofitting of important heritage structures can be critically useful in the future earthquakes.

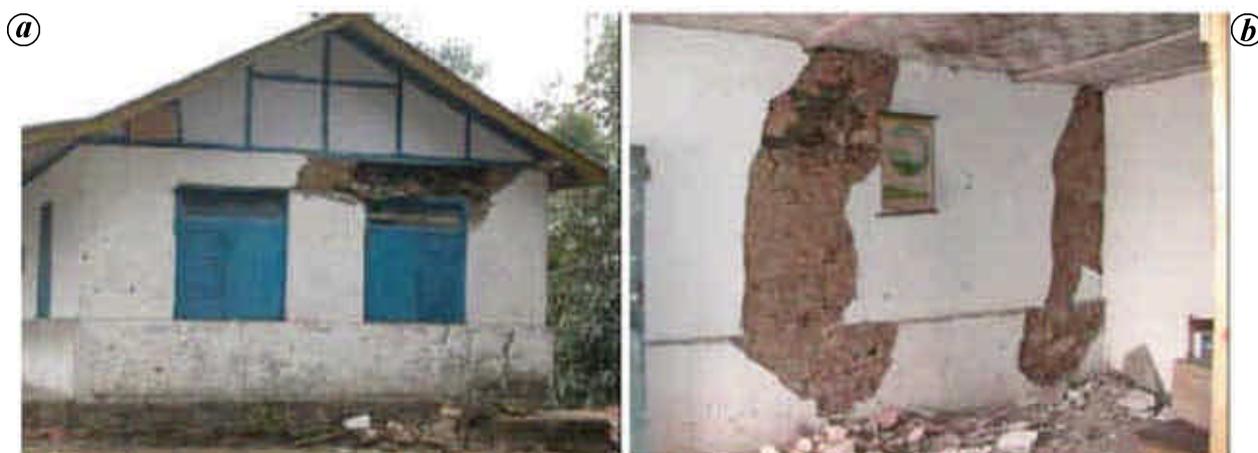
In rural areas of Sikkim, low-cost school buildings are generally constructed by the state government using stone masonry with mud mortar. Several such buildings suffered severe damage during the present earthquake. Earthquake-resistant features such as horizontal bands at various levels and stones at the corners are generally not provided in such constructions. This resulted in the formation of severe cracks near the corners and at the location of openings in such buildings, when subjected to even mild shaking (Figure 4). In addition, out-of-plane tilting of several masonry walls was observed at some places.

Figure 4. *a, b*, Severely damaged stone masonry low-cost school buildings in Sikkim. (Government Primary School, Thamidara near Gangtok).

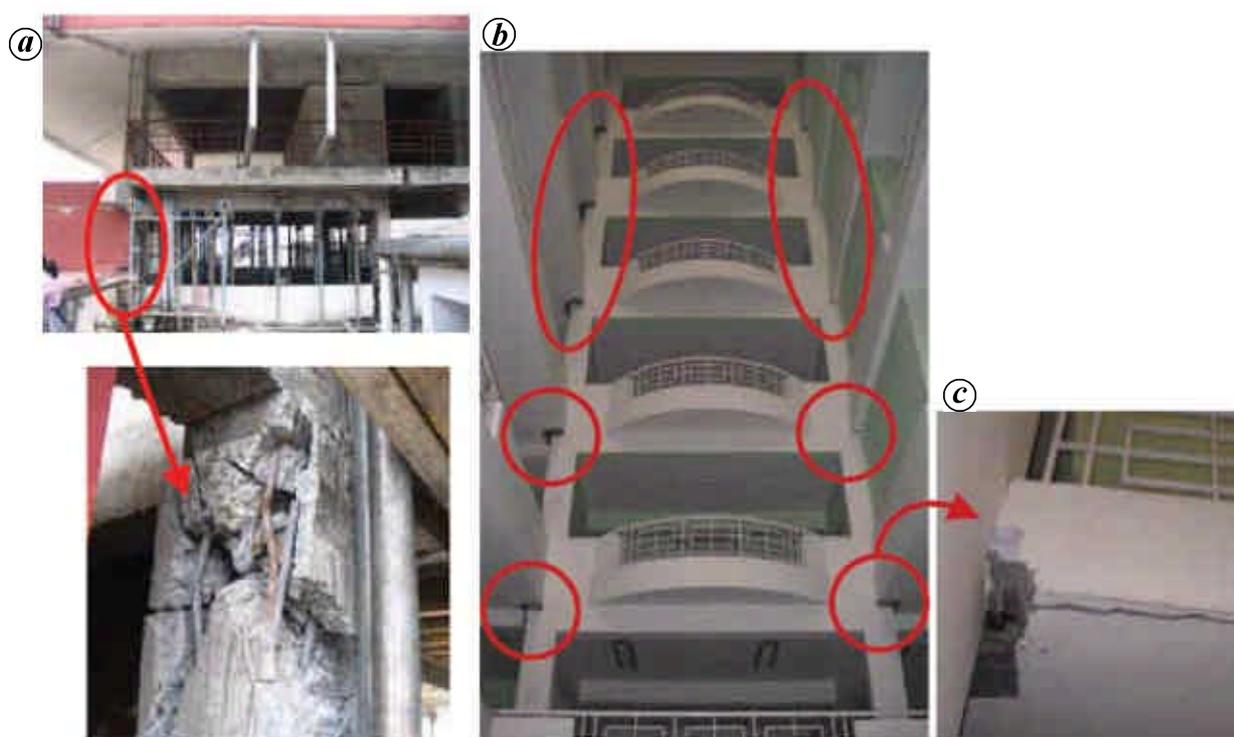
Figure 5. Damages in nine-storey RC hostel building (SMIMS). *a*, Damaged RC column supporting water tank on the roof. *b* and *c*, Pounding damages at the ends of the two wings took place at all the floor levels.

Several masonry-infill walls developed diagonal cracks due to the earthquake. One RC column below a water tank at roof level suffered heavy damage because of inadequate shear reinforcement, and improper lap splicing in longitudinal reinforcement (Figure 5 *a*). A few hostel rooms in the top storey just below the damaged column were evacuated soon after the shaking. Pounding damages were observed between two long wings in the building and corridors connecting these (Figure 5 *b* and *c*). Another four-storey RC building at Deorali suffered damages and was

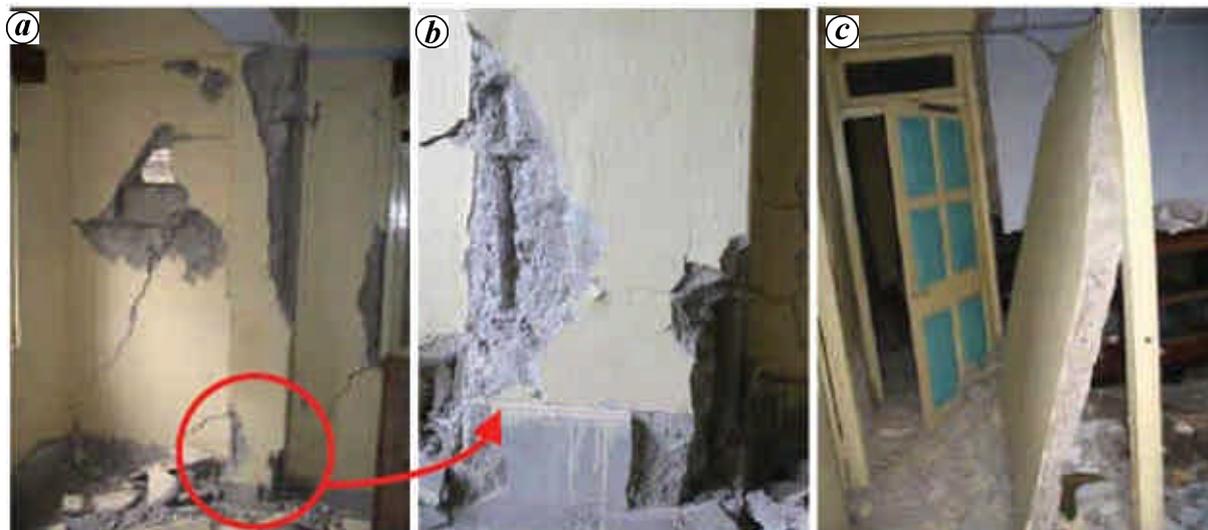
Figure 6. Damage in residential building at Deorali. *a*, Severe cracking in infill walls and damaged RC column. *b*, Exposed mild steel in damaged RC column; and *c*, Out-of-plane failure of infill wall.

evacuated. Severe damages were observed in several RC columns of the building, exposing mild steel bars as main reinforcement (Figure 6 *a* and *b*). Poor material quality and poor connection between perpendicular masonry walls resulted in out-of-plane failure of one infill wall, and severe damage to other infill walls in the building (Figure 6 *a* and *c*).

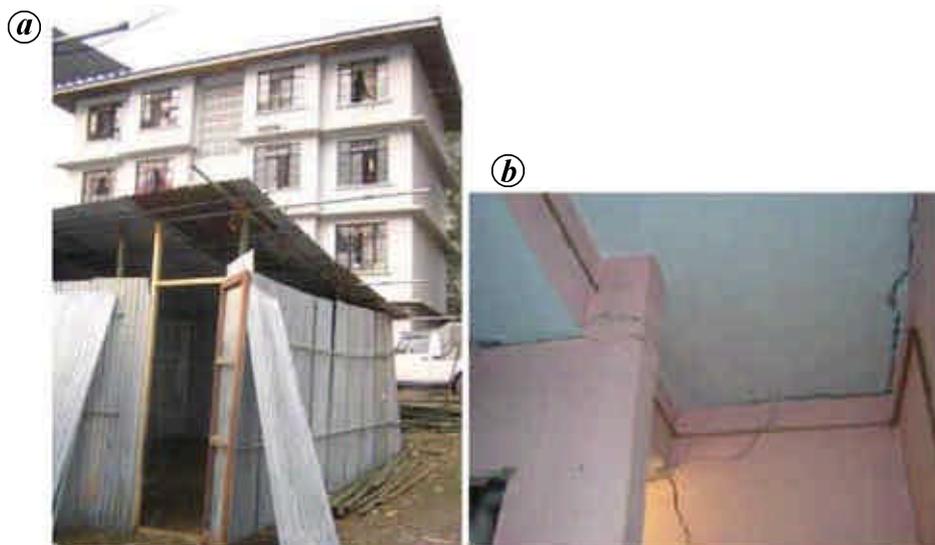
Figure 7. Four-storey government residential building (SNT colony) at Ranipool which suffered severe damage. *a*, Temporary shelters constructed using GI sheets in the backdrop of the RC quarters. *b*, Damaged columns and walls in one of the quarters.

along with cracks in several other infills. In several RC columns of the building, spalling of cover concrete due to corrosion of reinforcement bars was observed along with inadequate shear reinforcement. Several RC buildings (up to four-storey high) of Sikkim Nationalized Transport (SNT) colony at Ranipool near Gangtok suffered similar damages (Figure 7 *a*). At least one quarter was severely damaged (Figure 7 *b*), and the government had already given orders for evacuation. At the time of reconnaissance visit, temporary relief quarters (~7 m × 7 m) using GI sheets, bamboo posts and GI pipes were being constructed in front of the RC buildings, and residents were instructed to move into them (Figure 7 *a*).

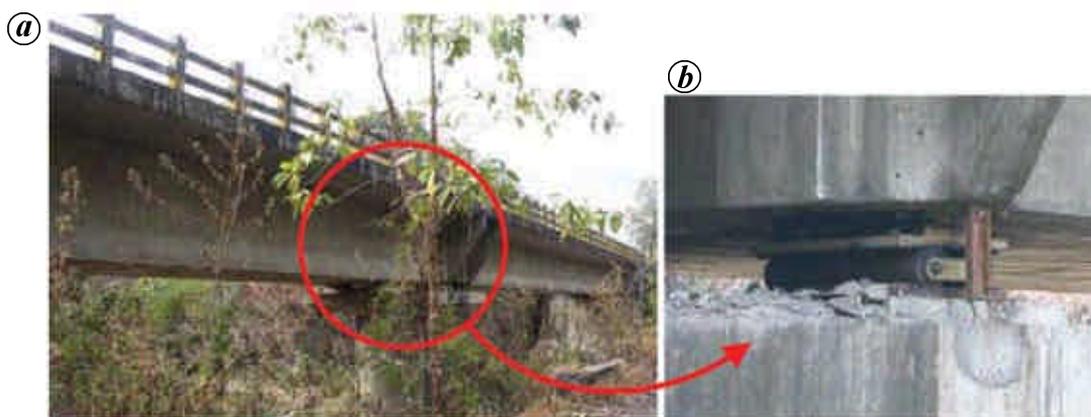
Figure 8. Two-span RC Tarkhola bridge between Melli and Rangpo appeared to be slightly damaged at the location of roller bearings on top of central pier. *a*, Bridge overview; *b*, Closer view of central pier cap showing spalling of concrete and insufficient lateral restrainer made of steel at the top of the pier.

There are several bridges on National Highway 31A, which connects Sikkim to the rest of the country. In the Tarkhola bridge between Melli and Rangpo, spalling of concrete was observed at the top of the central pier near bearings (Figure 8). One needs to ascertain if this was caused by the earthquake. Bridge-deck lateral restrainers, which can prevent the spans from dislodging-off the piers, were observed in most of the bridges along NH 31A. However, these steel lateral restrainers appeared to be insufficient in holding the bridge decks during severe ground shaking expected in seismic zone IV (Figure 8*b*). An RC pedestrian foot bridge constructed in 1989 near STNM Hospital, Gangtok sustained minor damage in the form of spalling of cover concrete in one RC beam due to corrosion of reinforcement bars. Horizontal cracks were observed in masonry walls of an RC office building of the Sanitation Section, Urban Development and Housing Department, Sikkim, constructed under the foot bridge at one end.
