National Information Center on Earthquake Engineering

# 2011 SIKKIM EARTHQUAKE

## Effects on Built Environment & A Perspective on Growing Seismic Risk

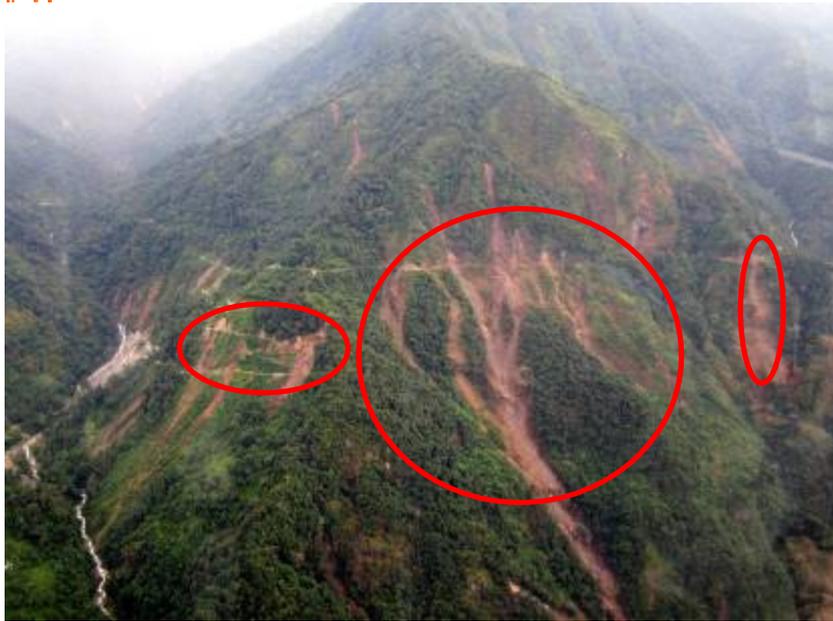
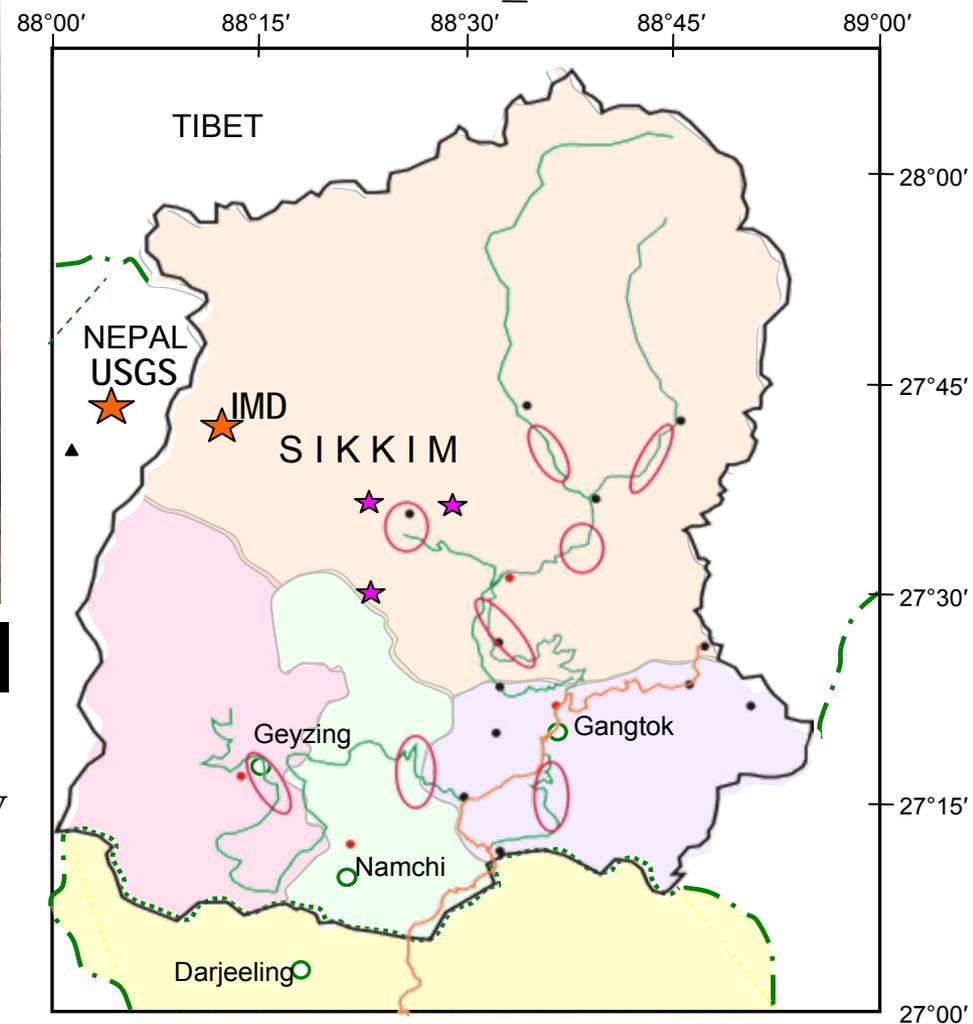
## Landslides disrupting the road network

More than 300 landslides occurred all over the state and disturbed the road connectivity to major towns like Mangan, Chungthang, and Lachung and even NH31A, main route connecting Sikkim and West Bengal.

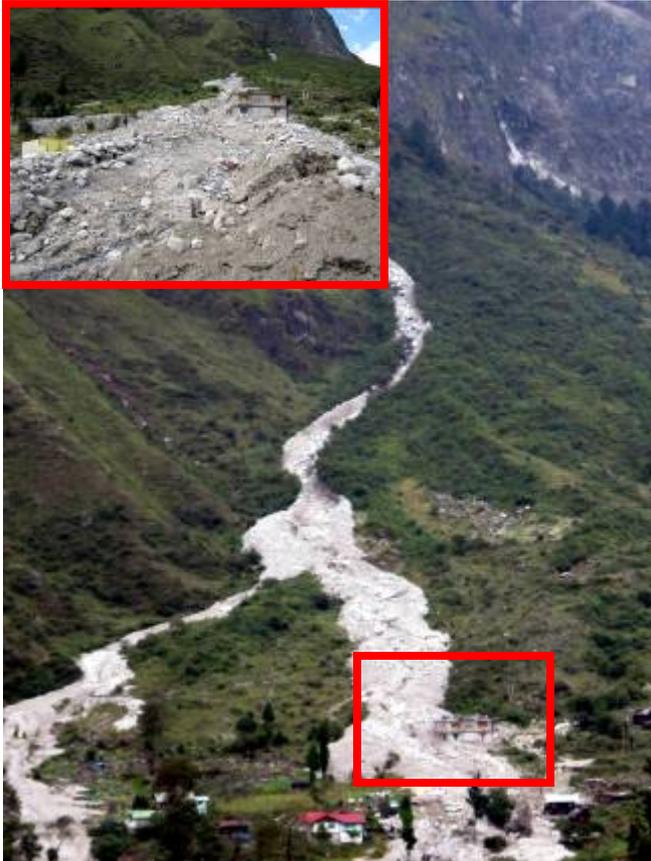
**Devastation in Lachung**

Huge rockslide that came two days after the earthquake damaged several housing units in Lachung.

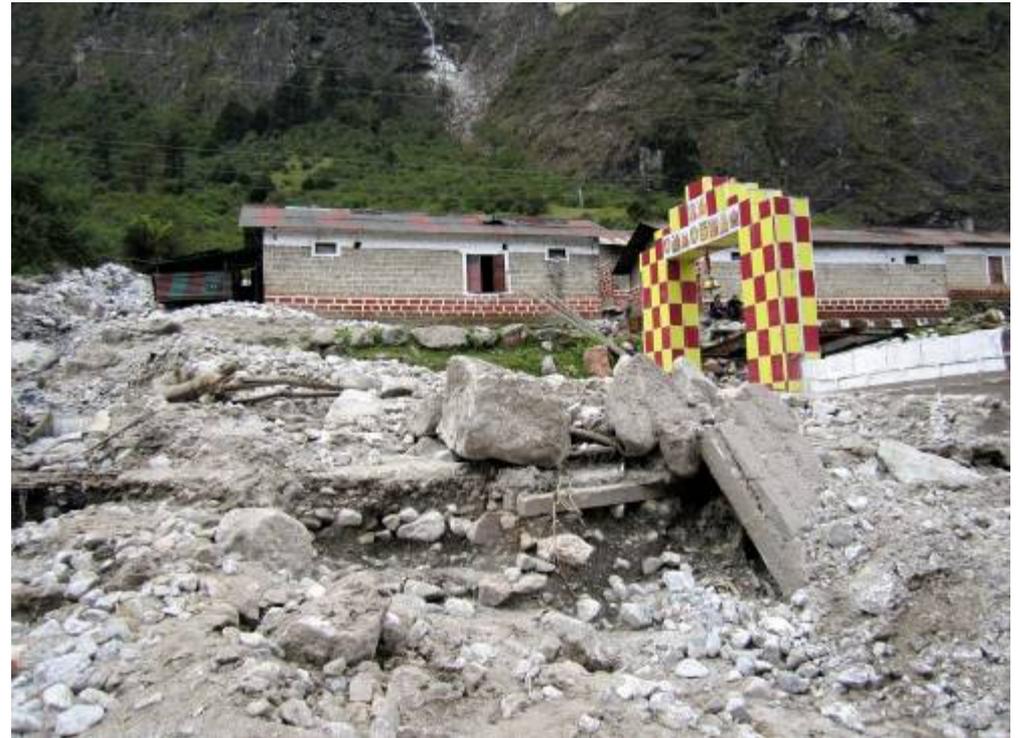
**Collapsed temple, Lachung**

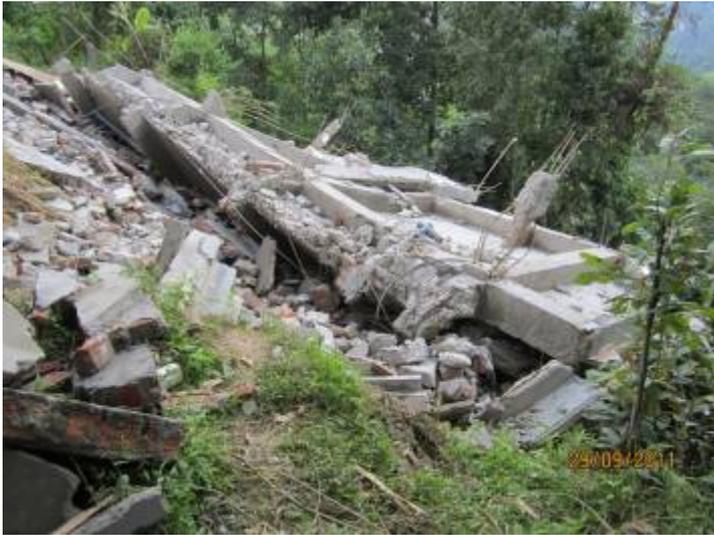
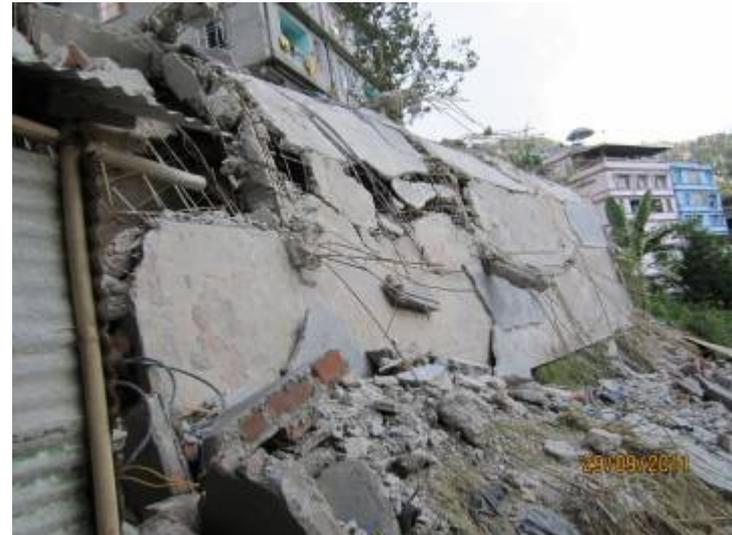
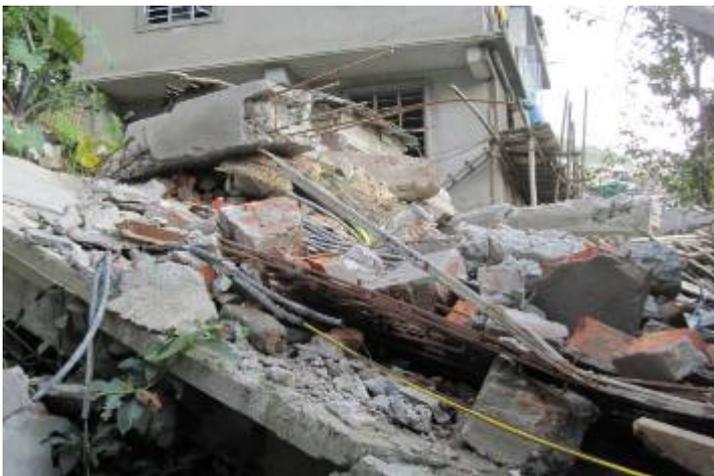
**5-storey building at Lumshey Bastey, Gangtok**

Collapse of the building highlights the structural deficiencies widely present in RC buildings in the affected region. This includes lack of earthquake-resistant design and detailing, faulty construction practices, poor quality of construction materials, workmanship, etc.

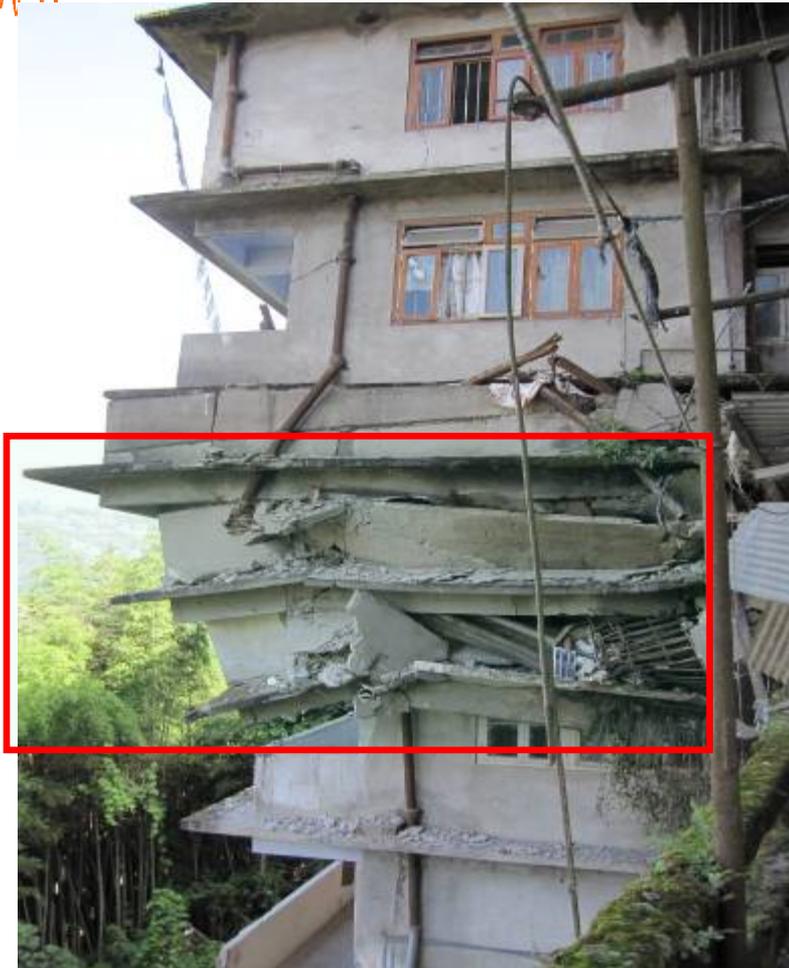
**Pan-caking failure of two stories of a 9-storey building at Gangtok**

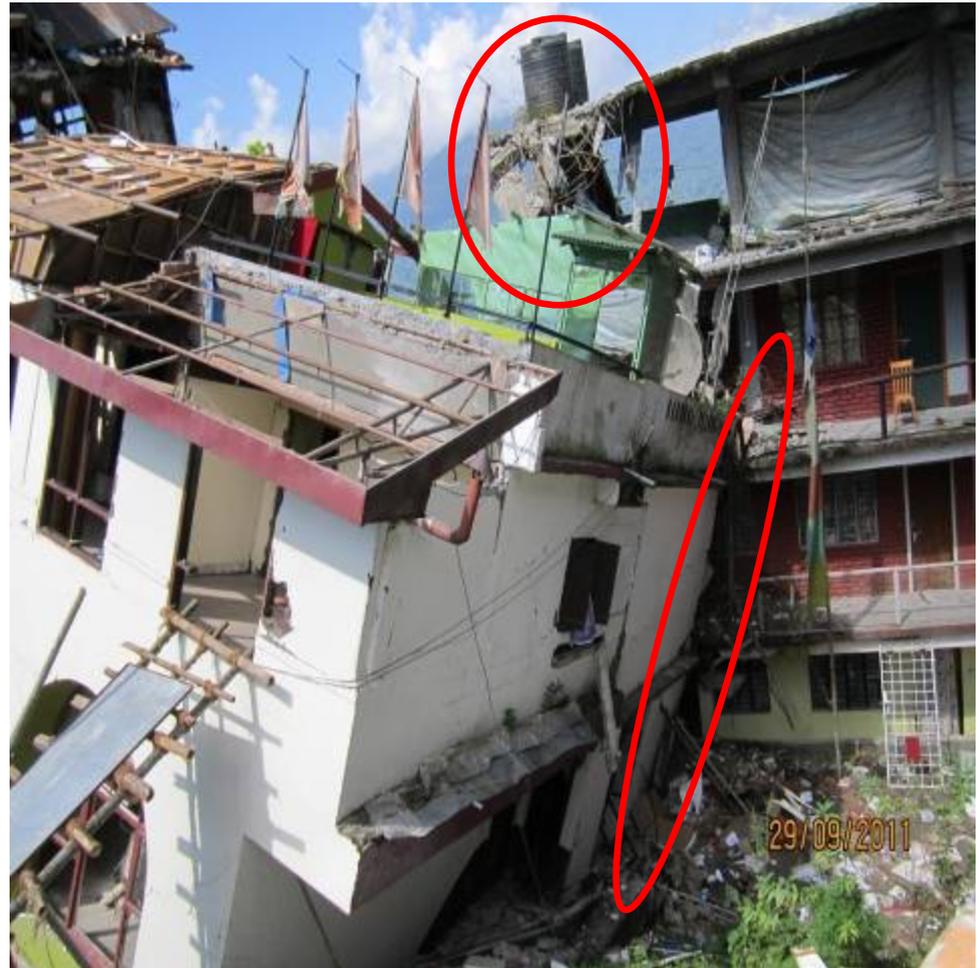
**Collapsed building colliding with adjacent building at Gangtok**

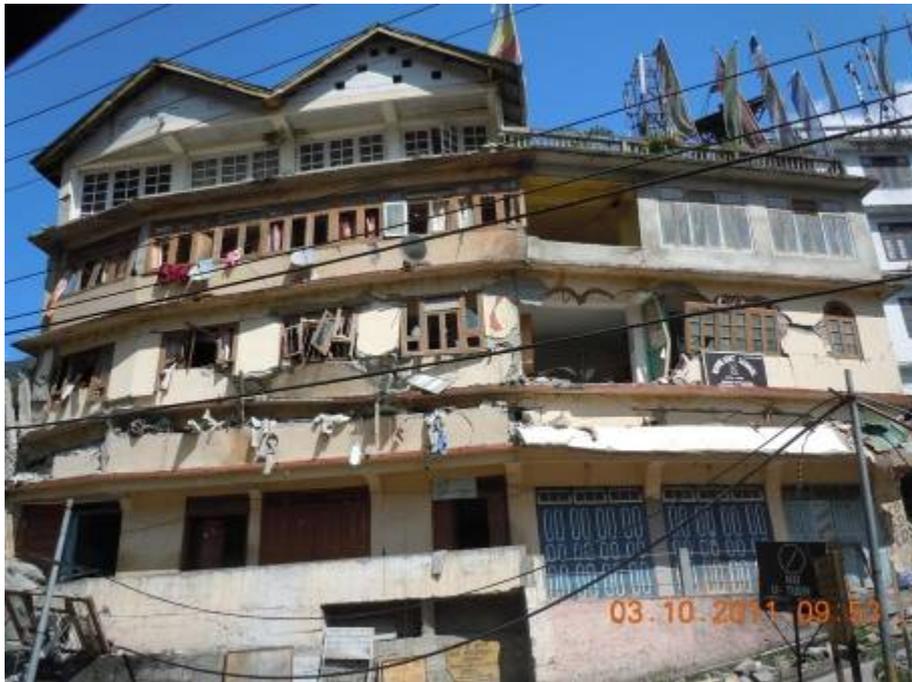
**Pan-caking failure of school-cum-residential building at Chungthang**

A large number of concrete and masonry buildings were severely affected in the town of Chungthang, highlighting serious deficiencies in the prevailing construction practices.

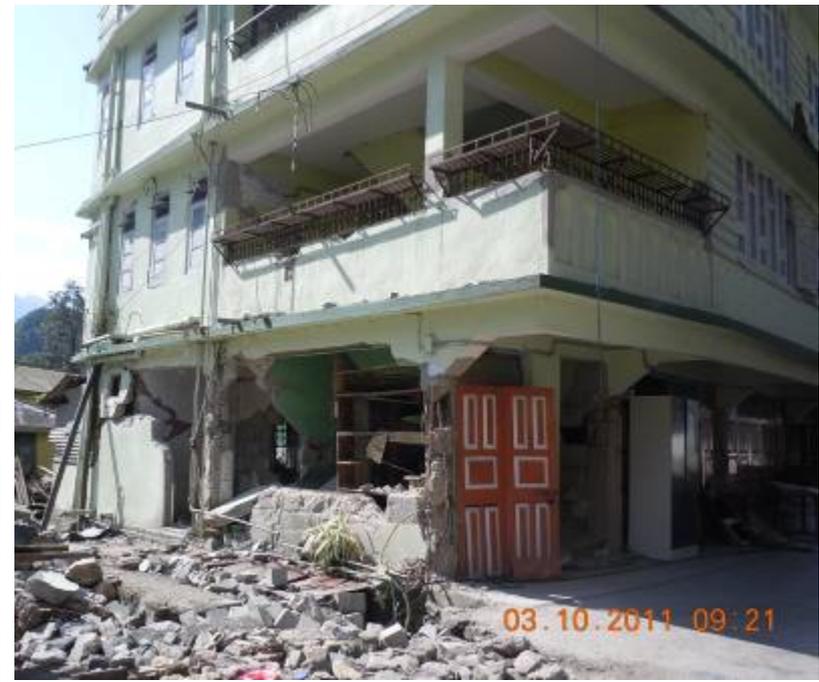
**Severe damage in a 5-storey building at Chungthang**

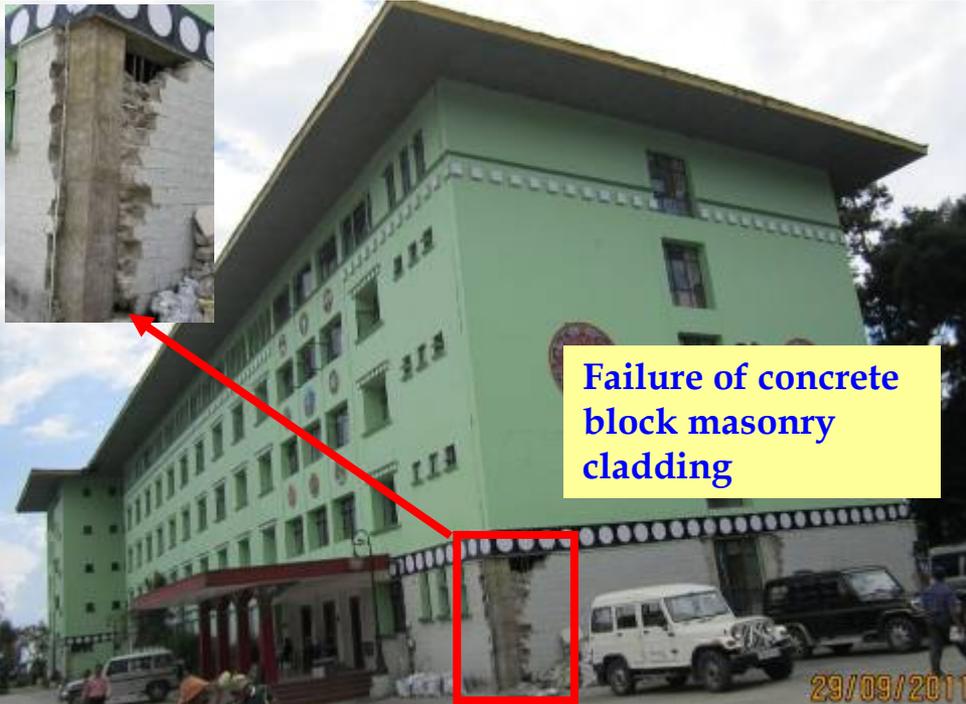
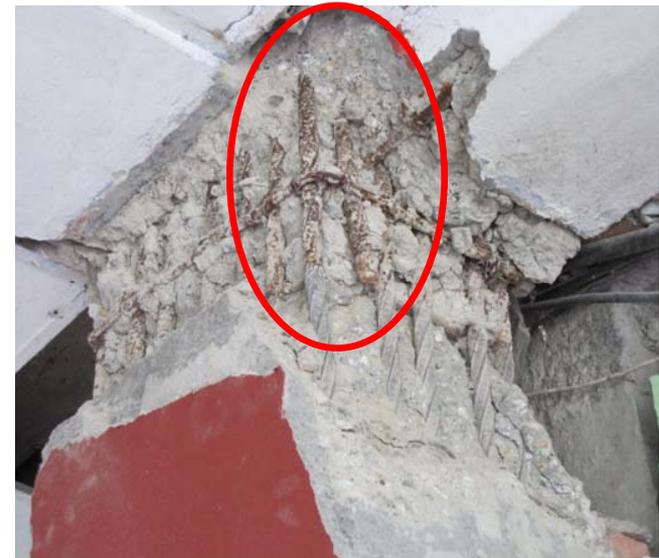
**State Secretariat building at Tashiling, Gangtok**

The building constructed in mid-70's suffered damage in the 2006 Sikkim earthquake and underwent repair. Lack of seismic detailing of RC frame members and beam-column joints, poor quality of infill material and concrete were the main causes of its poor performance in recent and previous earthquakes.

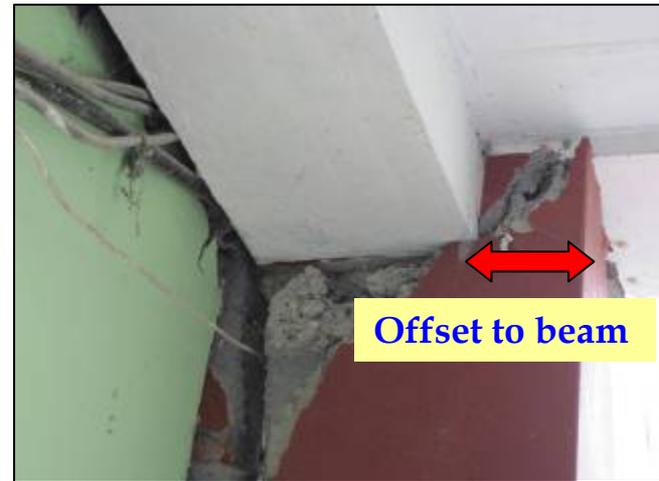
**Failure at beam-column joint**

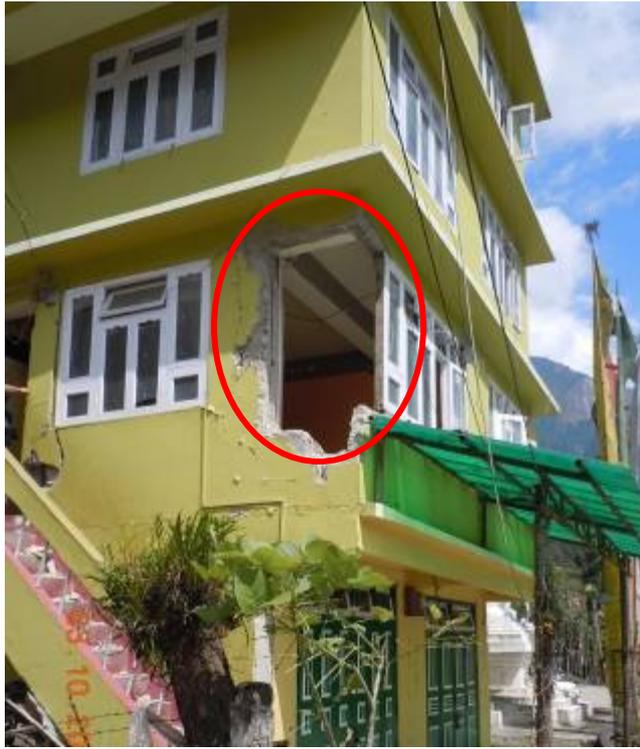
**Failure of unsupported wall**

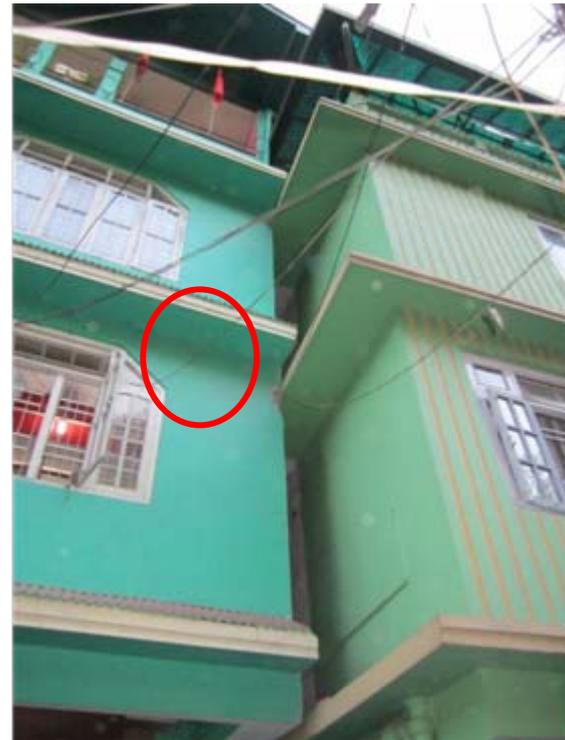
**Pounding between two adjacent buildings**

It is common practice to construct buildings very close to property lines due to smaller plots in urban areas, and sometimes with no gap at all between the adjacent buildings leading to damage due to pounding.

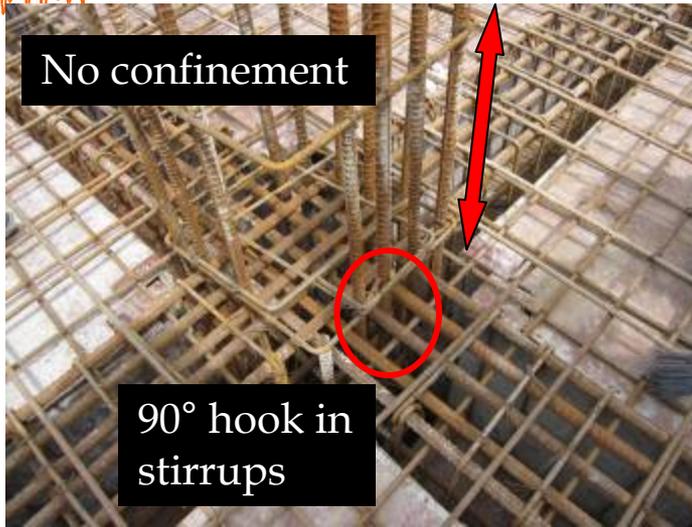
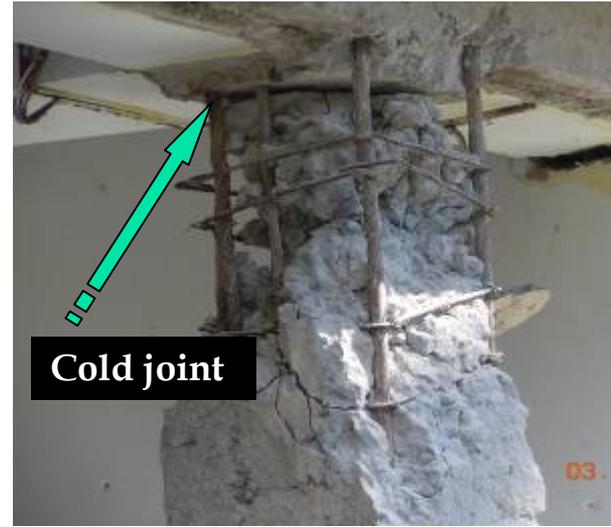
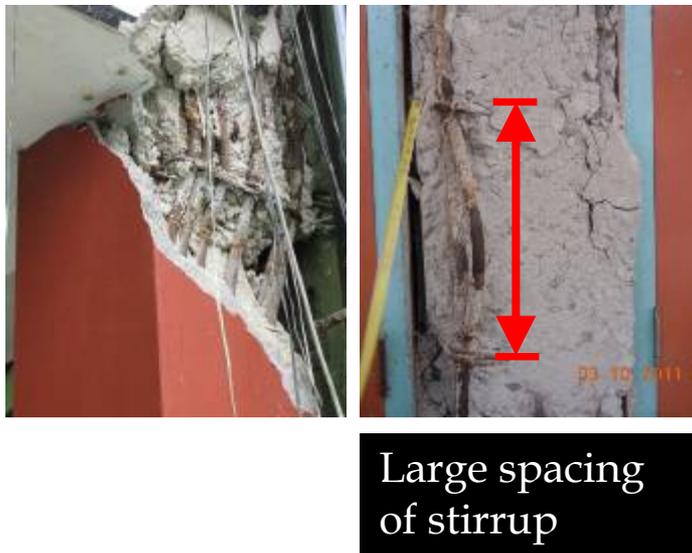
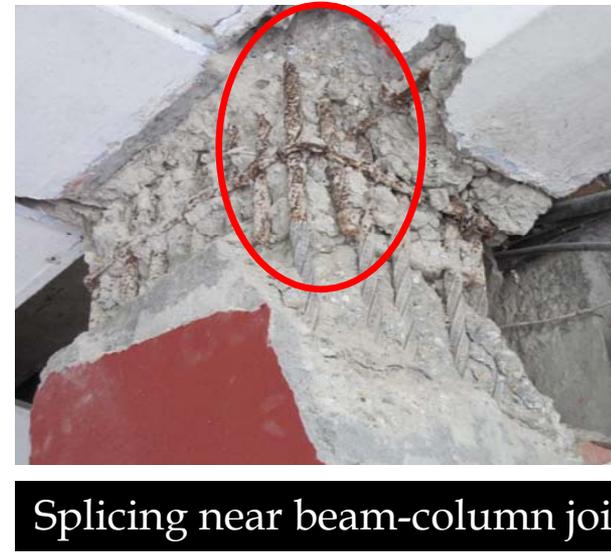
Not common problems observed in affected buildings are:

*No confinement of reinforcement at beam and column ends,*

*No shear reinforcement (stirrups) in joint regions,*

*Stirrups of very small diameter bar and inadequate tying,*

*90° hook and insufficient length of such hooks,*

*Splicing at member ends instead of at the middle,*

*Construction (cold) joint at top end of the column near beam-column joint,*

*Poor quality of concrete.*

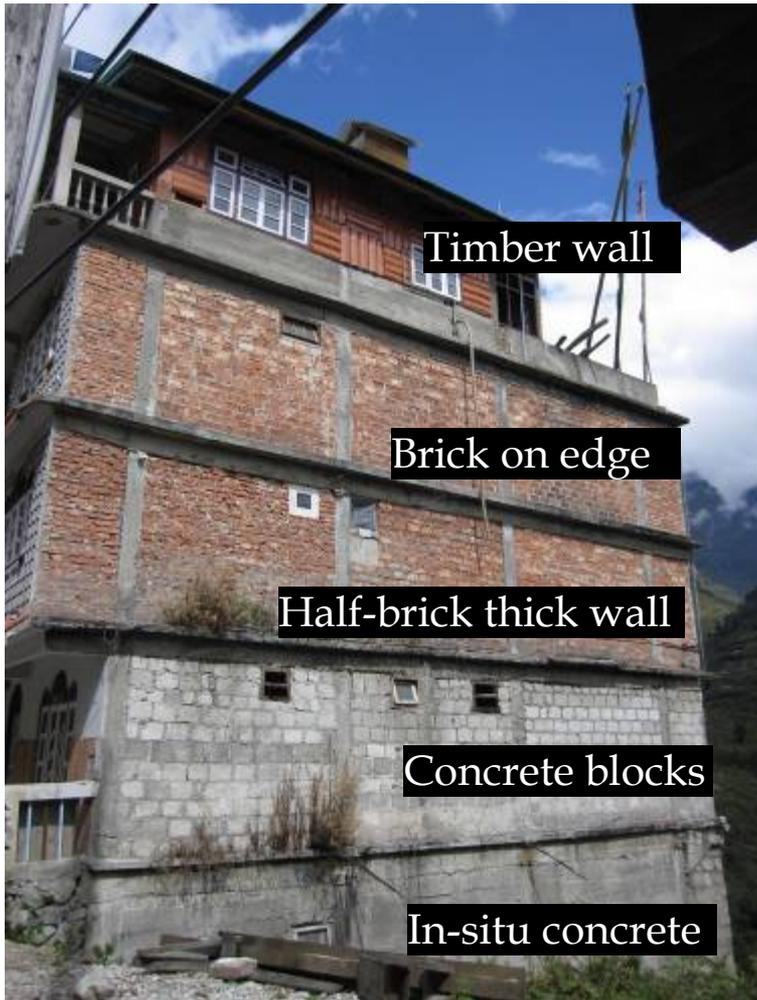
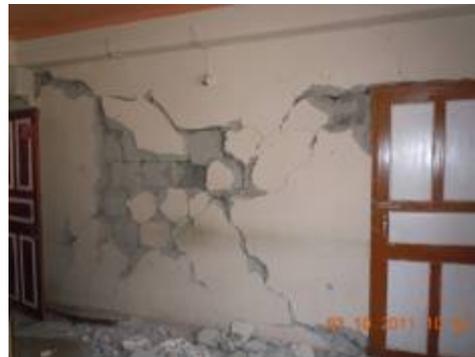
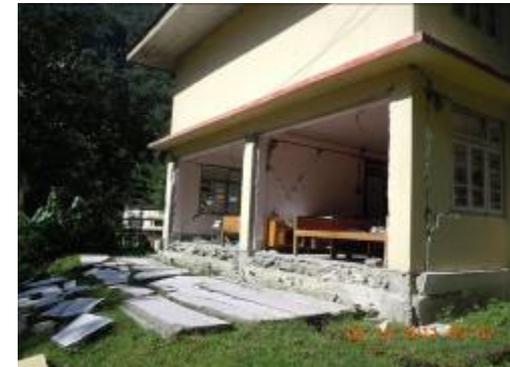
Unavailability of raw building materials and expensive transportation cost lead to the use of various substandard construction materials. Use of weaker infill materials and thin walls at upper floors to increase the floor area, makes the walls vulnerable to in-plane and out-of-plane seismic forces.

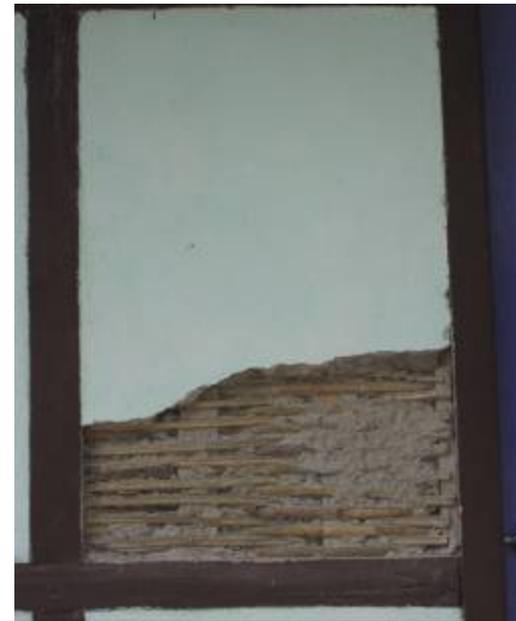
**Minor damages in bamboo panels**

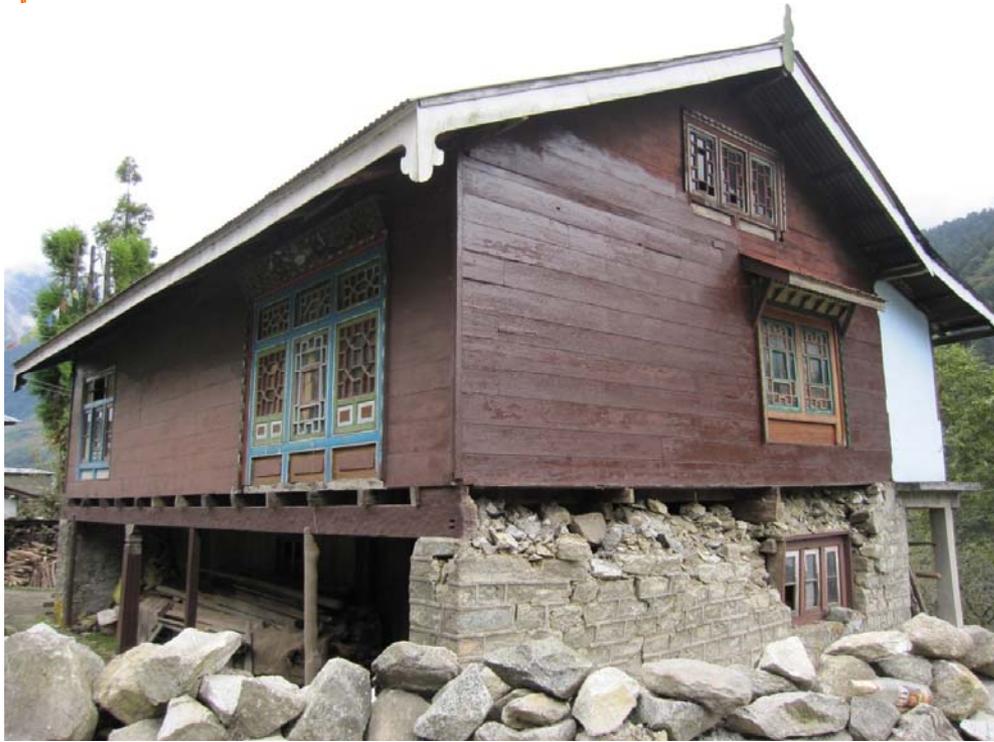
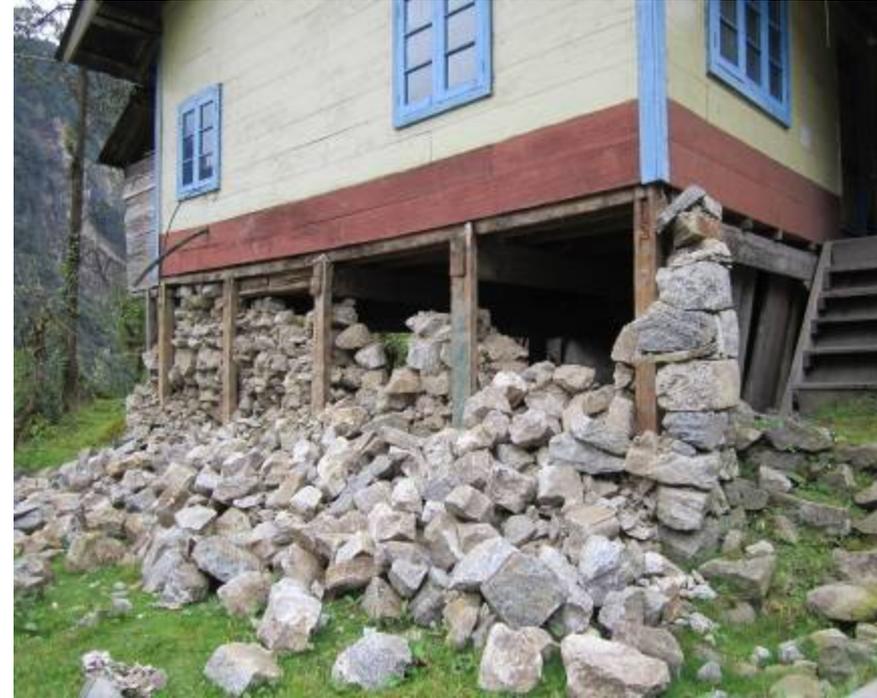
## Failure of R/R masonry at basement level

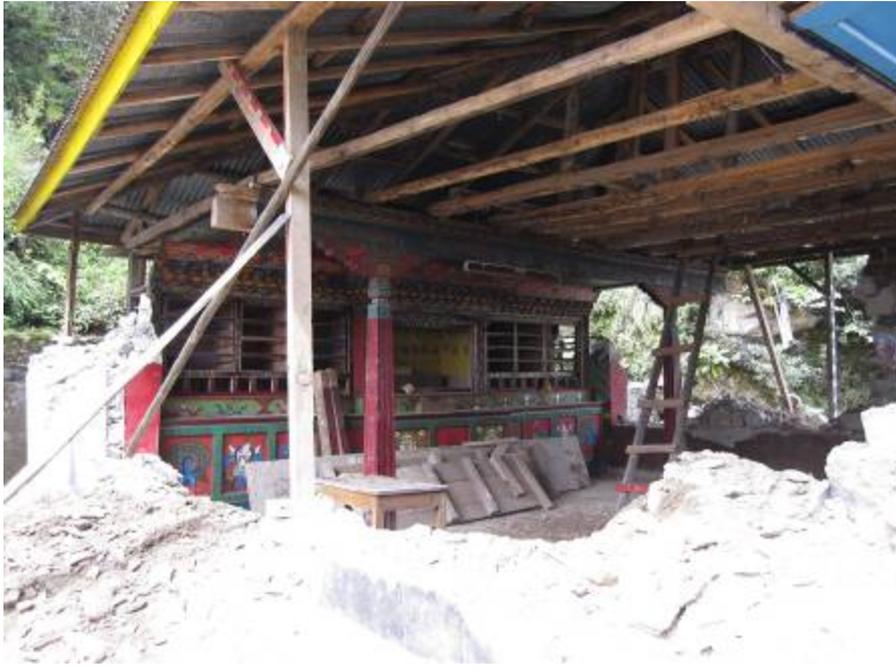
**Damage to masonry wall of temple at Lachung**

Mostly all monasteries suffered damage to their infills which was R/R masonry in mud/cement mortar. Part of the structure built in timber escaped with minor to negligible damage.

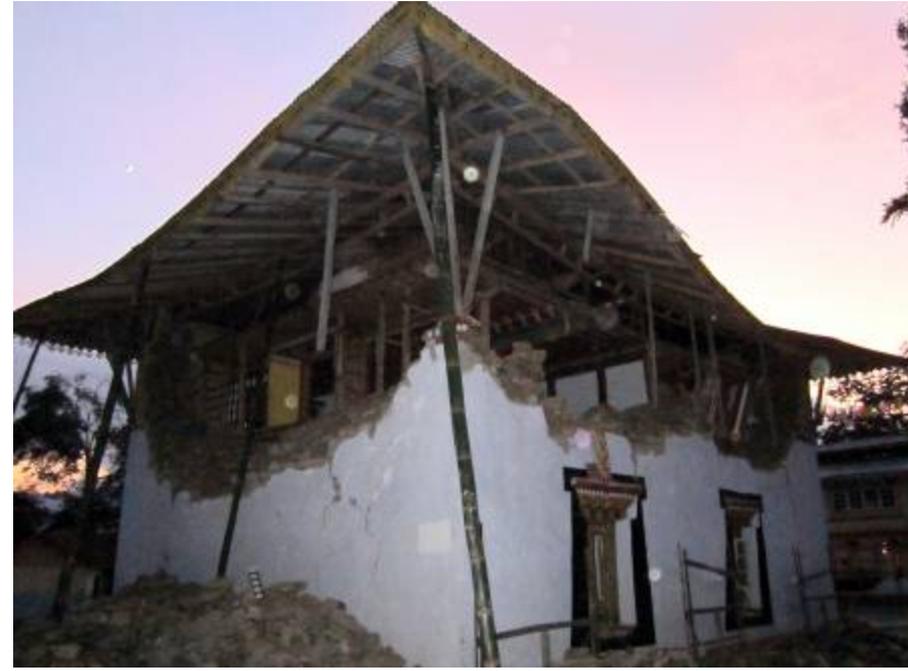
**Damage to Ringhim Monastery, Mangan**

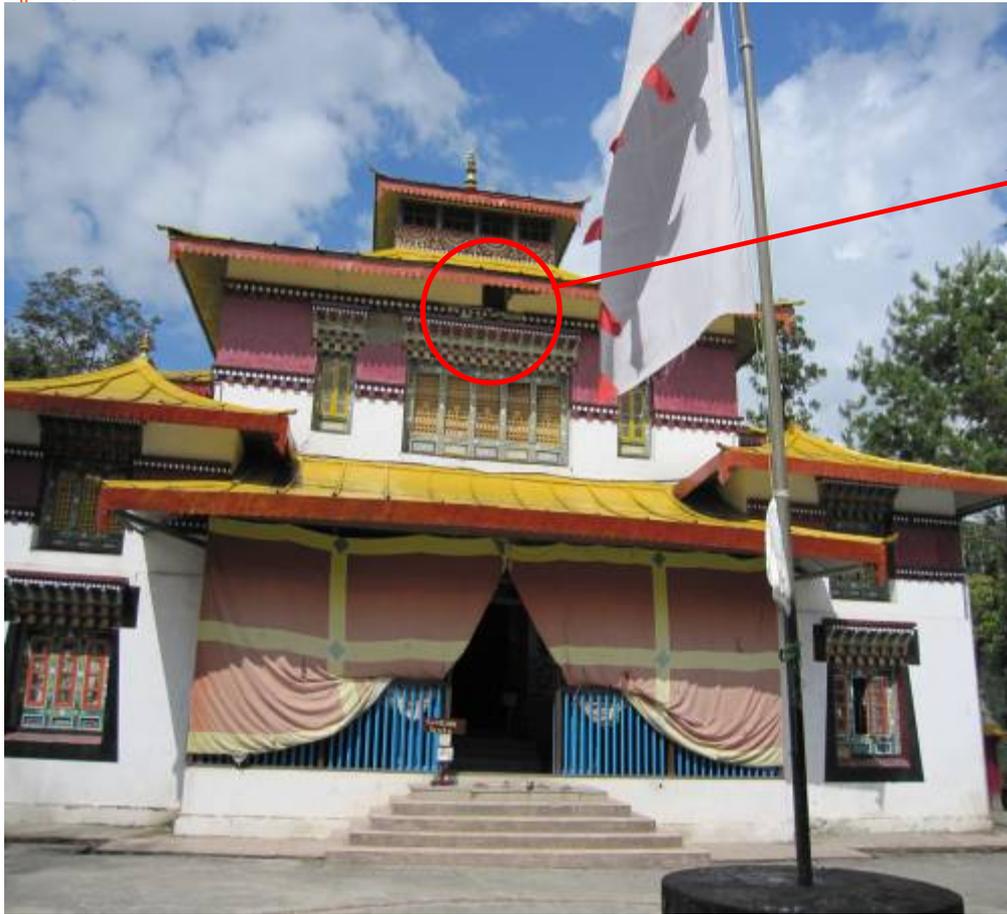
**Enchey Monastery, Gangtok**

It is a three-tiered monastery shaped like Chinese Pagoda, built about 200 years ago during the reign of *Thutob Namgyal*. During this earthquake the R/R stone masonry wall at the top floor suffered some damage around the opening in the wall.

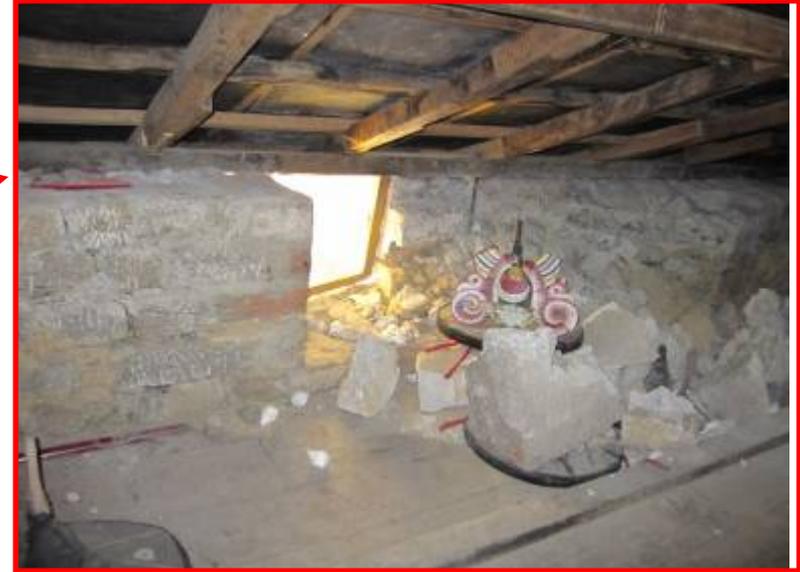
**Minor damages as seen from inside**

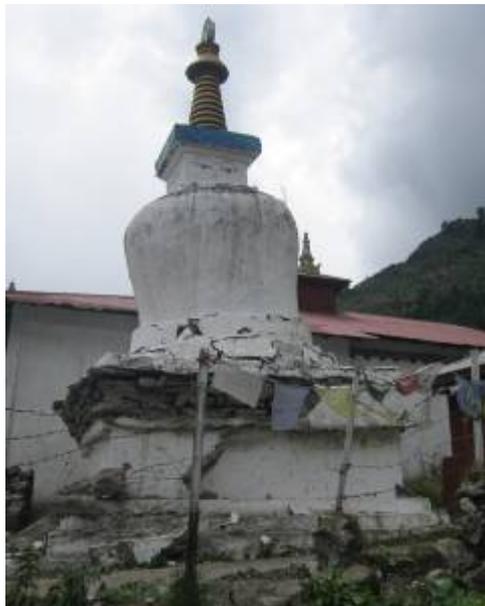
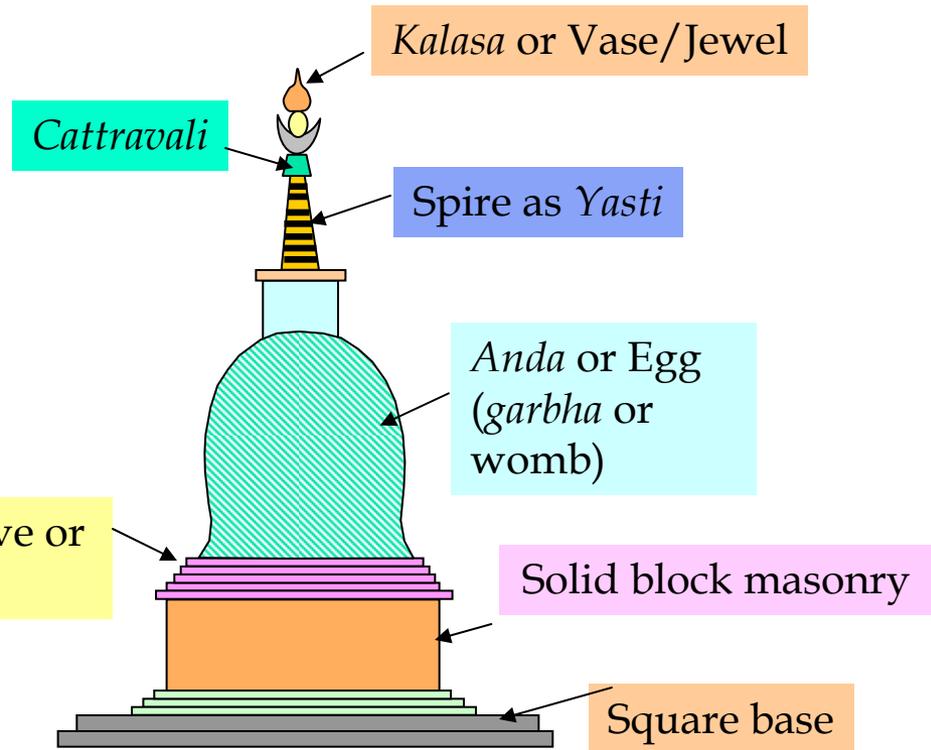
Such structure suffered damage mainly because of weak masonry and also because they are very old.

- Monastery temples being old and weak were deficient in strength to resist the seismic loads and these need effective strengthening measures to safeguard against future tremors.

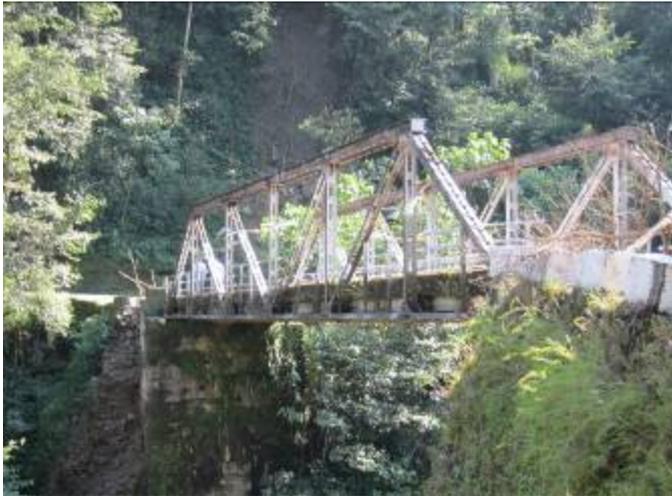
**Failure of wing wall (R/R masonry) of steel bridge (Ray Khola)**

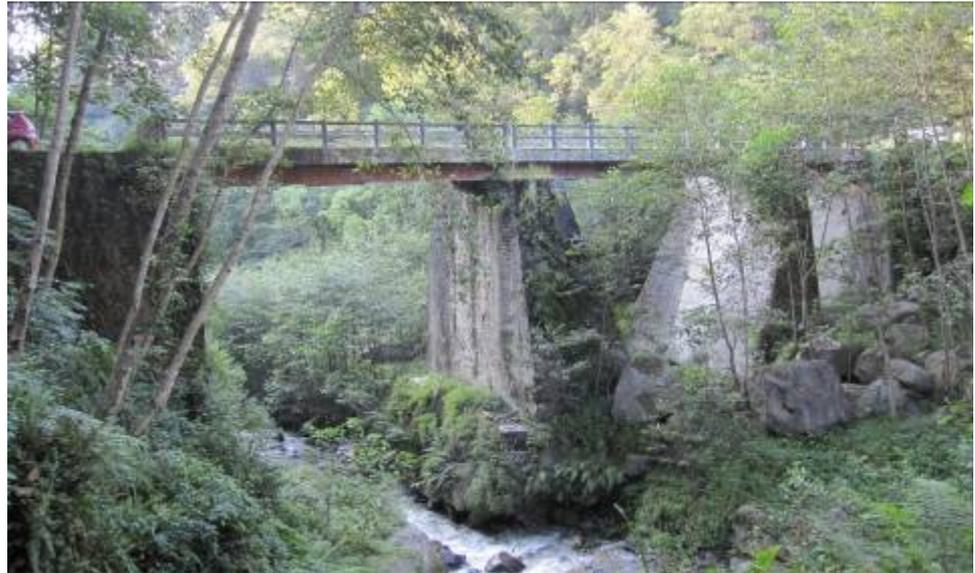
**RC bridge (Andheri Khola) had no damage**

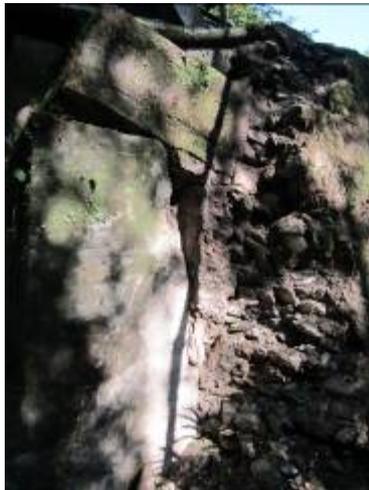
**Failure of abutment of Pale Khola bridge**
