Reconnaissance Report

North Andaman (Diglipur) Earthquake of 14 September 2002

by
Durgesh C. Rai
C. V. R. Murty

April 2003

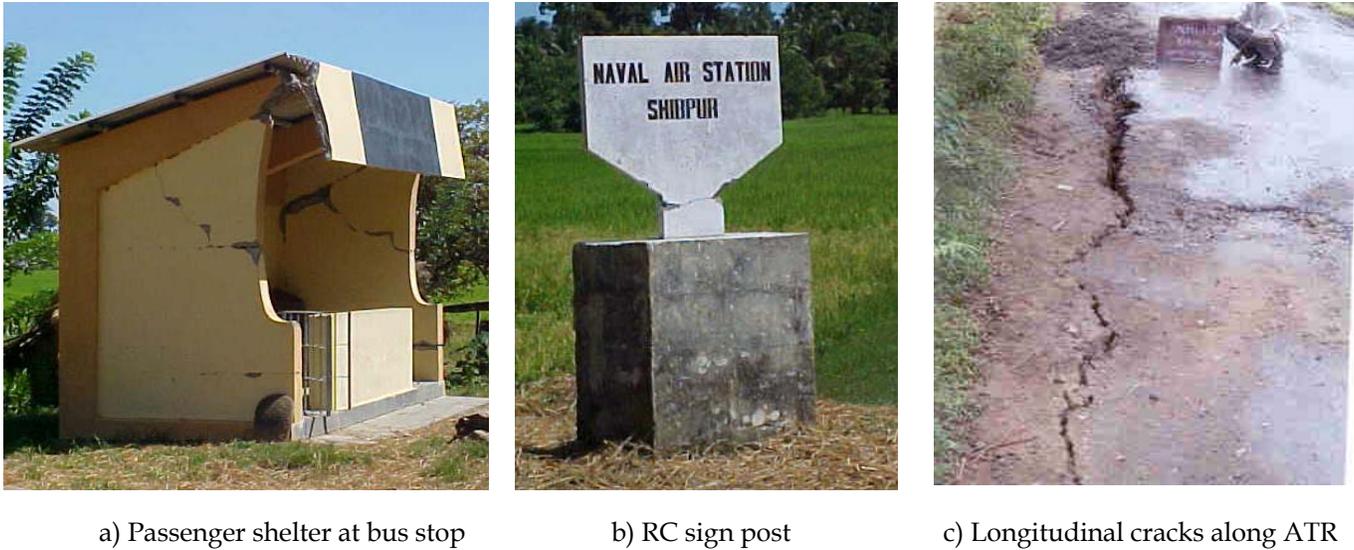
Figure 5: Damage due to significant shaking in Shibpur area near shoreline in Diglipur.

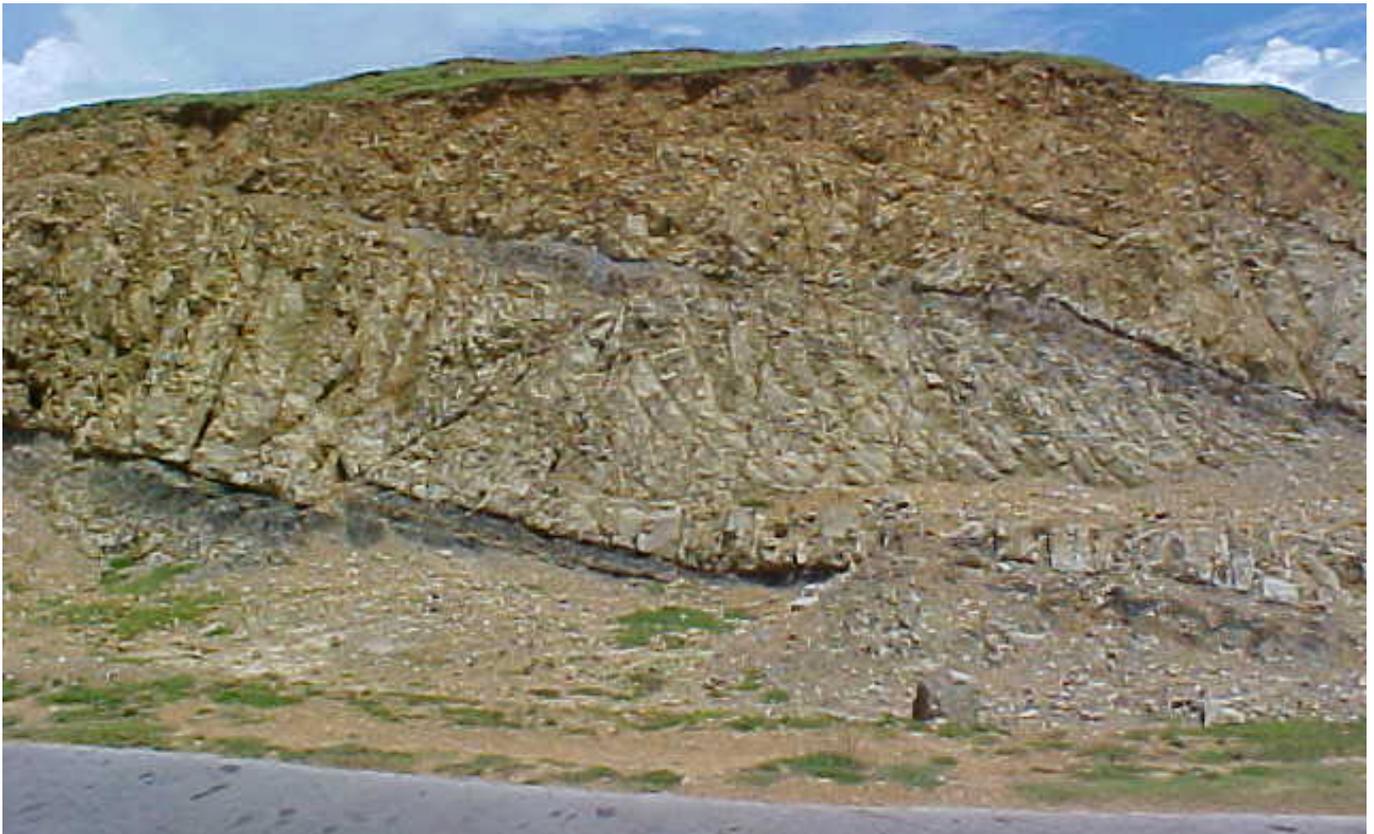
Figure 7: Vertical cut exposures in the town of Port Blair showing highly fragmented rock structure with interstices loose sediment layers.

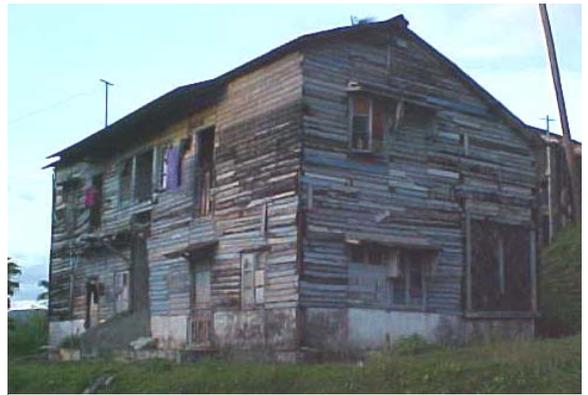
Figure 12: An old 2-storey timber house in dilapidated condition; numerous such constructions stand vulnerable under expected strong shaking in the region.

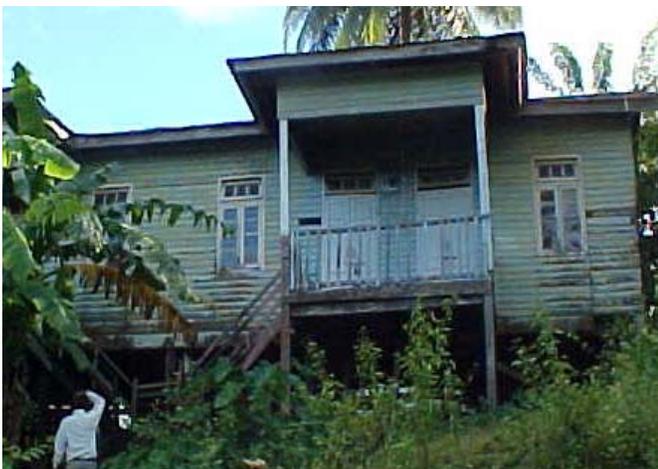
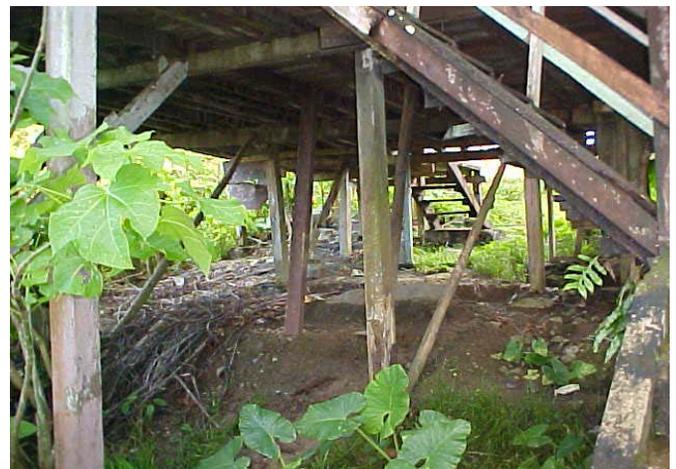
Figure 13: An old and poorly maintained wooden frame building on stilts on slope with a long history of soil movement and settlement rendered unsafe for further occupation in Diglipur.

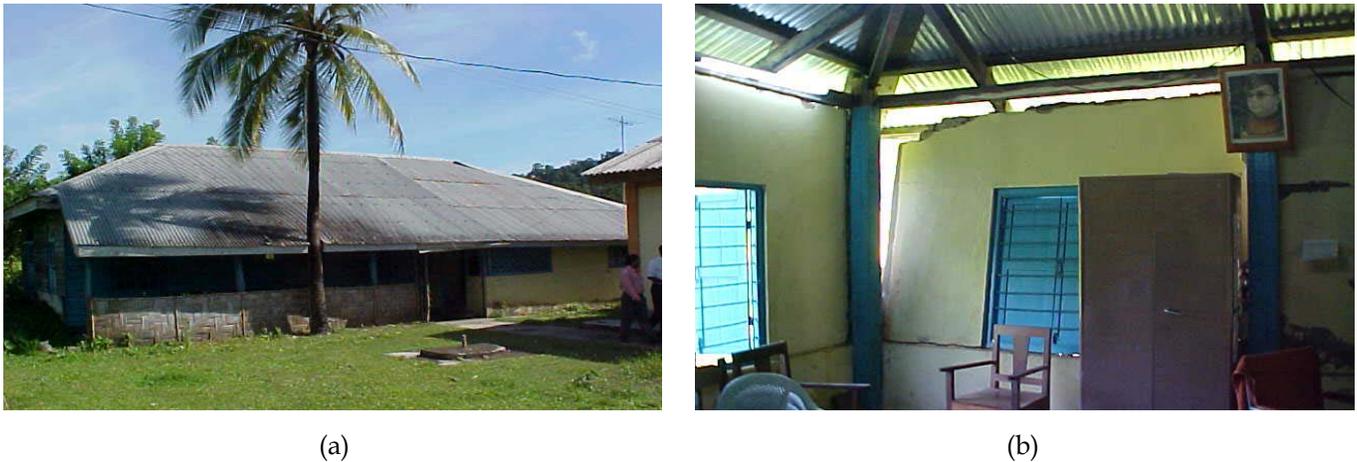
The islands have a large inventory of buildings that have masonry load bearing walls and light roof truss made of either steel pipes or timber. Often these walls are not tied together to create the necessary box-action in masonry construction required for lateral resistance. No positive connection is provided between the wall and truss members resting on them. In figure 14 is an example of such structures; wherein the masonry wall was pushed out-of-plane during large movement of flexible roof that consists of poorly jointed wooden truss members. Presently, steel trusses involving hollow circular pipes are fast replacing the older practice of timber trusses. However, connections between truss members are purely ad-hoc as shown in Figure 15 a. Figure 15 b shows the straining of seating connection at the column top caused by large movements of the flexible truss.

Figure 14: Masonry bearing wall dislodged out-of-plane due to large movements of flexible roof structure.

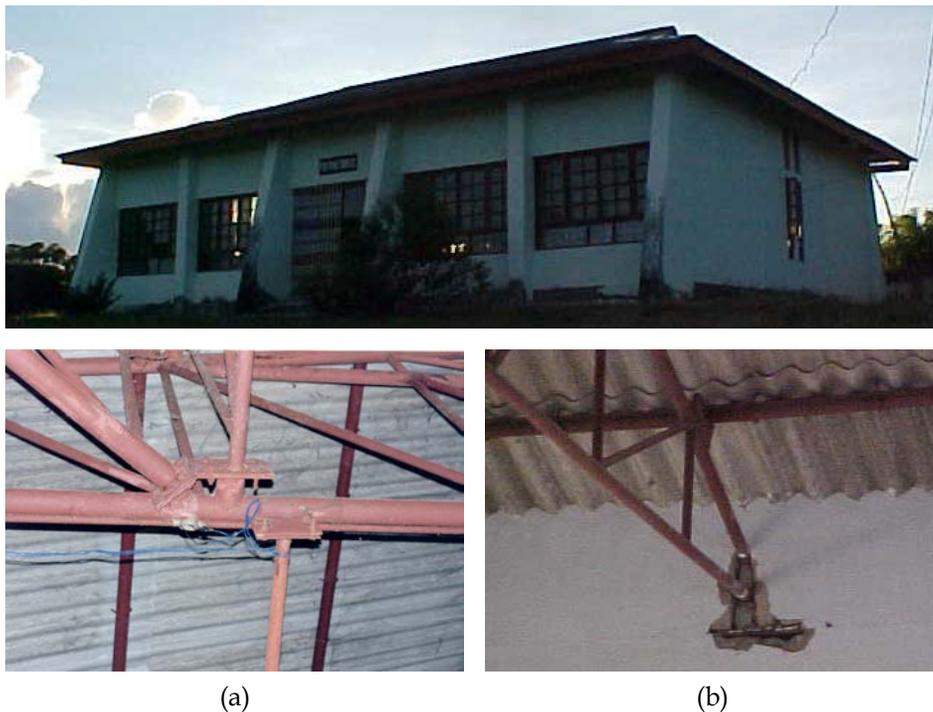
Figure 15: Poorly detailed joints between truss pipe members, and between the truss and the supporting RC column.

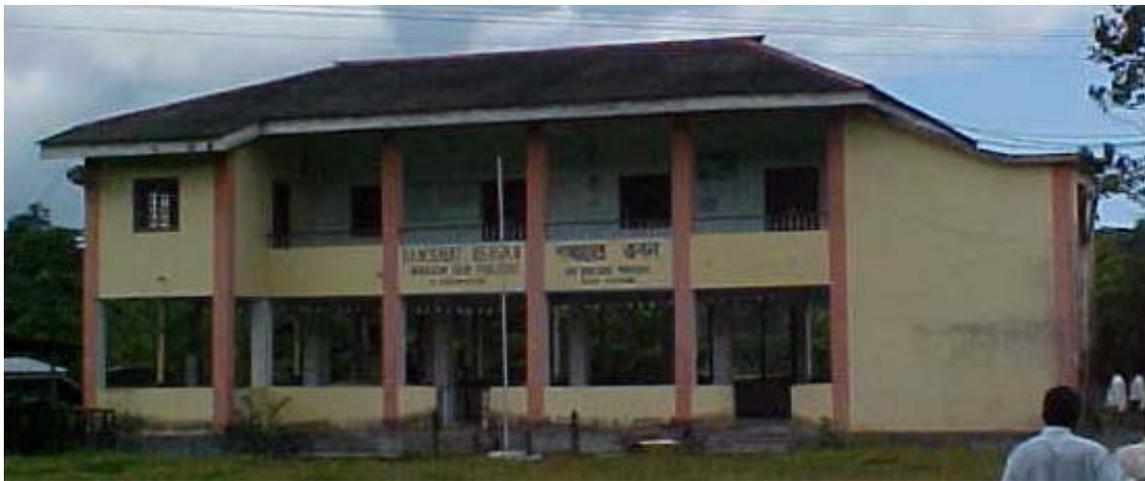
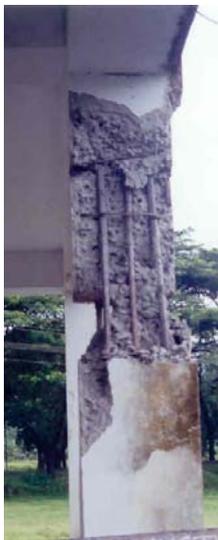
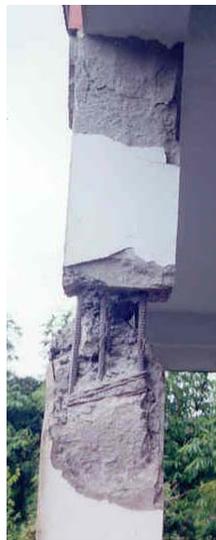
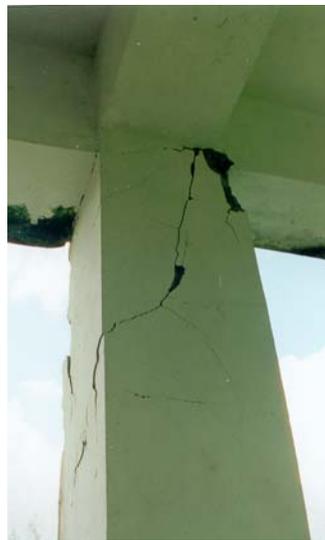
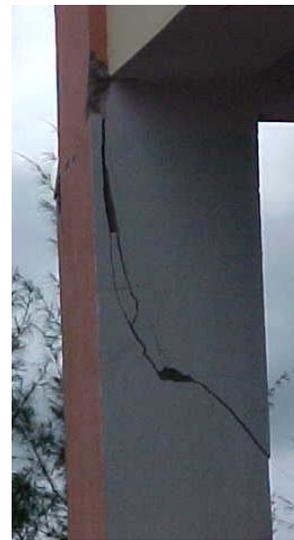
One such building, the Nabagram Panchayat building, suffered extensive damage to its ground floor columns near the side farthest from the stiffer side near the stair case block. Many of the columns were severely cracked and damaged near beam-column joints and at mid-heights (Figure 17). A close inspection revealed that no transverse stirrups (ties) were present over a length greater than 350 mm for the 200 mm wide columns. The ties were not securely held in place and as a result slipped from their position while placing concrete. Two-to-three tie rings were found stacked at one place. Absence of ties rendered these relatively short columns extremely vulnerable to shear forces generated during the earthquake and even a general shaking of intensity VI was serious enough to damage the structure and undermine its safety. The RC columns were not designed for earthquake forces and required ductility to begin with. Further the building was made susceptible to poor seismic performance by creating the open first storey and by the lack of transverse stirrups in that storey where shear resistance is most needed.

Figure 17: Severe cracking and damage to the soft first storey columns of the Nabagram Panchayat building due to 'missing' ties.

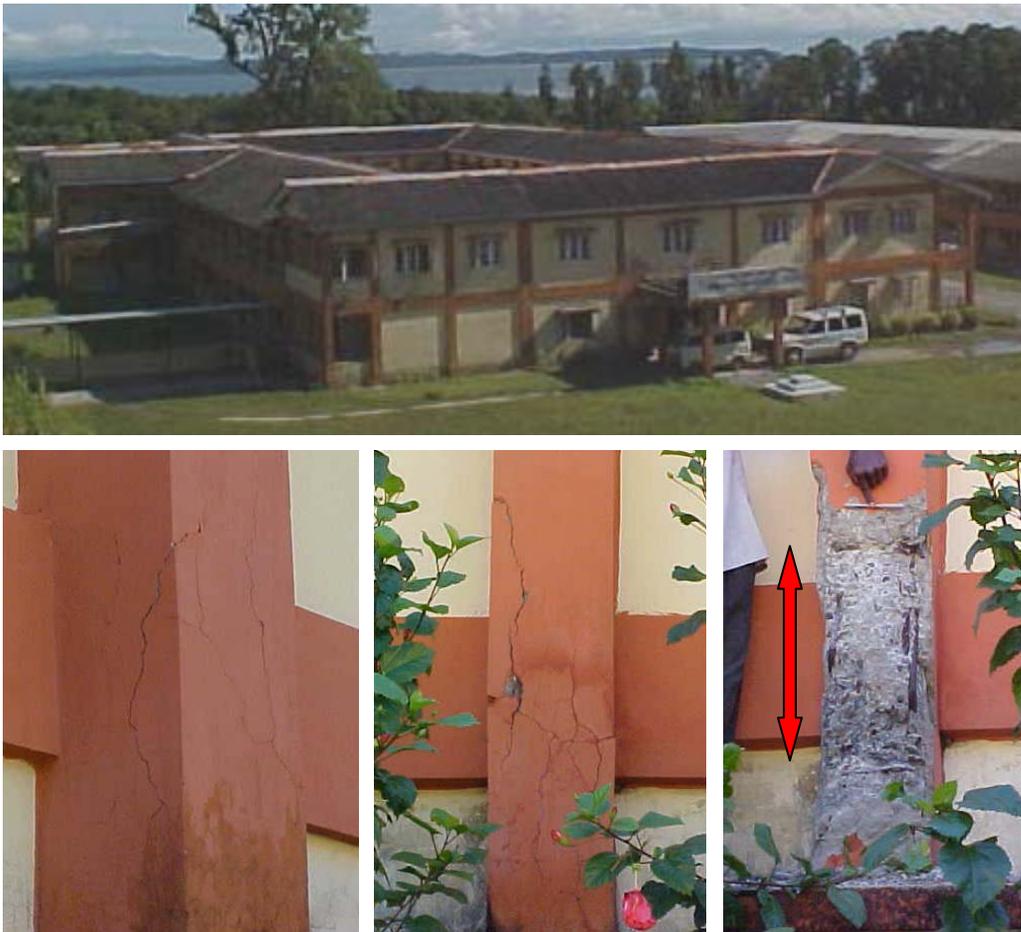
Similar constructional errors were responsible for damage to columns near beam-column joints in the main building of Mahatma Gandhi College near Mayabunder, which also received a less than moderate shaking of VI on MSK scale. As shown in Figure 18, the deep cracks were noticed in beam-column joint regions in one wing of the 'donut' shaped building which was constructed at a later date. Upon chipping away the concrete cover, no stirrups were found in the column for entire beam depth for a distance in excess of 450 mm. Such a reinforcement detailing in joints is not even appropriate for gravity loads and is a clear violation of the design practices specified by Indian Standards. Obviously, the performance of the building in the earthquake was not satisfactory; in far greater damage would have resulted in the event of greater shaking which is probable in this highly seismic Andaman and Nicobar Island region.

Figure 18: Cracking in critical beam-column joint regions due to 'missing' ties for entire beam depth (more than 450 mm) in the main building of Mahatma Gandhi College in Mayabunder.

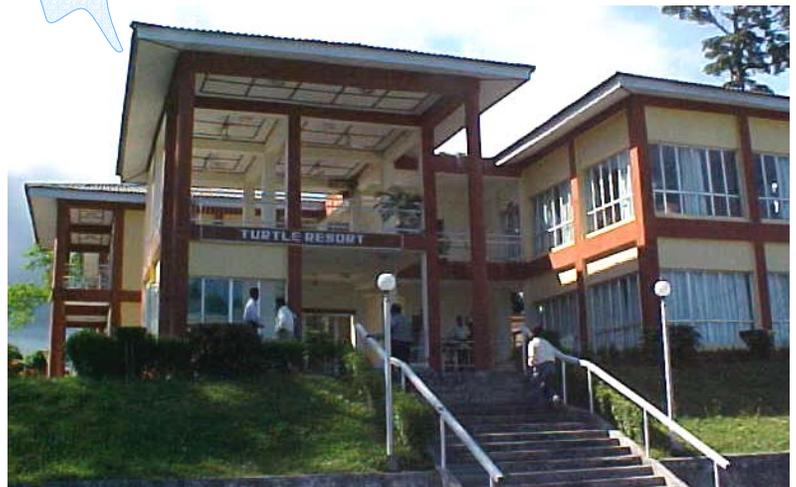
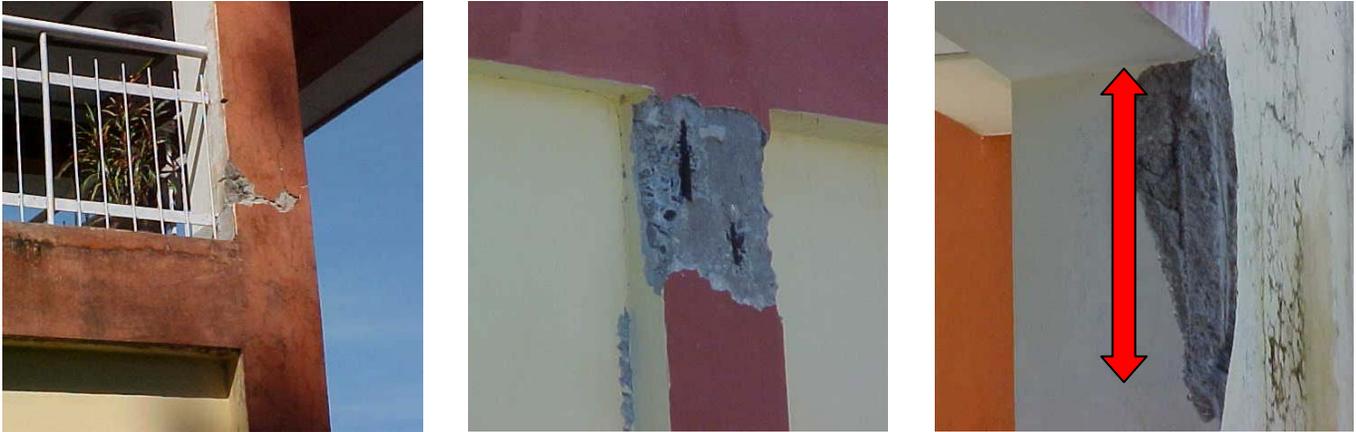
Similar omissions in reinforcement detailing and serious errors on part of architectural layout and planning of structures in high seismic zones was vividly illustrated in recently completed Turtle Resort building at Shibpur, near Diglipur. The building is a two-storey RC frame building with concrete block masonry infills, as well as load bearing one in some parts of the building. The building is highly irregular not only in the plan but also vertically with floors at various levels connected through lobbies and walkways (Figure 19). The building developed cracks in columns and in the large number of partition and bearing walls. The cracking near the column tops were primarily due to absence of transverse stirrups over a length greater than

two times the column width. The building suffered damage disproportionate to the observed shaking primarily due to poor layout of structural elements causing additional forces, irregularities in strength and stiffness, discontinuities in the load path, and absence of column ties (Figure 20). The seismic vulnerability of this building was sufficiently illustrated during this earthquake and its performance provides enough clues to predict its behaviour in the event of greater shaking.

Figure 20: Damage to columns, which reveal absence of transverse ties over a length of about 450 mm from the beam soffit. This omission during the construction compounded with poor architectural planning and configuration resulted in significant damage in an area that sustained less than moderate shaking.

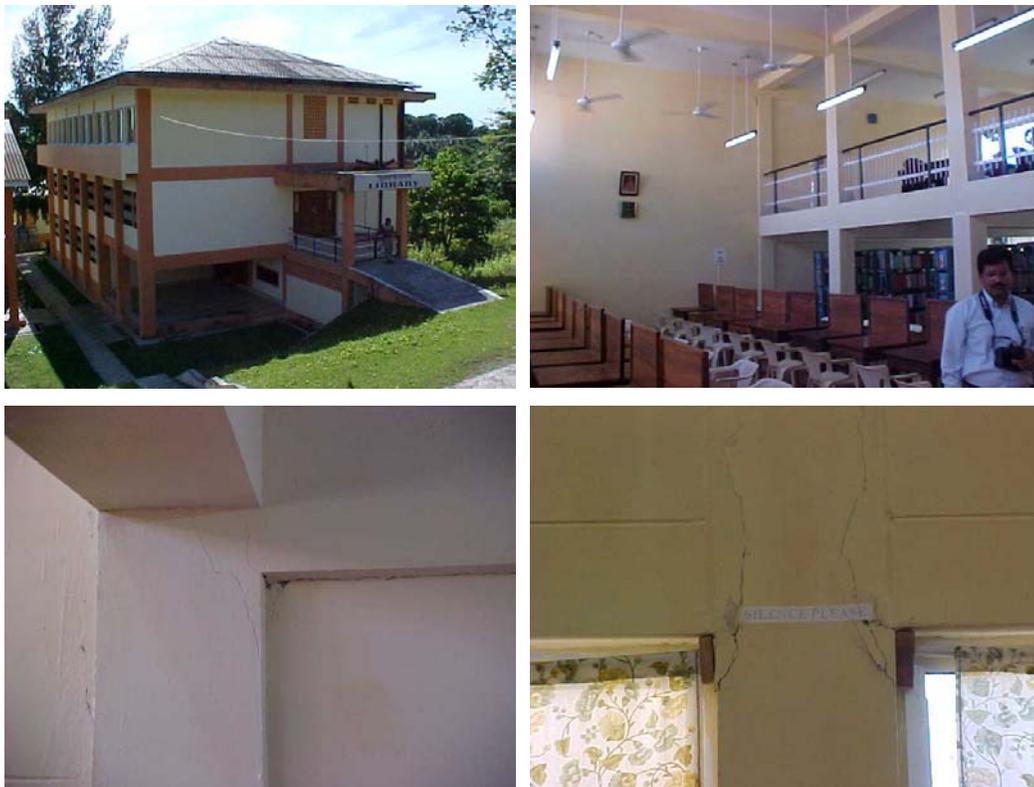
Another interesting example of poor layout and planning consideration from the point of view of earthquake resistance was observed in the newly constructed library building of Mahatma Gandhi College in Mayabunder (Figure 21). This three-storeyed building is asymmetric in plan and has a high ceiling over a part of the building. Besides cracking to infill walls, cracking was also noticed in the beam-column joint region. Inadequate shear resistance due to possible absence of ties is likely suspect.

Figure 21: Cracking in the joint region of columns in the asymmetric library building at Mahatma Gandhi College in Mayabunder.

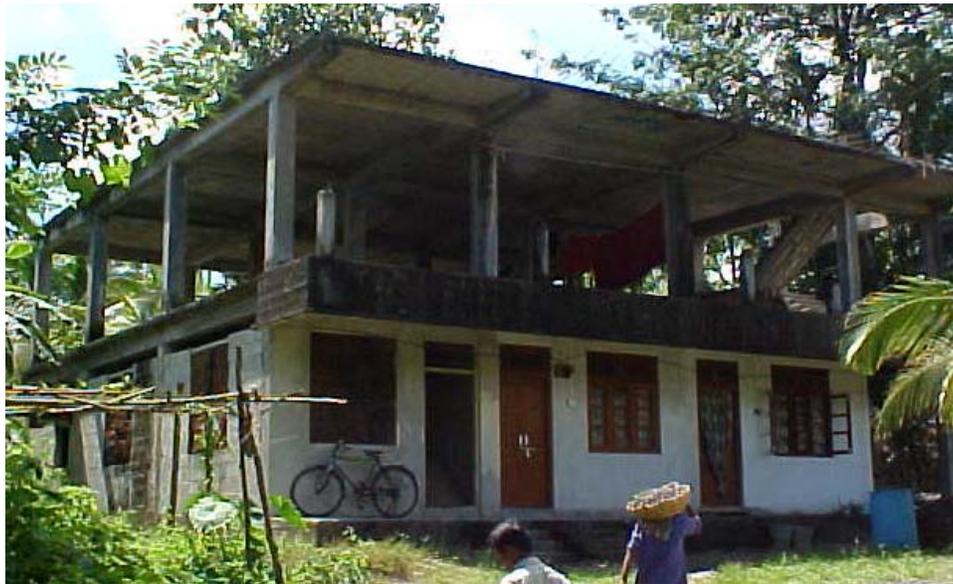
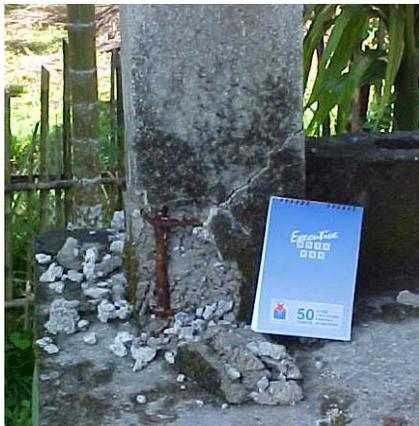
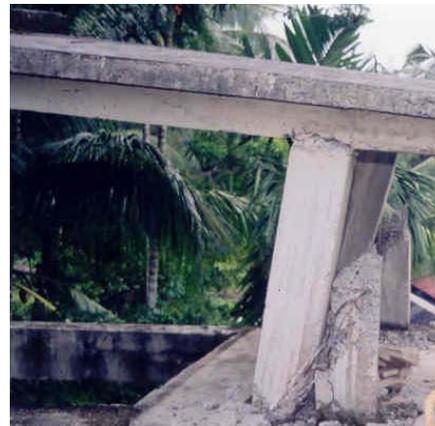
The practice of earthquake resistant design and construction is practically non-existent in building construction in the Andaman and Nicobar Island region. A two-storey building in Keralapuram under construction presented a interesting example of the kind of damage to columns that is likely if the columns are are not provided adequate confinement at the column ends. As shown in Figure 22, the top storey columns (in the absence of masonry walls) acted as 'cantilever' supports and could not respond satisfactorily to the seismic moments and shears produced in it during the earthquake. At the base of majority of the upper storey columns, flexural cracking was noticed as 'plastic hinges' were formed. Clearly, the usual practice of providing 90⁰ hook ties at 150 mm centres is not adequate for the necessary confinement for stable and ductile behaviour. Similar reinforcement detailing could not safely hold the columns supporting slab over the stair case, and the columns failed in shear at the in mid-height.

Figure 22: (a) Unfinished residential building, (b) and (c) Cracking at the base of second story column as 'plastic-hinges' were developing, and shear failure of columns supporting staircase slab, due to inadequate the transverse confinement less than required from seismic consideration.

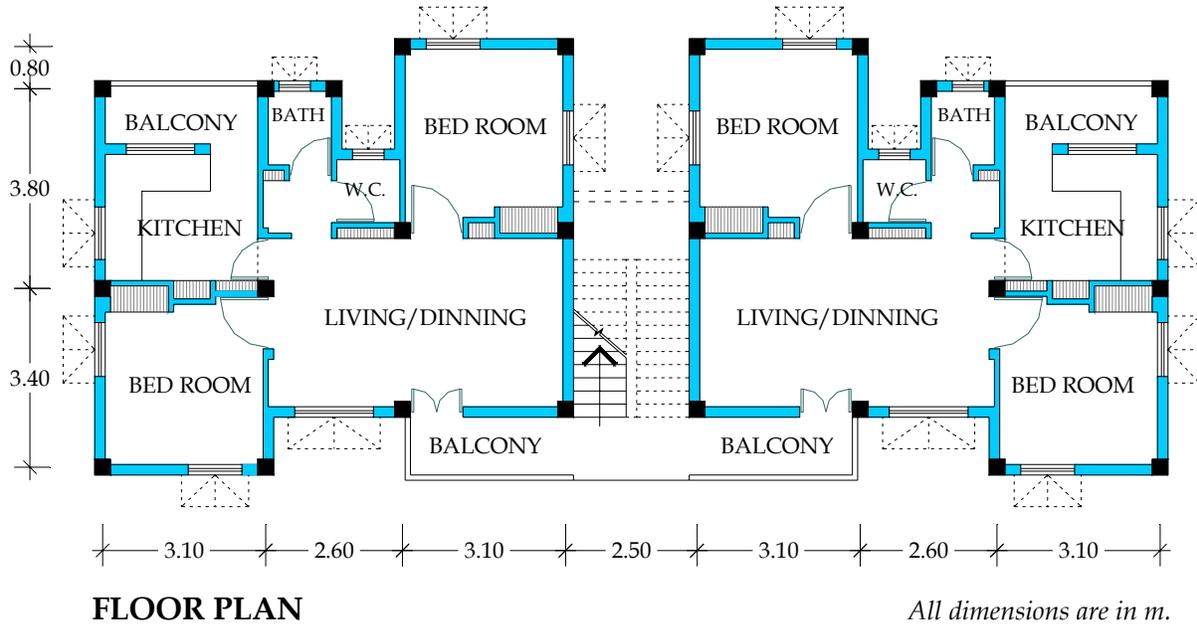
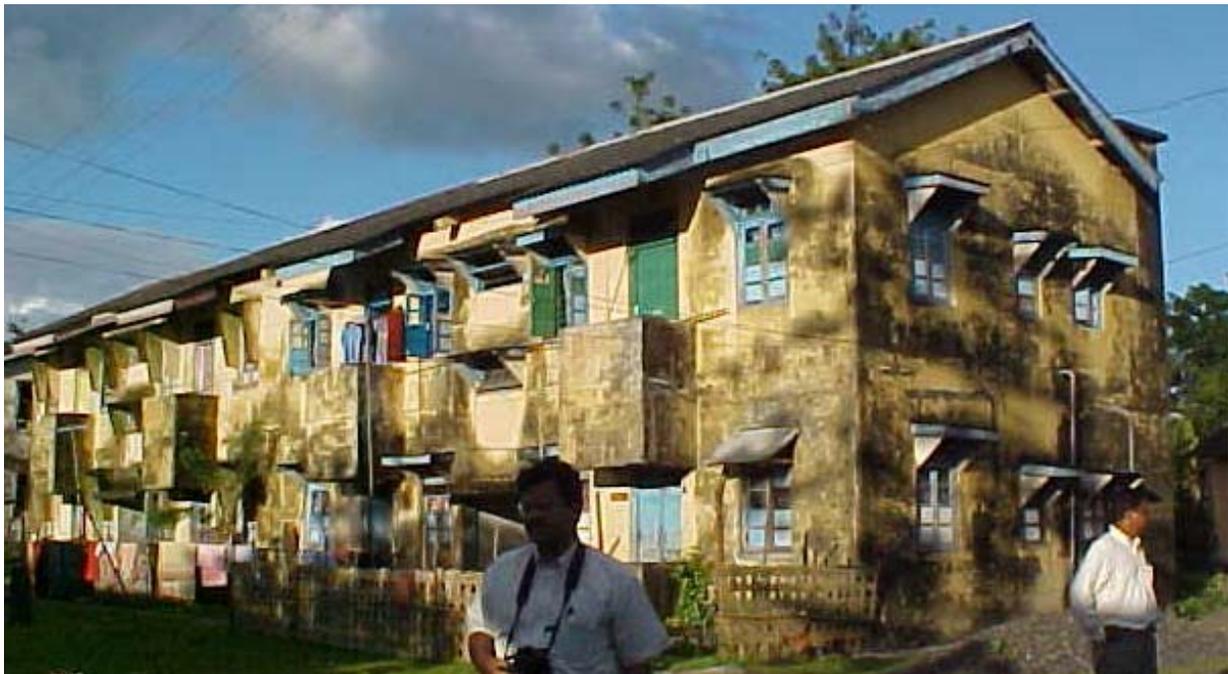
Figure 23: Two storey load bearing masonry building for Govt. employees in Diglipur performed satisfactorily despite poor maintenance and upkeep, primarily due to better structural layout and relatively light roof.

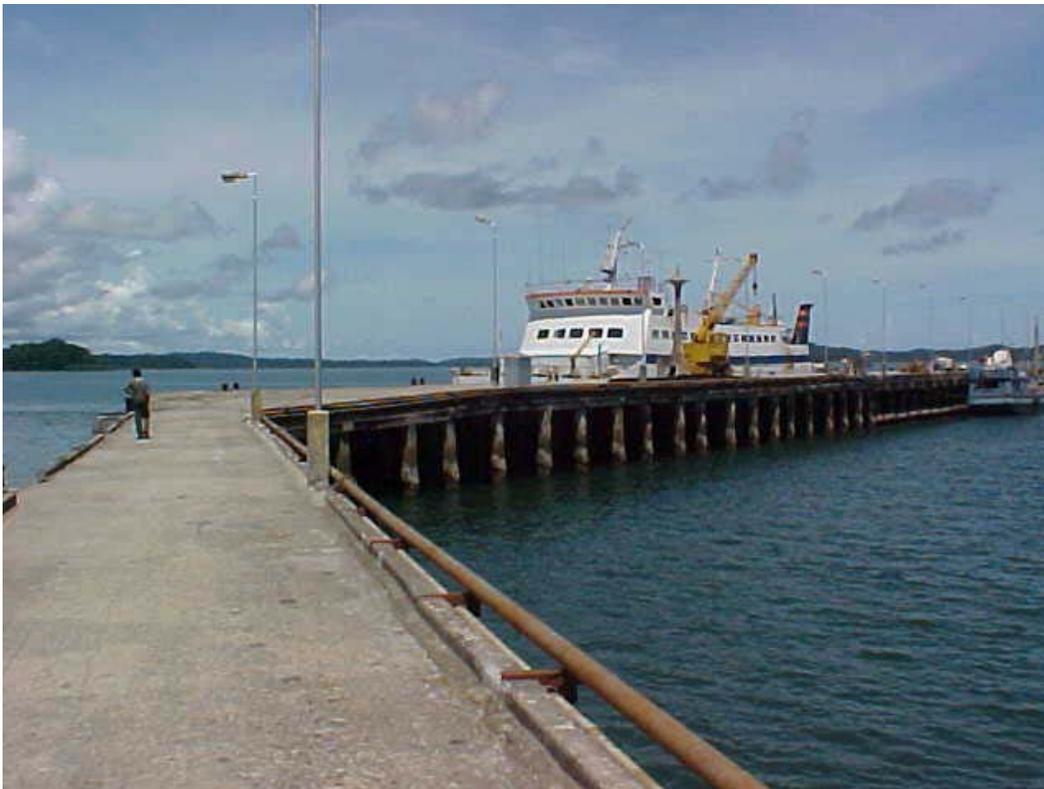
Figure 24: Approach jetty meeting an angle with the main berthing jetty at Diglipur harbour. The damage to jetty slab was concentrated at the intersection.

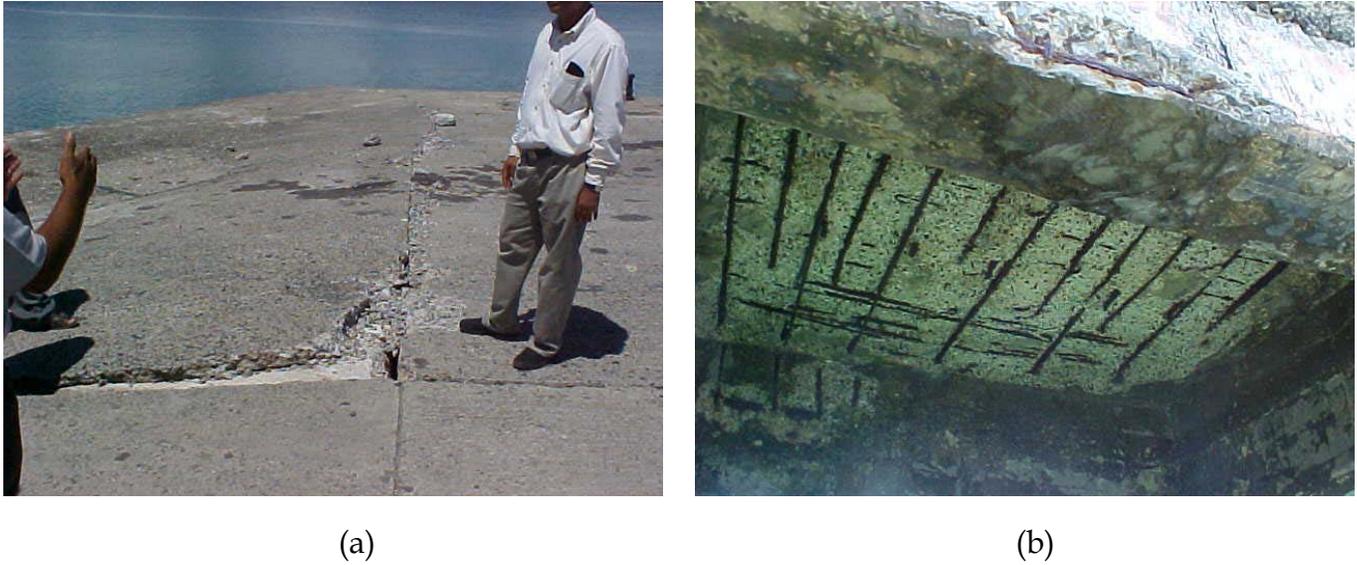
The Arial Bay jetty structure consists of approach segment meeting the main berthing structure of at 120° angle as shown in Figure 24. Figure 25 shows the plan of various structures at the Diglipur harbour. The berthing structure was originally constructed in 1968 and extended in 1999. The entire approach and berthing structure consists of 400 mm square reinforced concrete piles connected at the top by a box-type pier cap made of beams, columns, braces and slabs. Pounding damage was observed at the intersection of the approach segment and the main berthing structure; the wearing coat was broken (Figure 26). Also, a portion of the main berthing structure that protrudes into the longitudinal direction of the approach segment around the bollard was sheared off during the shaking. The pier components suffered significant spalling during the shaking and the reinforcements were exposed. An inspection of the piles and the pier cap elements indicated that it was not adequately protected against the corrosive marine environment; the transverse ties were either missing or severely corroded as shown in Figure 27.

Figure 26: (a) Pounding damage at the intersection of approach to main jetty at the top, and (b) exposed slab reinforcement underneath due to heavy corrosion.

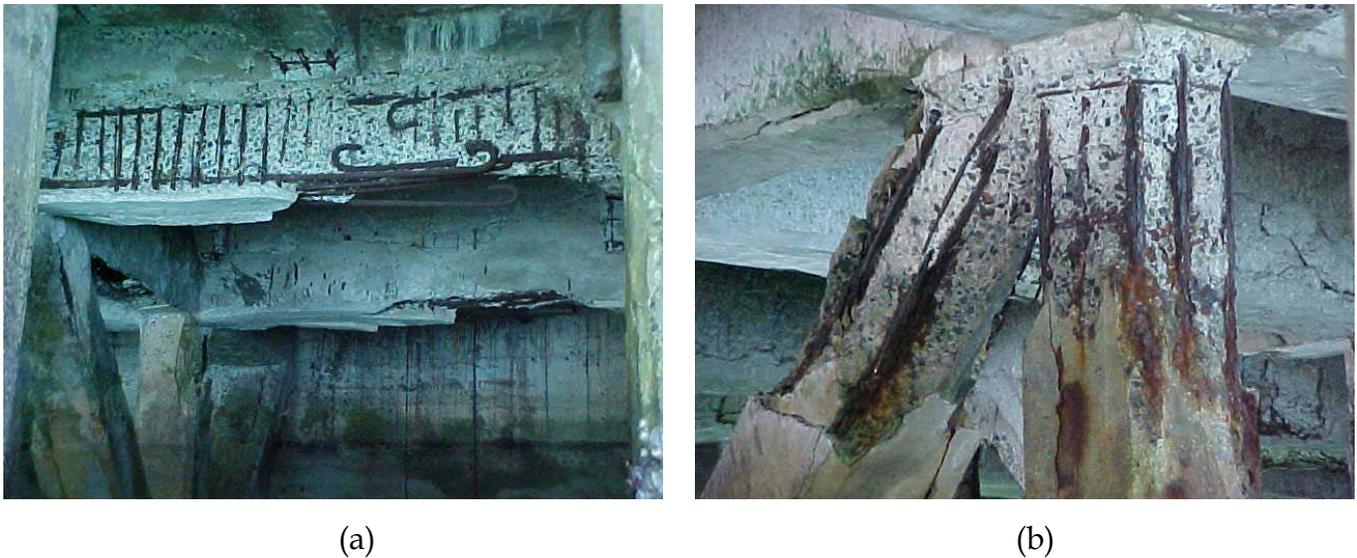
Figure 27: Severe corrosion of reinforcing bars and spalling off cover concrete from beams, and (b) columns and batters.

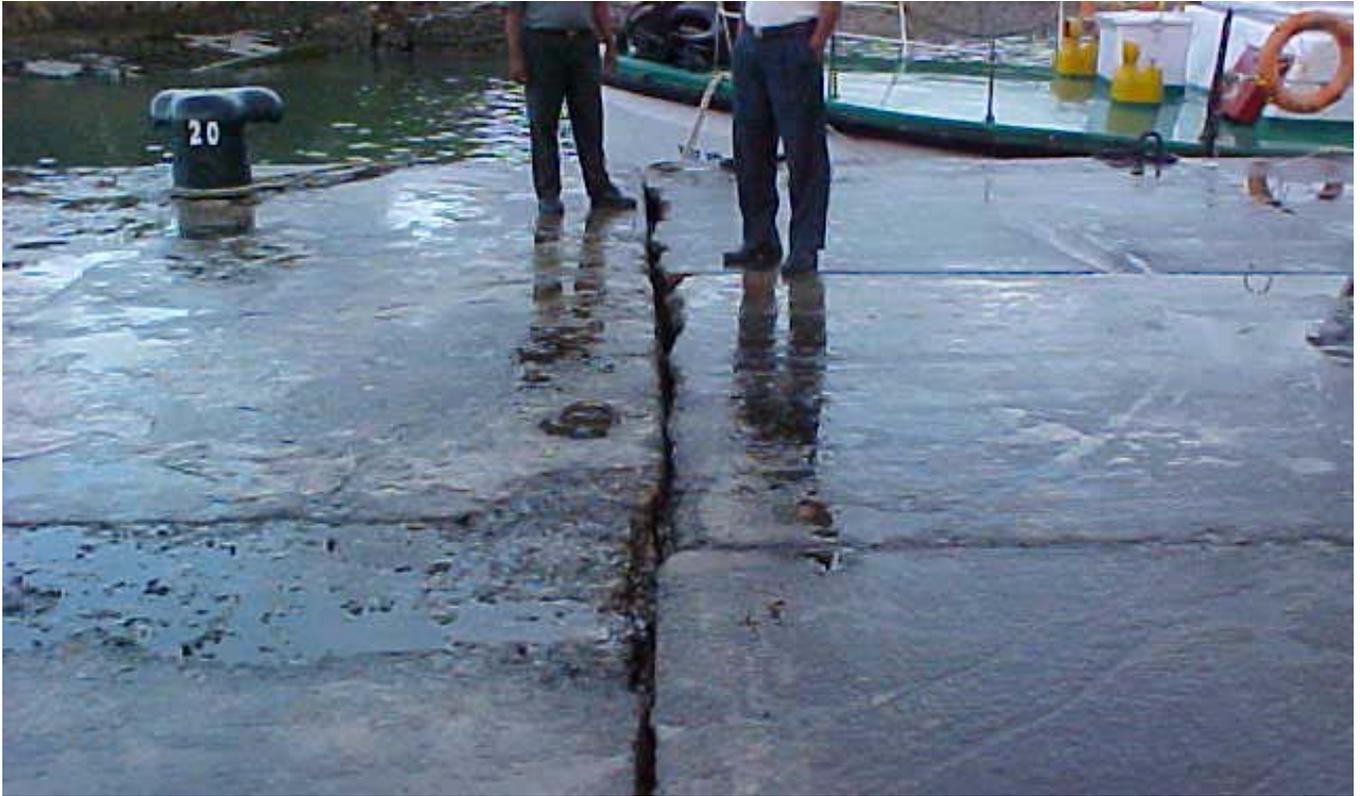
The Mayabunder harbour is a major facility for sea transportation among the islands and to the main land. The arrangement of the harbour is shown in Figure 30. Pounding damage was afflicted to the jetty slab across at expansion joints, which was later repaired (Figure 31). Subsequent to the earthquake, vertical cracks were noticed on the piles supporting the jetty; some horizontal cracks in the slab were also visible from the underside. The bottom tie of wooden roof trusses in the cargo shed broke causing sagging of ridgeline.

Figure 31: Pounding damage at the expansion joints on the main jetty.

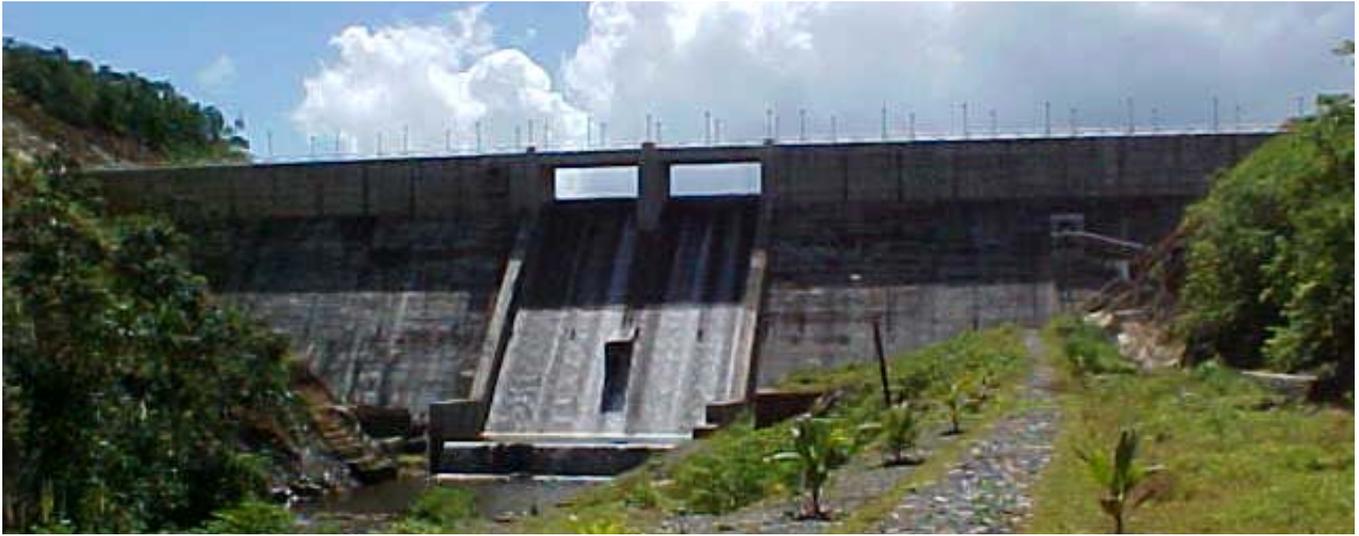
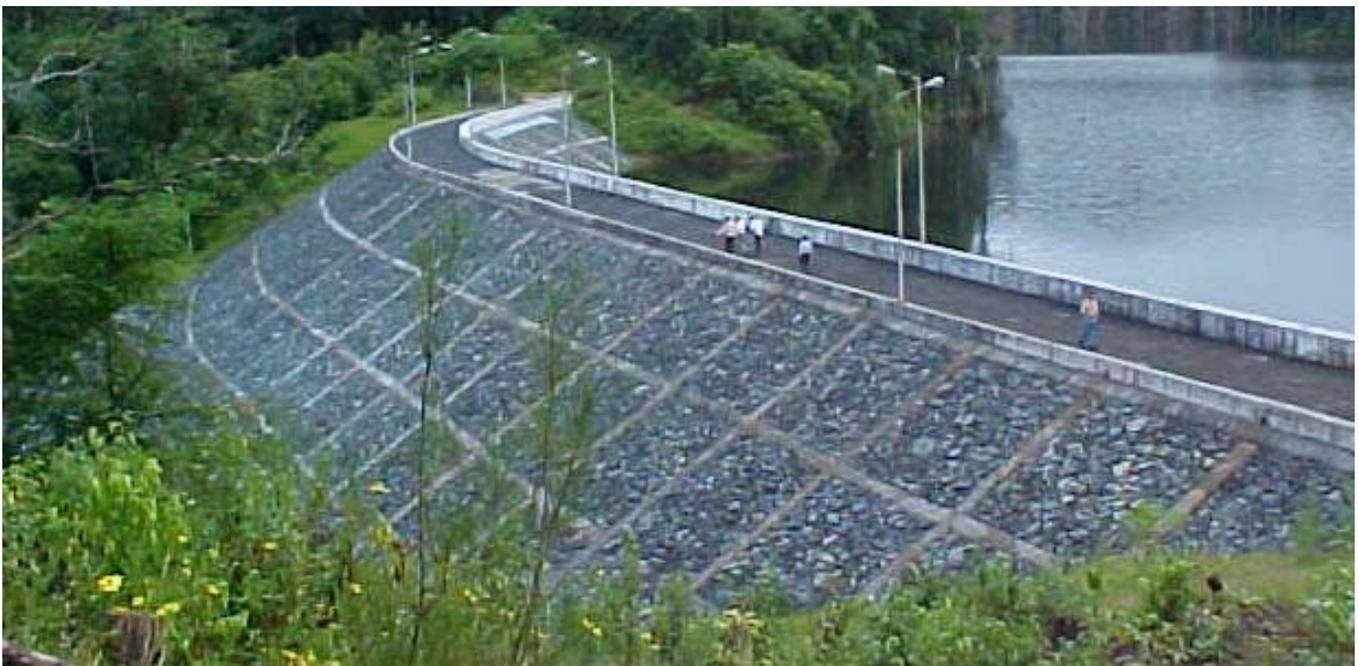
No damage was noticed in the dam structure. However, peeling off of paint across construction joints in the observation gallery of concrete dam suggested that dam structure was shaken during the earthquake. A marginal increase in the seepage flow from 55 lpm to 60 lpm was noticed after the earthquake. However, the readings of joint meters and pressure meters recorded no change before and after the earthquake. The powerhouse building is a 2-storey RC

frame structure where separation of infill masonry from the surrounding frame was noticed in the high ceiling area of generator room.

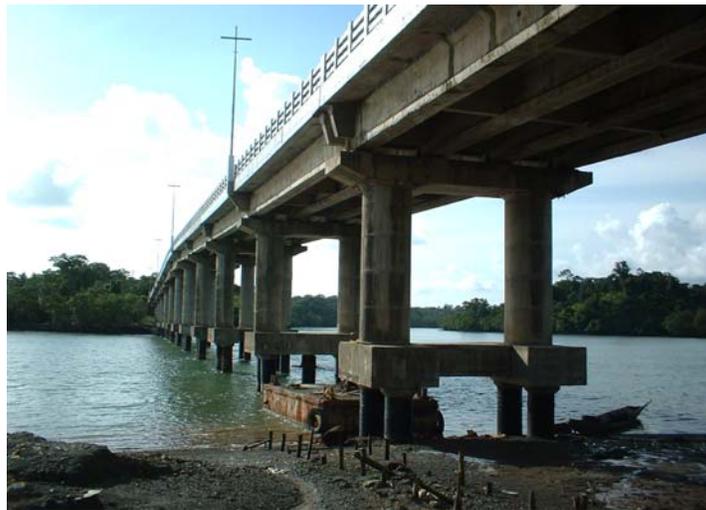
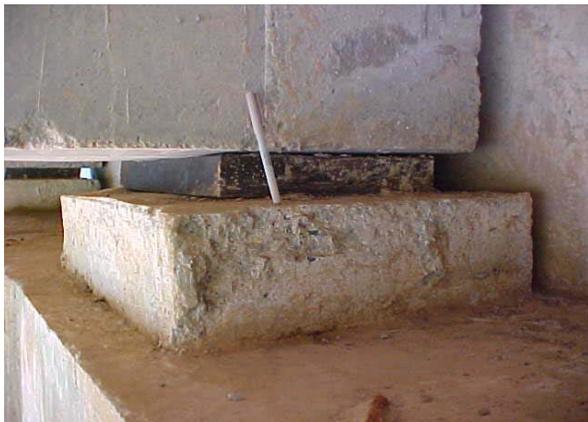
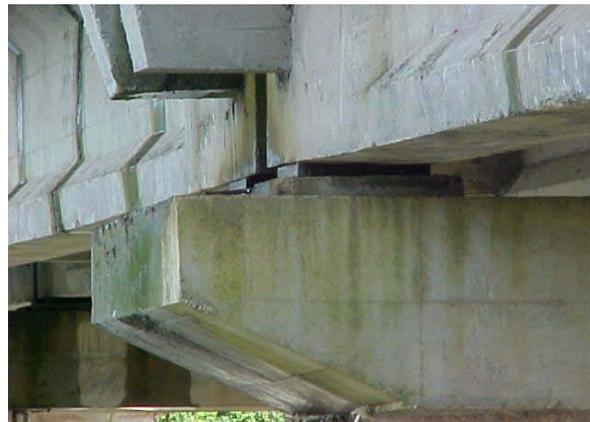
The newly constructed bridge over the Austin Creek at Mayabunder that connects Middle Andaman Island to North Andaman Island along the Andaman Trunk Route (ATR) was not open to traffic at the time of the earthquake (Figure 34). This 268 m long RC bridge is simply supported over 13 cast-in-place piers. The bridge deck is 9.3 m wide and is made of pre-cast girders and cast-in-situ slab. The superstructure is merely rested on the pier caps with no fastening between any of them. No damage was noticed to the bridge structure in this earthquake. However, inadequate seating of bridge deck over piers and abutment is a serious concern for its safety during a stronger earthquake in future. The bearings are simple neoprene pads which are far from satisfactory for a bridge located in seismic the zone V. Bridge deck restrainers are the minimum that need to be provided to ensure that the spans are not dislodged from the piers in future earthquakes.

Figure 34: (a) Newly constructed RC bridge at the Austin Creek, and (b) and (c) inadequate seating for bridge deck and absence of restrainers to prevent the unseating of deck during probable strong motion at the site.

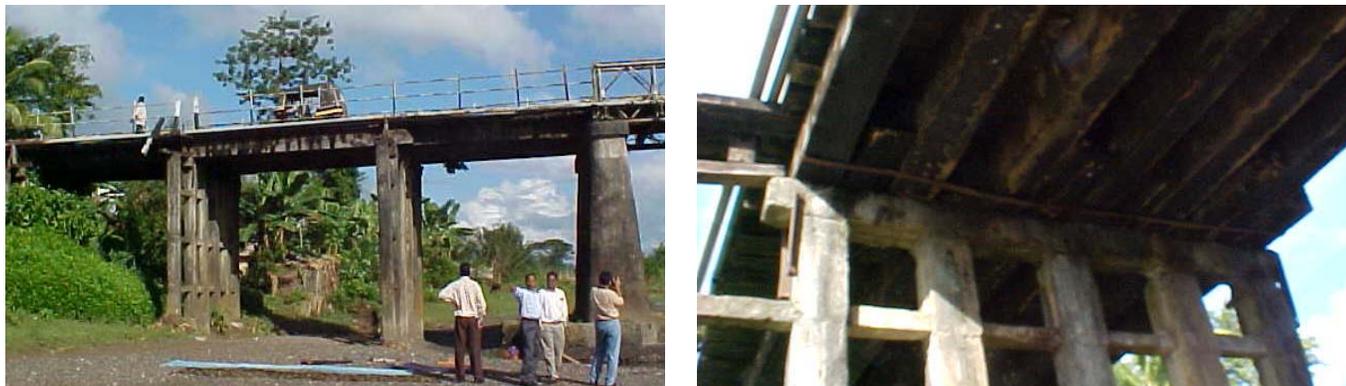
The earthquake affected region has many small bridges over natural drains which are in poor condition and pose serious safety threat in the event of greater shaking. The Kalpong bridge on ATR between Diglipur and RK Gram is a 30-year old structure and was in poor state of health (Figure 35). No serious damage was noticed to the steel superstructure of the 20 m main span. However, timber beams of approach spans supported on RC frame piers appeared to have moved. The seating of beams at 6 m tall piers may not be adequate in the event of stronger shaking and needs to be retrofitted urgently. The poorly maintained masonry and RC piers of the main and approach spans indicate significant deterioration in their strengths, raising concerns on the residual strength of the bridge.

Figure 35: Kalpong bridge north of Diglipur town has no earthquake resistant features. This deficiency is further accentuated by its poor maintenance.

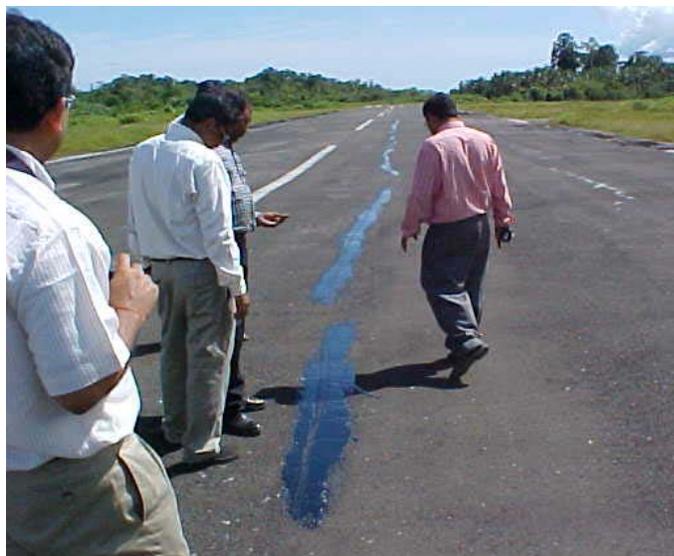
Port Blair airport provides the only civilian air link to the Andaman & Nicobar Islands from the main land. The newly constructed airstrip in Shibpur (south of Diglipur) is meant for light aircrafts. The flexible airstrip developed on unconsolidated marshy land developed cracks near the centerline. The cracks were filled with Grade 80/100 bitumen as seen in Figure 36. The terminal building under construction did not experience damage. However, the 1.5 m high boundary wall of the airport premises fell at many places.

Figure 36: Longitudinal fissures of the flexible pavement of the airstrip at Diglipur, which were closed with bitumen pours.

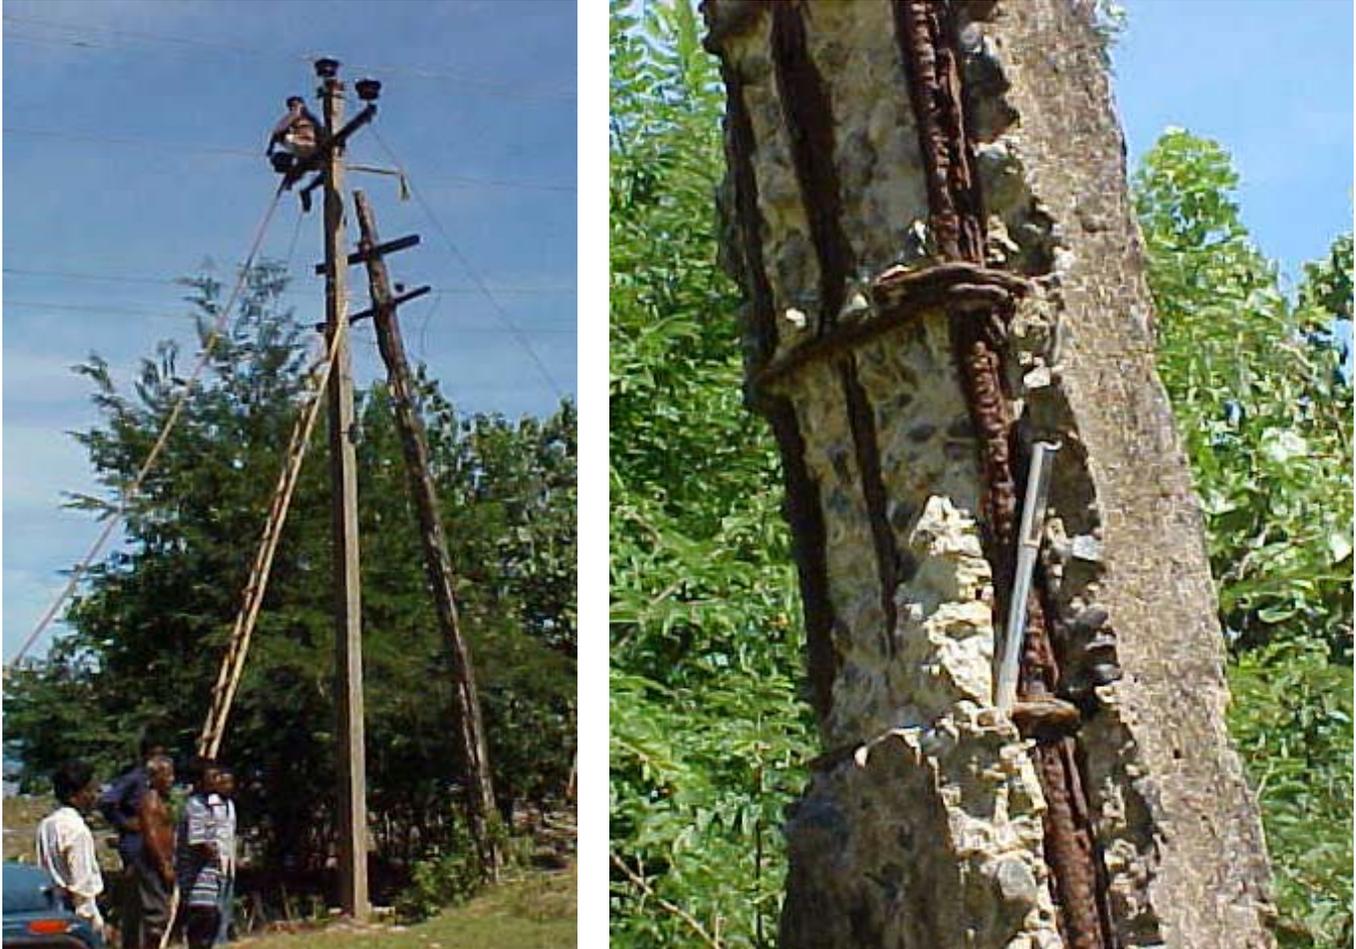
There was disruption of telephone link for two days due to uprooting of telephone poles in the Diglipur area. Drinking water supply was affected in Diglipur town due to landslides at Lamia Bay, where surface run-off water is collected and distributed after treatment. Electric power supply was also affected due to damage to 50 poles over 8 km stretch between Arial Bay and Kalipur. The reinforcement in the precast RCC electric poles was corroded and concrete cover had fallen off. These already environmentally weakened poles were easily overwhelmed by ground shaking (Figure 37).

Figure 37: Deteriorated RCC electric poles gave way in the area of major shaking disrupting power supply.
