Reconnaissance Report

North Andaman (Diglipur) Earthquake of 14 September 2002

by
Durgesh C. Rai
C. V. R. Murty

April 2003

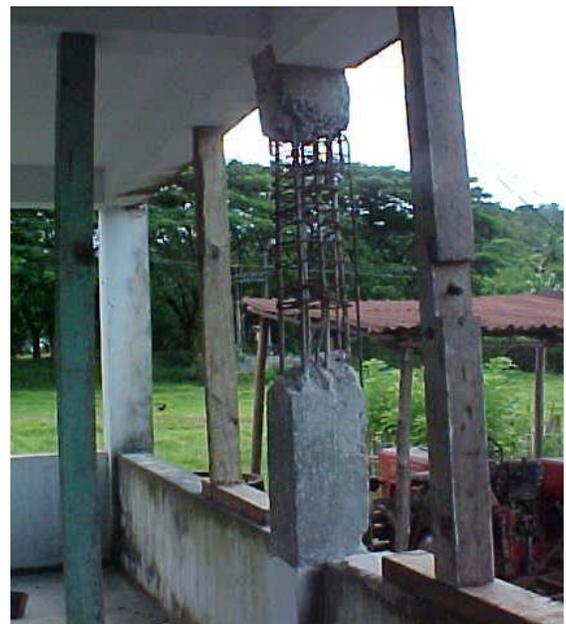
After the earthquake, major government departments present in the islands, namely Andaman Public Works, Andaman Harbour Works and Military Engineering Services carried out a survey of damage to the structures under their care. APWD prepared a list of buildings under the following categories: (a) buildings to be repaired/restored, (b) buildings to be retrofitted, (c) buildings to be reconstructed, and (d) buildings that are seismically deficient. However, the Department appeared not equipped with proper technical knowledge to undertake these projects successfully. For example, the damaged columns of Nabagram Panchayat building will be just restored to the original without addressing the seismic deficiency of the structure and its components in any comprehensive manner (Figure 38).

Figure 38: Inadequate repair of damaged columns of the Panchayat building at Nabagram village.
