PRELIMINARY REPORT ON THE 2005 NORTH KASHMIR EARTHQUAKE OF OCTOBER 8, 2005

Durgesh C Rai and C V R Murty
Department of Civil Engineering
Indian Institute of Technology Kanpur, India

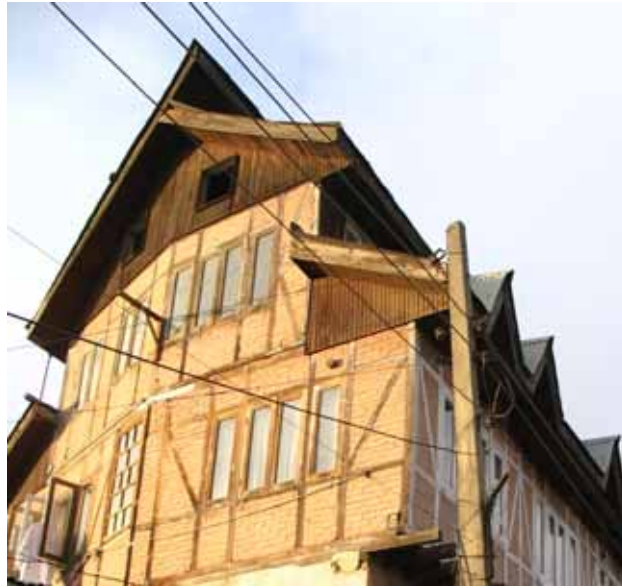
In Kashmir traditional timber-brick masonry construction consists of burnt clay bricks filled in a framework of timber to create a patchwork of masonry, which is confined in small panels by the surrounding timber elements. The resulting masonry is quite different from typical brick masonry and their performance in this earthquake has been once again shown to be superior with no or very little damage. No collapse has been observed for such masonry even in the areas of higher shaking. This timber-lacing of masonry, which is locally referred as *Dhajji-dewari* (meaning patch quilt wall) has excellent earthquake-resistant features. Presence of timber studs, which subdivides the infill, arrests the loss of the portion or all of several masonry panels and resisted progressive destruction of the rest of the wall (Figure 2). Moreover, the closely spaced studs prevent propagation of diagonal shear cracks within any single panel, and reduce the possibility of the out-of-plane failure of masonry of thin half-brick walls even in higher stories and gable portion of the walls. Dhajji-dewari system is often used for walls of upper stories, especially for the gable portion of the wall, even when the walls in bottom stories could be made of brick or stone masonry (Figure 2a).

Figure 2. Traditional masonry for proven earthquake resistance: (a) *Dhajji-dewari* system of timber laced masonry for confining masonry in small panels (b) *Taq* system of embedding timber logs in thick walls and (c) Brick masonry piers for timbers in stone infilled wall.

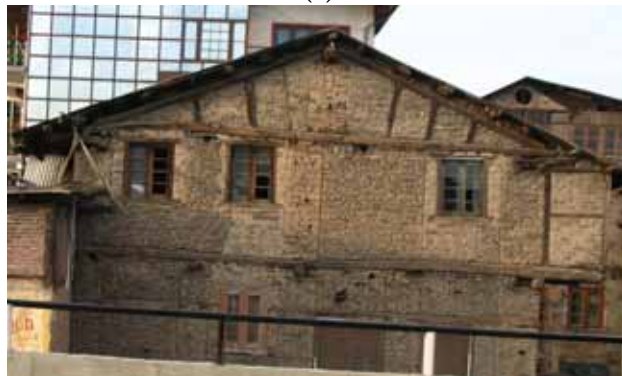
(b)

In older construction, another form of timber-laced masonry, known as *Taq* has been practiced in which large pieces of wood has been used as horizontal runners embedded in the heavy masonry walls, which add to the lateral load resisting ability of the structure (Figure 2b). The concept of Dhajji-dewari has also been extended to develop a mixed construction in which stones are used as filler hard material in wall panels created by a series of piers in softer coursed brick masonry of greater integrity under lateral loads (Figure 2c). The masonry walls with stones confined in such a manner have performed quite satisfactorily, in contrast to usual brick or stone masonry.

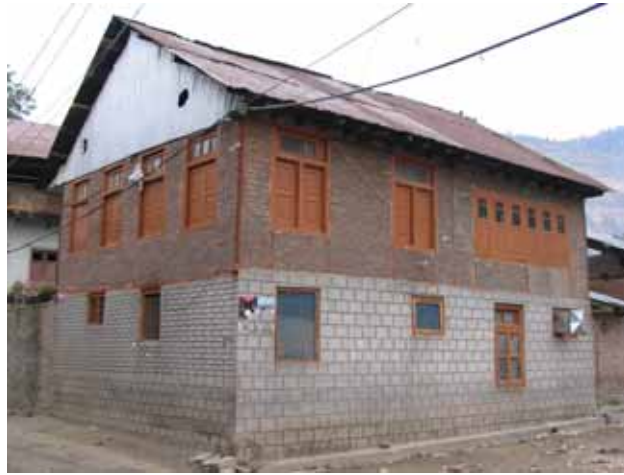
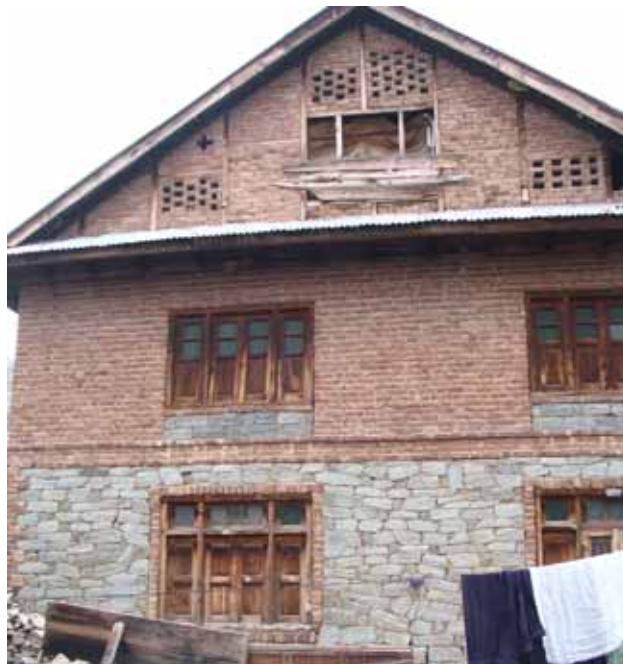
In the upper reaches of North Kashmir Himalayas, majority of houses use stone masonry in mud mortar for walls and flexible diaphragms for floors and roofs consisting of timber. Stone masonry is produced from a wide range of materials and constructed in many different forms that have shown varying degree of performance in this earthquake. Unreinforced stone masonry is very durable even in the hostile environment and can accommodate movements and resist natural forces without becoming unstable and falling apart, especially when they are laid in even courses after proper dressing (Figure 3).

Figure 3. Examples of mixed construction involving *dhajji-dewari* and dressed/undressed stone masonry and brick masonry.

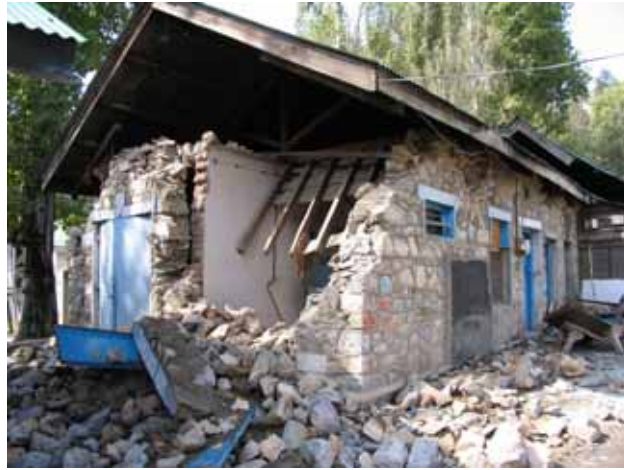
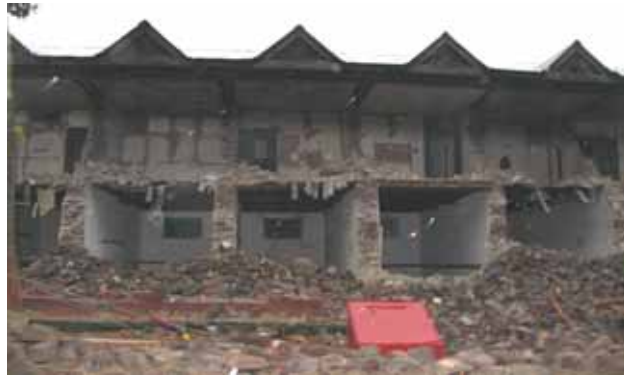
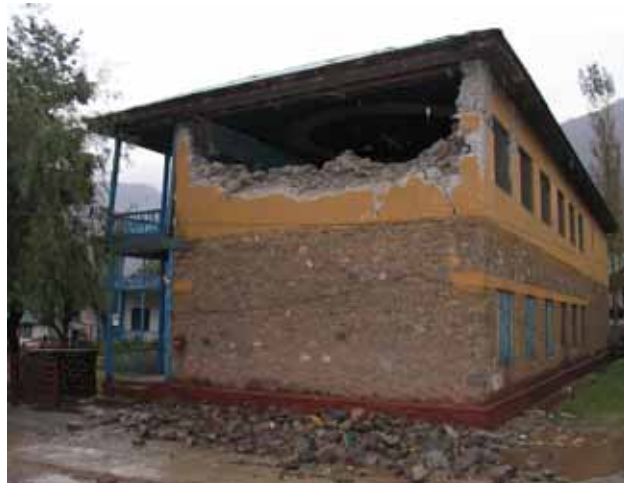
However, some forms of stone masonry, especially Random Rubble (R/R) stone masonry construction are extremely vulnerable to earthquakes. Undressed stones are laid in mud or cement mortar and plastered in cement mortar to provide finished surface. Most of government buildings, hospitals, schools, jails, etc., built during the last 4 to 5 decades suffered heavy damage especially when the structure is old. This was primarily due to the fact that the walls could not maintain its integrity during the shaking. The collapsed walls of army buildings in Uri and Kupwara are a few examples. Such out-of-plane failures arising from the dynamic instability of unsupported walls were also evident in collapse tall slender end wall in brick masonry as well. Moreover, masonry walls are weakened by openings for doors and windows (Figure 4).

Figure 4. Out-of-plane collapse of stone masonry walls

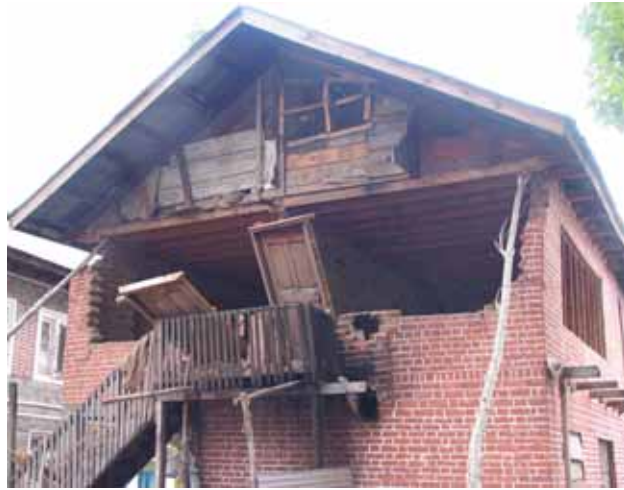
deficiencies can render typical brick masonry buildings vulnerable to damage as shown Figure 5. However, timber-laced masonry can maintain its integrity even when the supporting masonry walls in lower stories are severely damaged (Figure 6). There are many small scale buildings using all timber construction which have generally performed satisfactorily. Even large buildings in timber had no observed damage whereas neighboring stone masonry buildings suffered partial to total collapse (Figure 7).

Figure 5. Damage to brick masonry buildings: (a) Out-of-plane collapse of walls and (b) In-plane failure of masonry walls in lower stories and out-of-plane collapse at uppermost storey

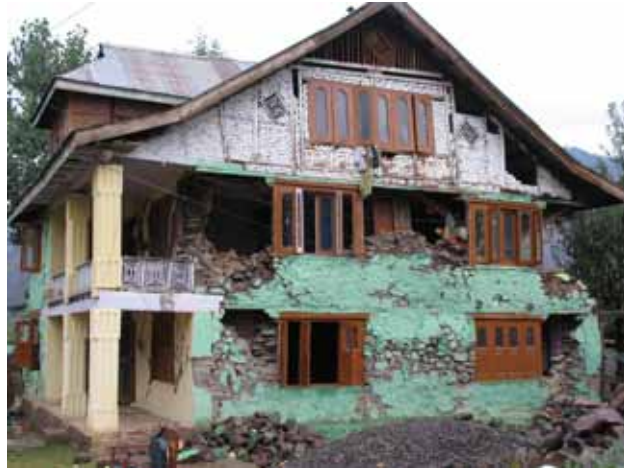
Figure 6. Timber-laced masonry in gable wall suffered little damage whereas extensive damage in stone masonry wall rendered the building unsafe at Uri.

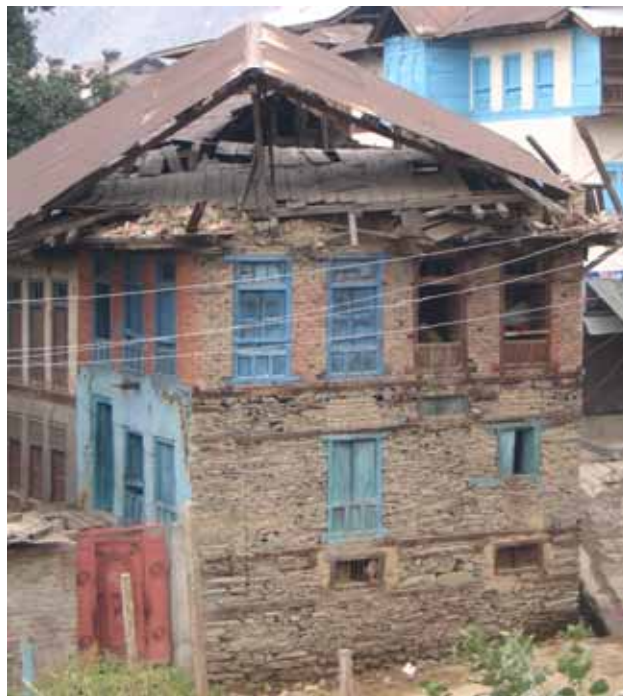
Figure 7. Failure of supporting walls for the roof in a traditional building using *Taq* system of masonry at Baramulla.

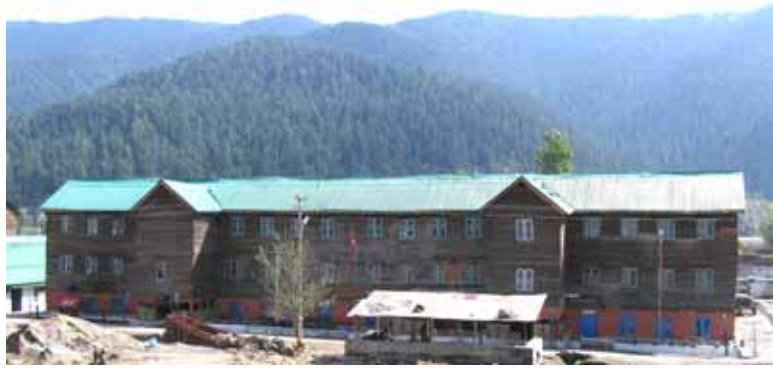
Figure 8. All timber building escaped the ground shaking without significant damage at Kupwara.

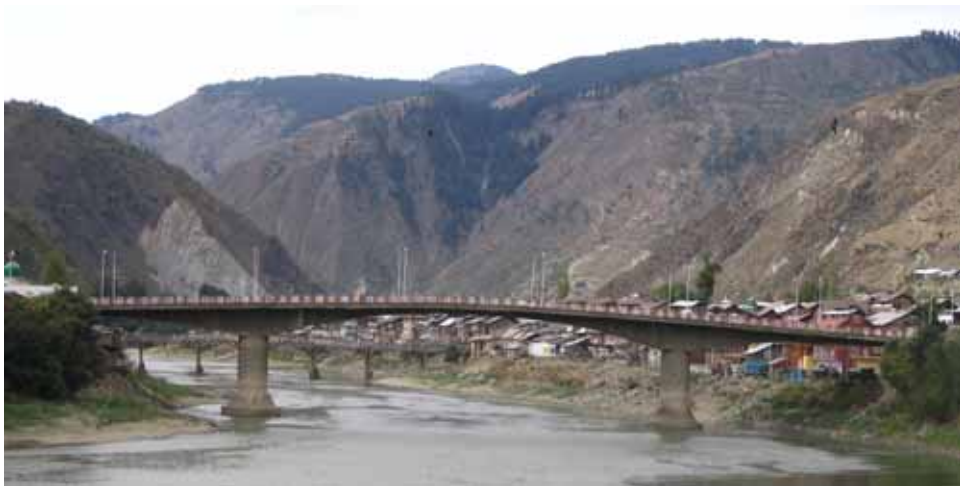
The area has a number of highway and pedestrian bridges over rivers, rivulets, and gorges. No serious damage to any of the highway bridges was noticed in the areas visited, however, it has been reported that the Aman Setu at India-Pak border on the road to Muzaffarabad had suffered damage. The balanced cantilever bridge at Baramulla over Jhelum river had no observed damage (Figure 9a). The affected region which may experience ground shaking more than IX on MSK scale, has a number of major bridges which are simply supported prestressed concrete girder type with inadequate seating or any provision to prevent unseating (Figure 9b). Most of pedestrian bridges were of suspension types and no particular damage to the bridge structure or to the supporting pylons was noticed.

Figure 9. (a) No observed damage to balanced cantilever bridge over Jhelum at Baramulla and (b) Simply supported prestressed concrete girder bridge over NH1A in Zone V. Note lack of restrainers for preventing unseating during earthquakes.

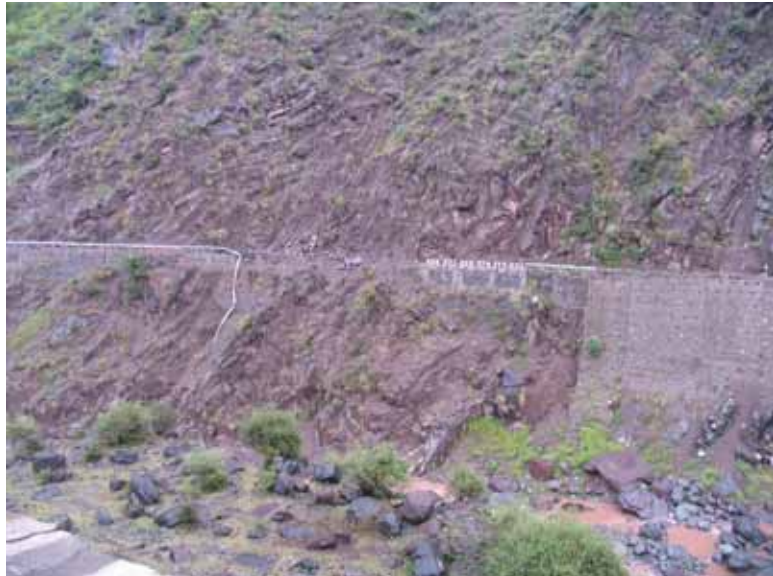
Roads closer to epicentral area in the mountainous region suffered extensive landslides which resulted in the closure of traffic for many days (Figure 10). The road to Tangadhar from Kupwara was not open even a week after the quake. Fissures on roads were noticed at places which were primarily due to ground movement across unstable slopes. Pipe lines for drinking water supply broke at several places causing severe hardships. An overhead water tank on shaft supported staging in Traigaon suffered circumferential flexure tension and shear cracking which was empty at the time of earthquake (Figure 11). Such damages have been observed in many past earthquakes which highlight the inadequacy of current design of such tanks.

Figure 10. Landslide on NH1A near Uri disrupted the road traffic.

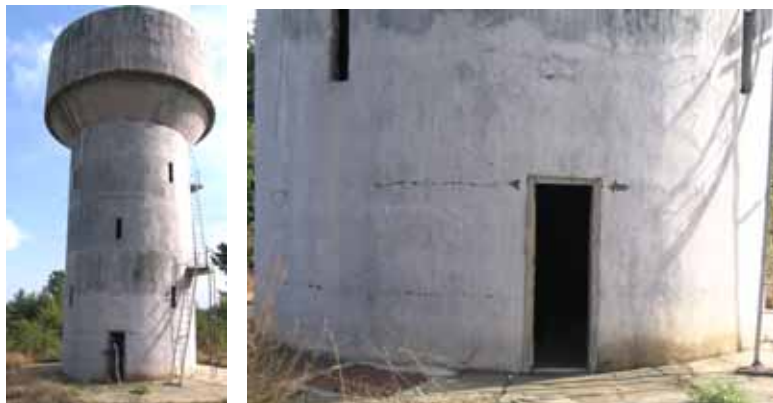
Figure 11. A 50000 gallon water tank at Traigaon developed flexure tension cracks in its supporting shaft rendering it unsafe for use.
