The September 29, 1993, M6.4 Killari, Maharashtra Earthquake in Central India.

EERI Special Earthquake Report, EERI Newsletter, Vol. 28, No. 1, January 1994

Sudhir K. Jain, C.V.R.Murty and Navin Chandak
Department of Civil Engineering
Indian Institute of Technology Kanpur

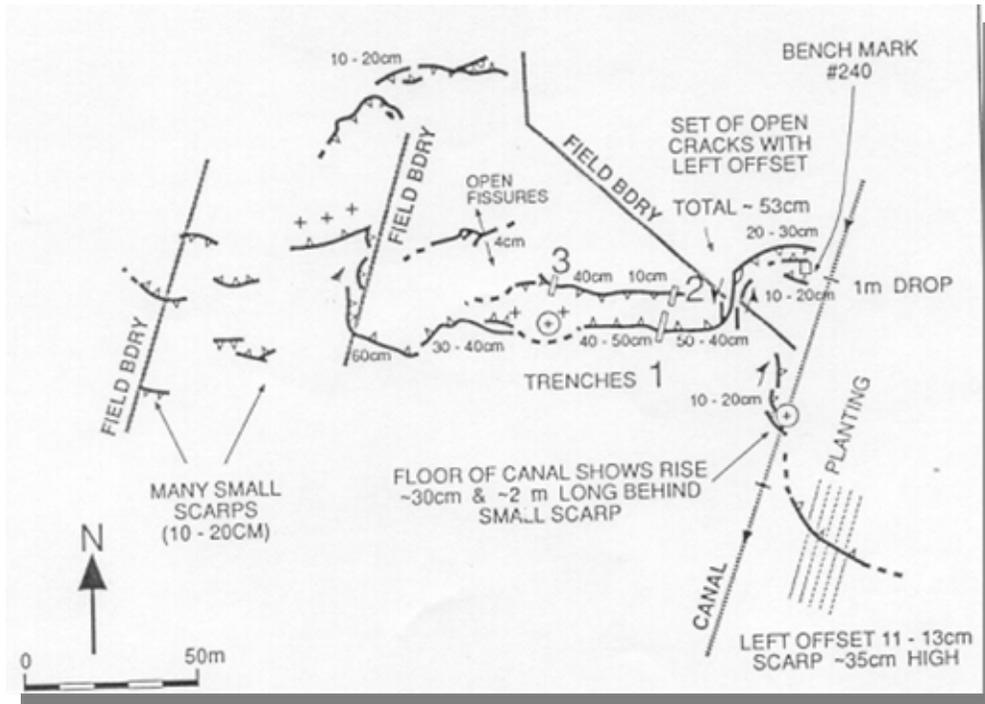
The 1993 Killari earthquake ruptured the surface. Three weeks after the main shock, at the time of our field investigation, discontinuous scarps were discernible along a west-northwest zone about 1km long and starting 1.5km west of the village of Killari. Where best expressed, the surface trace of the rupture is very complex; it is multibranching, double vergent, and discontinuous (*Figure 2*). Most scarps trend approximately east west; a few north-northeast trending scarps show evidence of predominant horizontal components of motion. The sense of movement is in each case consistent with their interpretation as "transform" faults connecting different branches of the system.

Figure 2: Portion of the surface rupture associated with the 1993 Killari earthquake. This rupture was mapped discontinuously in an east-west zone over a distance of about 1 km. Barbs indicate the uplifted side of the scarps; the approximate height of the scarps is also indicated. Plus signs indicate uplifted area, circled when localized. Note that a 'transform' fault connects a south-facing scarp in the center of the map with a north facing scarp on the right. This 'transform' offsets a field boundary by 53 cm left laterally, which is a minimum measure of the shortening. The strike of this and other 'transforms' in this map is north-northeast, the inferred direction of shortening.

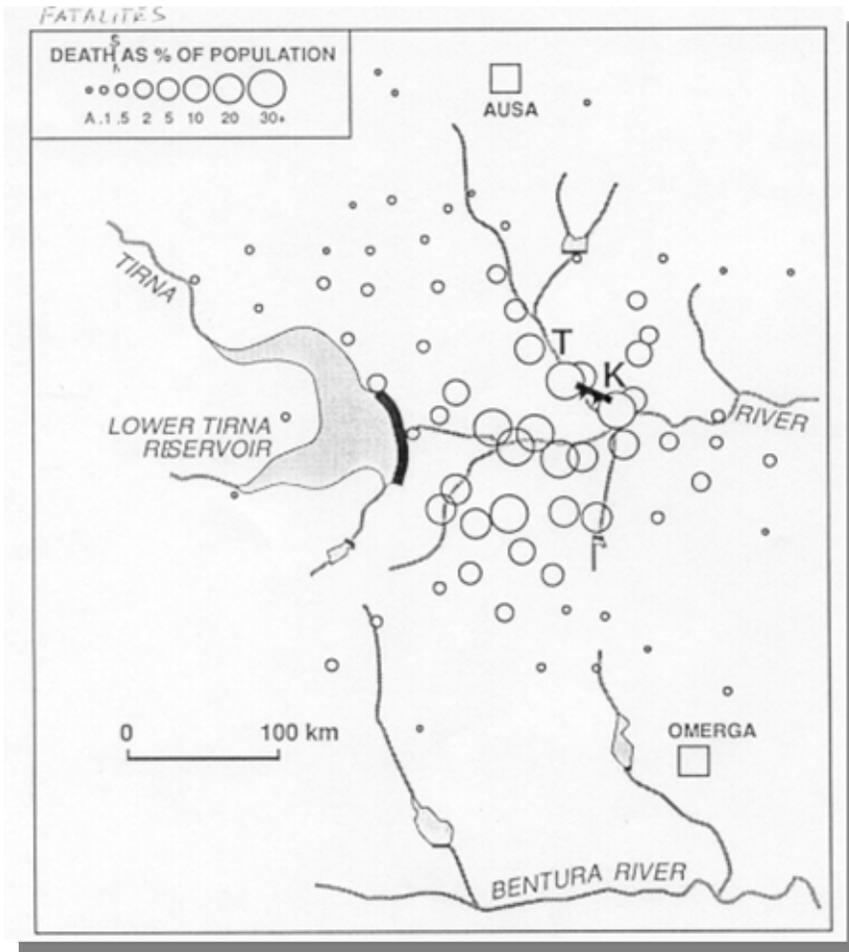
Figure 3 shows fatalities relative to the total population in each village. These gruesome statistics are quite effective in delineating the mesoseismical area. In an area about 10 x 10 centered on the Tirna River, 20-30% of the people were killed. Outside this area relative casualties decrease rapidly. This mesoseismical area probably corresponds spatially to the main shock rupture; the surface area of the rupture is along the northern limit of this area.

Figure 3: Number of officially recorded fatalities as percentage of population in villages in epicentral area. A surface rupture was mapped near the village of Killari (K) and inferred to extend at least to the village of Talni (T). Surface deformation features reflect a reverse fault dipping to the Southwest. Note that the zone of highest relative fatalities (20-30 %) is centered Southwest of the trace of the thrust, above the inferred rupture. Note also that this rupture is centered about 10km from the Lower Tirna Dam.

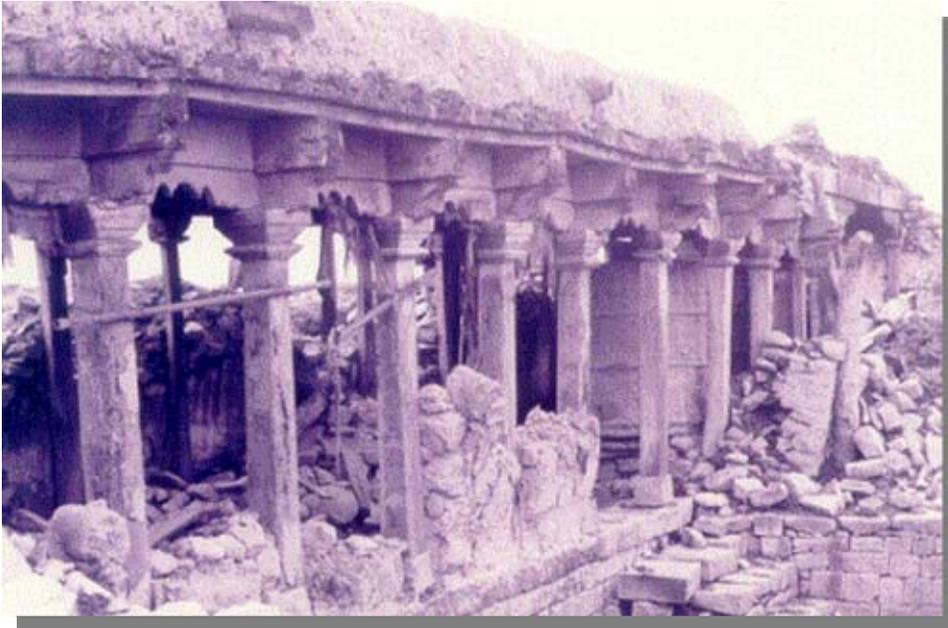
A number of dwellings in the affected villages had timber columns connected together with transverse and longitudinal beams. The roof planks in these houses were supported by the timber beams and columns rather than the rubble masonry walls. When securely anchored to the floor and to the roof beams, the posts tended to hold up the roof and prevent the inward collapse of the walls, thereby saving the inhabitants.

Figure 4: In some buildings, the traditional heavy clay roof was supported on a frame of wood posts and beams. In most cases, the timber columns continued to hold the roof together while the walls collapsed, generally outwards from the timber frame, saving the lives of many occupants

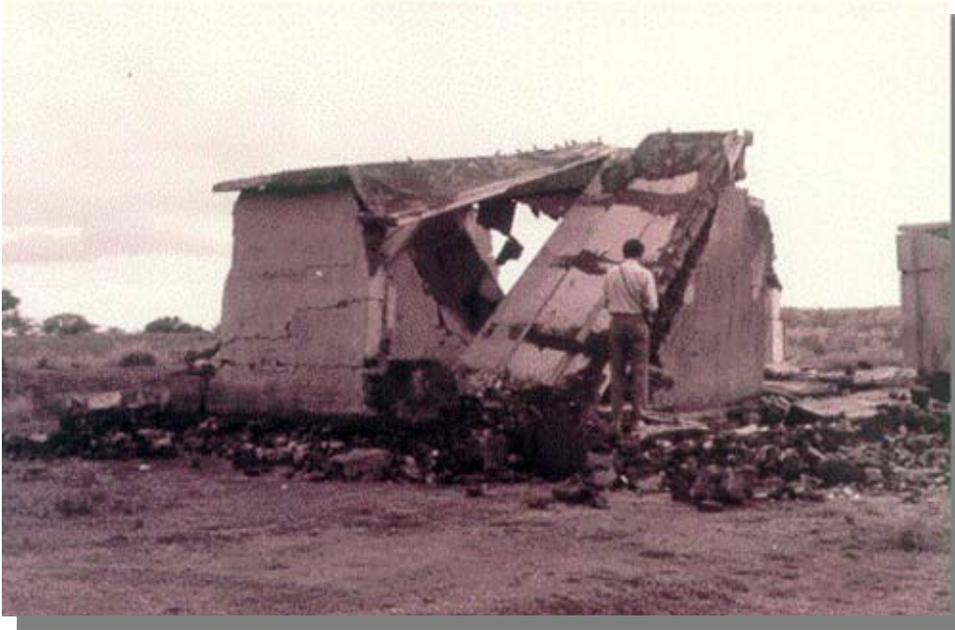
A one-room 8x8 m school building in the village of Rajegaon had exterior load-bearing walls of brick masonry with cement mortar. The roof consisted of lightweight precast planks 4 m long and 12 cm thick spanning from a light steel truss at the center of the building to the masonry walls. The planks were held together at the line of the truss by steel strips tacked with an epoxy material. No diaphragm action was possible due to the lack of proper connections between the walls and the panels and the truss, and between the panels themselves. The roof panels collapsed, demonstrating, yet again, the seismic vulnerability of precast panels without adequate connections.

Figure 5: A brick masonry school building in Rajegaon collapsed. The roof of precast panels lacked adequate connections

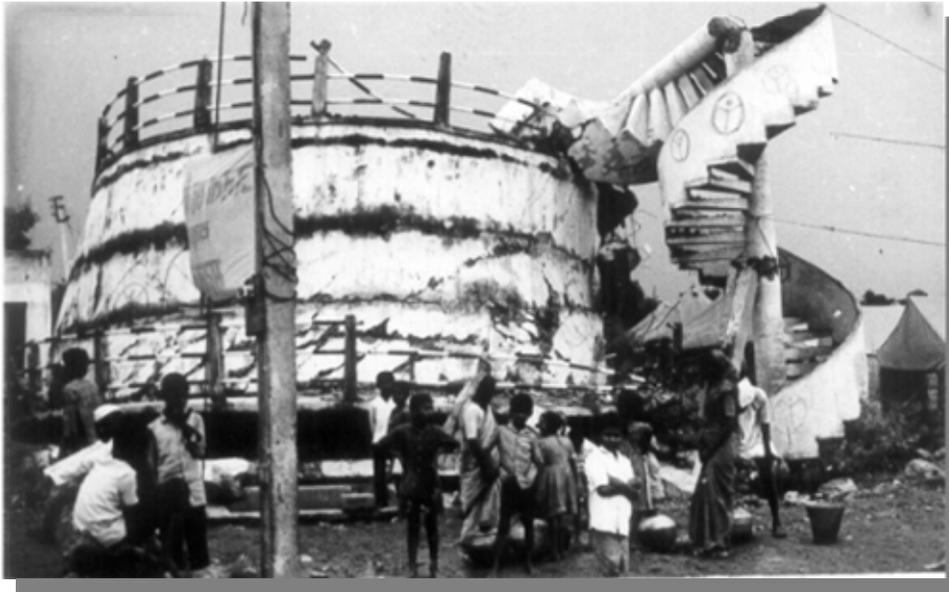
Figure 6: While most elevated water tanks performed well, this tank of Kautha collapsed straight down into its crumpled supports. Circumferential displacement of about 0.5m suggests that rotational vibration led to its collapse.

For water supply, most of the villages had an elevated water tank consisting of a reinforced concrete container supported on a concrete moment-resisting frame about 10 m high, a standard design of the public health engineering department. Tank capacities ranged from 40 kl to 200 kl. Most of these tanks survived the earthquake with little or no damage. The one tank that suffered a complete collapse came straight down, burying the remains of six supporting columns directly under the bottom dome of the tank. That, and evidence of a circumferential displacement of about 0.5 m, suggest torsional vibrations were the primary cause of the damage.
