RECONNAISSANCE REPORT
SIKKIM EARTHQUAKE OF 14 FEBRUARY 2006

Hemant B Kaushik
Kaustubh Dasgupta
Dipti R Sahoo
Gayatri Kharel

NATIONAL INFORMATION CENTER OF EARTHQUAKE ENGINEERING
INDIAN INSTITUTE OF TECHNOLOGY KANPUR
KANPUR 208016 (INDIA)

April 2006

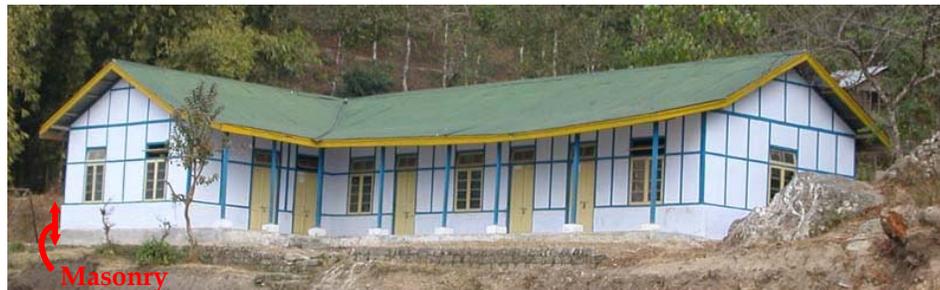
Traditional construction in Sikkim consists mostly of typical bamboo houses, known locally as *Ikra*, same as what is otherwise known as *Assam type* housing. Typically, *Ikra* houses are single storey structures consisting of brick or stone masonry walls up to about 1 m above the plinth (Figure 2a).

Figure 2: Traditional construction in Sikkim: (a) Typical *Ikra* structure (School building at Nandok in East Sikkim); (b) *Ikra* house under construction near Nandok; and (c) internal view (note use of wooden trusses and GI sheets in roof construction).

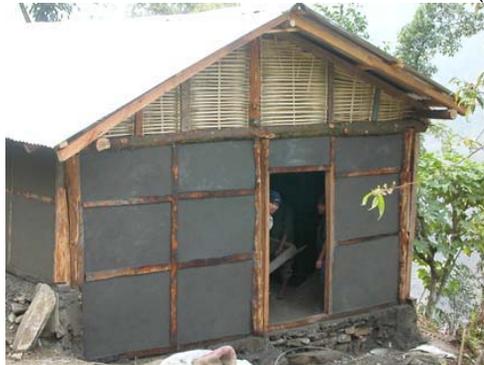
(b)

This masonry supports the walls consisting of bamboo woven together with wooden frame, and plastered with cement or mud plaster (Figure 2b). Roof generally consists of GI sheets supported on wood/bamboo trusses which laterally connect the parallel walls (Figure 2c). Bamboo *superstructure* is connected to the masonry *foundation* walls using steel angles, and flats with bolts and nails. There were no reports of any significant damages to *Ikra* structures during this earthquake.

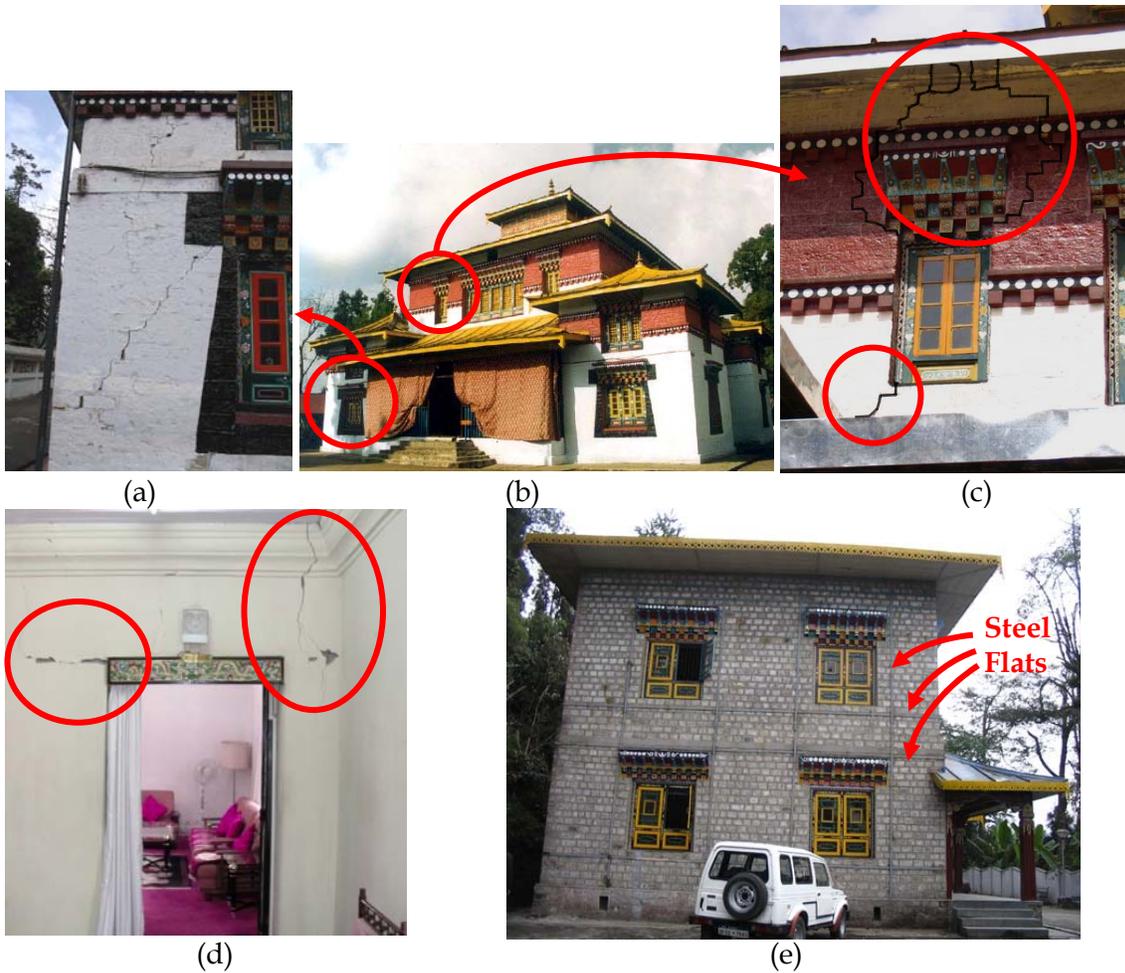
Generally, stone masonry structures in the area are of undressed stones with mud mortar. A few important structures have dressed stone masonry with mud and lime-based mortar (*e.g.*, *Raj Bhavan*). Stone masonry buildings suffered damages primarily because of undressed stones used without proper bonding between adjacent courses of masonry, and also at the corners. The mud mortar used as bonding material in these buildings further aggravates their lateral strength capacity. Some of the important masonry buildings damaged during the earthquake are *Enchey monastery* (Figures 3a, 3b, 3c) and *Raj Bhavan* (Figure 3d). These buildings were also damaged during the 1980 and 1988 earthquakes (CBRI 1988). It seems that these buildings were only “repaired” and not adequately retrofitted against future events. During the present earthquake, several masonry walls of these buildings suffered damages in the form of inclined shear cracks, and vertical cracks (Figures 3a-3d). These cracks were concentrated at corners, and also at location of window and door openings. The two storey Archive building was previously the legislative assembly building at Gangtok until it was damaged during 1988 Bihar-Nepal earthquake. Subsequently, this masonry building was retrofitted by fixing horizontal and vertical steel flats of about 50 mm × 8 mm size on all the outer faces of the exterior walls in each storey (Figure 3e). The building performed well in the present earthquake and sustained no damage. Clearly, sensible retrofitting of the important heritage structures can be critically useful in the future earthquakes.

Figure 3: Performance of masonry structures at Gangtok: (a), (b), (c) wide shear and vertical cracks in masonry walls at corners and near openings in *Enchey Monastery*; (d) numerous cracks near door/window openings were observed in *Raj Bhavan*; and (e) good performance shown by retrofitted Archive building (arrows indicate locations of steel flats used to retrofit the building after 1988 Bihar-Nepal earthquake).

Existing deficient buildings, particularly the important heritage structures, should also be repaired/strengthened on priority. Resource materials on repairing and strengthening of existing RC and masonry structures, such as, IS:13935 1993, and IITK-GSDMA Guidelines on Seismic Evaluation and Strengthening of Existing Buildings (downloadable from www.nicee.org) can be quite useful in this.

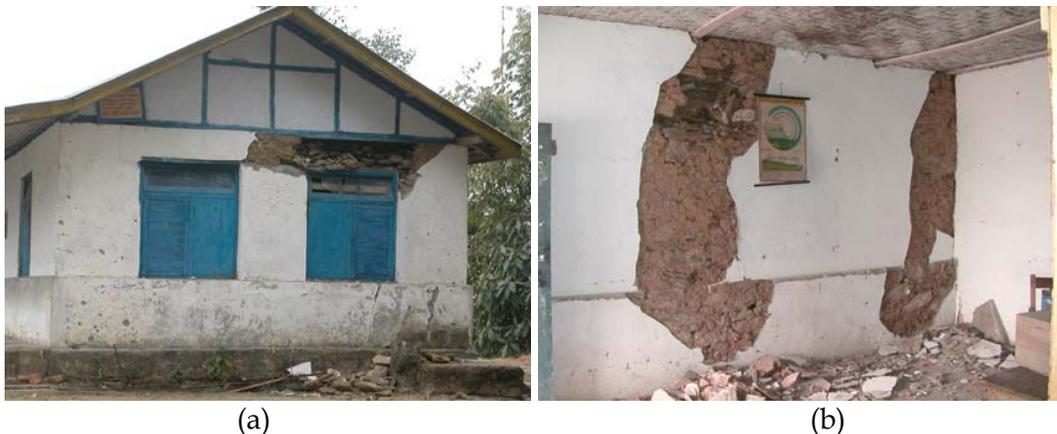
In rural areas of Sikkim, low cost school buildings are generally constructed using stone masonry with mud mortar even by the State government. Several such buildings suffered severe damages during the present earthquake shaking. Earthquake resistant features, such as, horizontal bands at various levels and through stones at corners are generally not provided in such constructions. This resulted in formation of severe cracks near corners and at the location of openings, when subjected to a mild shaking as the present one (Figure 4). In addition, out-of-plane tilting of several masonry walls was observed at some places.

Figure 4: Severely damaged stone masonry low cost school buildings in Sikkim: Government primary school, Thamidara (near Gangtok).

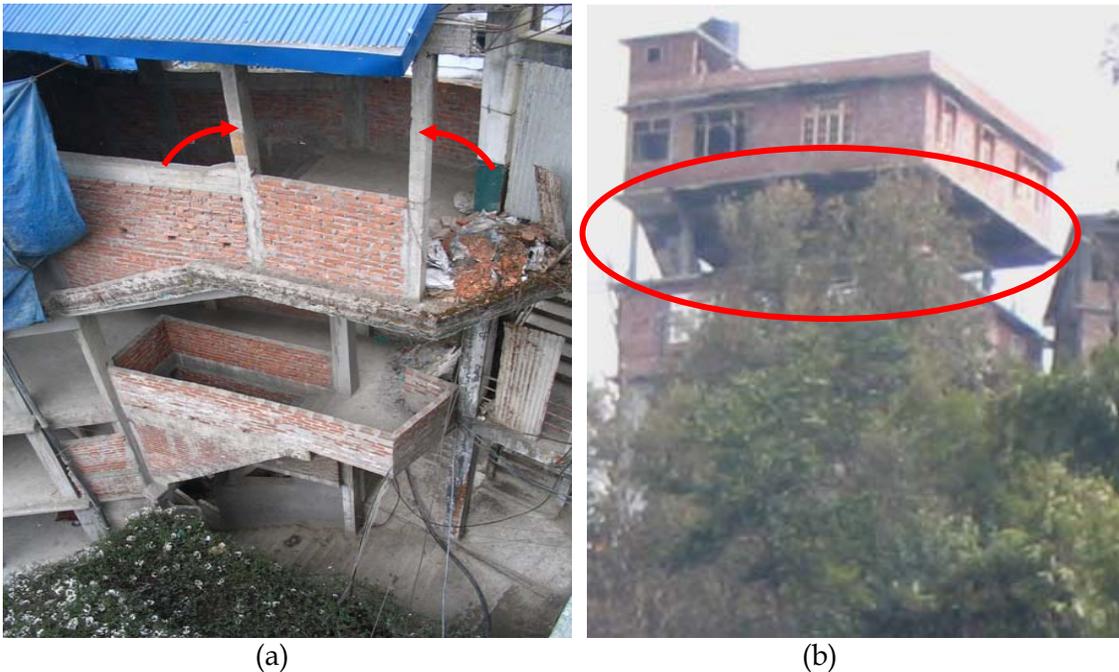
In RC buildings, burnt clay bricks or solid/hollow concrete blocks are commonly used as infills. Noticeable features of this type of construction are, (i) absence of RC lintels above doors and windows in private buildings (brickwork is generally supported directly by the wooden frame used for doors/windows), (ii) floating columns in upper storeys (Figure 5a), (iii) intermediate soft storey in multistoreyed buildings (Figure 5b), and (iv) poor reinforcement detailing. Quality control of materials was observed to be poor in most of the constructions.

Figure 5: Poor construction practice in Sikkim: (a) floating columns (shown by arrows) in the upper storey of an RC building; and (b) multistoreyed building with intermediate soft storey.

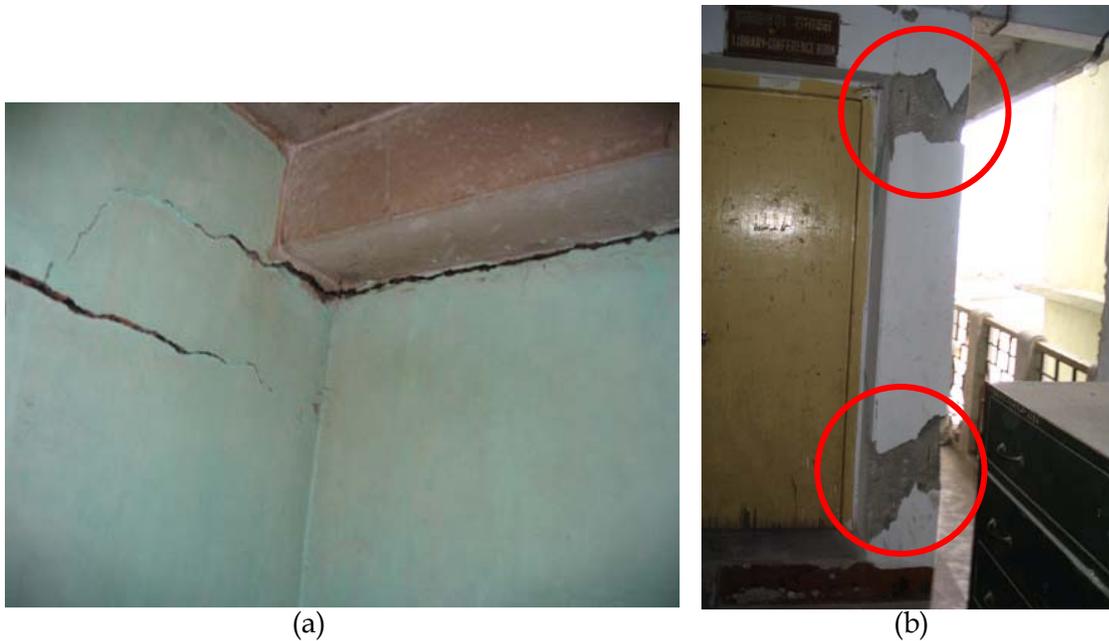
Most RC buildings at Gangtok suffered damages in some form or the other, the most common damage being cracks in masonry infills, and separation between RC frame and infill. Several Government buildings including legislative assembly building, *Tashiling* Secretariat, State Legislators' Hostel, Geological Survey of India (GSI) building at Deorali, suffered varying degree of damages (Figure 6). Among Government buildings, GSI building was the worst affected. Fortunately, the shaking was quite moderate and no RC building collapsed.

Figure 6: Damages to masonry infills in RC buildings at Gangtok: (a) cracks at beam-wall interface in Secretariat building; and (b) damages in walls near openings in GSI building at Deorali.

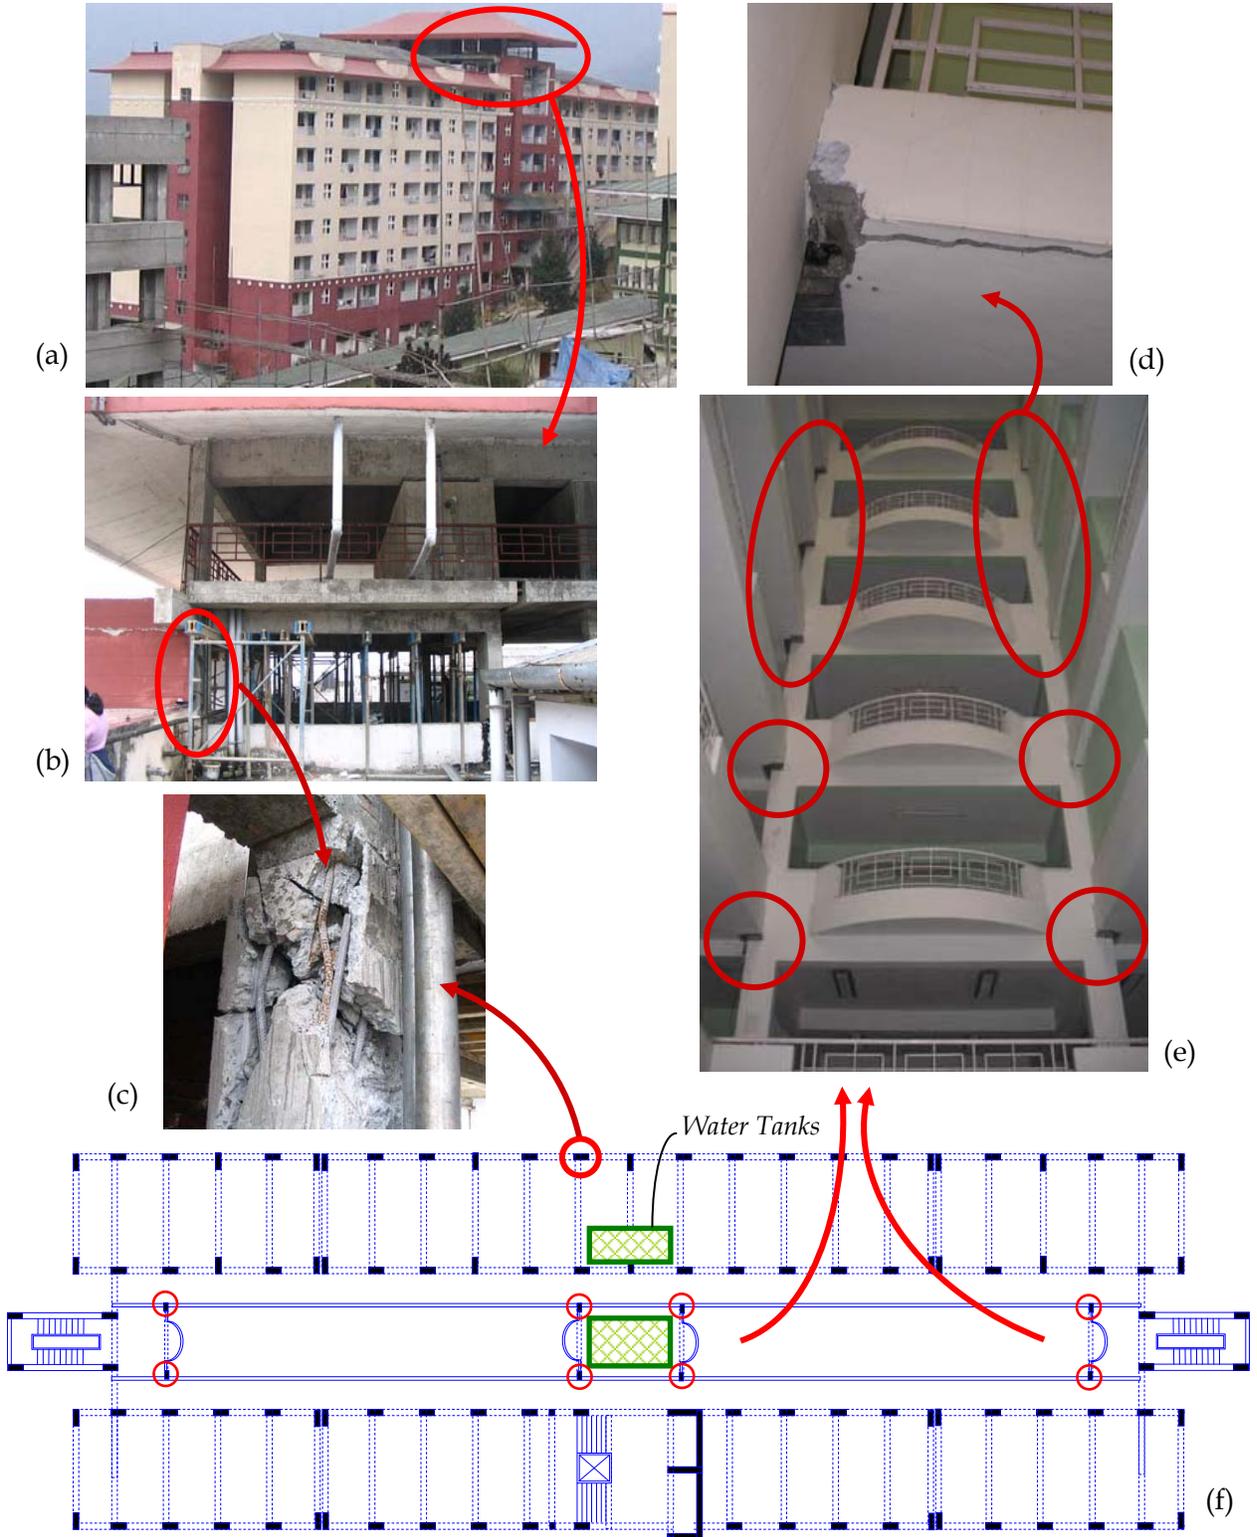
The nine-storey masonry infill RC frame hostel building at Sikkim Manipal Institute of Medical Sciences (SMIMS), Tadong, Gangtok suffered damages in walls and columns. Several masonry infill walls developed diagonal cracks due to earthquake shaking. One RC column below a water tank at roof level suffered heavy damages because of inadequate shear reinforcement, and improper lap splicing in longitudinal reinforcement (Figures 7a, 7b, 7c, and 7d). A few hostel rooms at the top storey just below the damaged column were evacuated soon after the shaking. Pounding damages were observed between two long wings in the building and corridors connecting those (Figures 7e, and 7f). Another four-storey RC building at Deorali suffered damages and was evacuated. Severe damages were observed in several RC columns of the building exposing mild steel bars as main reinforcement (Figures 8a and 8b). Poor material quality, and poor connection between perpendicular masonry walls resulted in out-of-plane failure of one infill wall, and severe damages to other infill walls in the building (Figures 8a and 8c).

Figure 7: Damages in nine-storey RC Hostel building (SMIMS): (a) elevation of the building; (b) damaged RC column supporting the water tank on the roof; (c); (d) pounding damages at the ends of the two wings took place at all the floor levels, (e) close view of the damaged column; and (f) plan of the building.

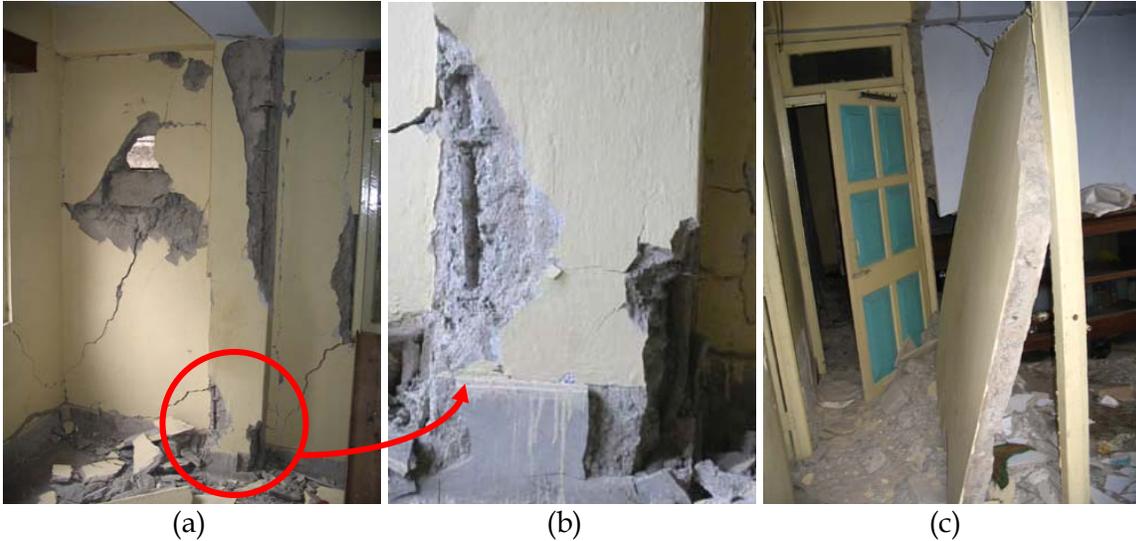
Figure 8: Damage in residential building at Deorali: (a) Severe cracking in infill walls and damaged RC column, (b) exposed mild steel in damaged RC column, and (c) out-of-plane failure of infill wall.

In most RC buildings in Sikkim, the grade of concrete being used currently is M15, as against the specified minimum grade of M20 for general RC structures (IS:456 2000). It was observed that mild steel bars are being used as main reinforcement in RC members. But for proper bonding with concrete and desirable characteristics, high yield strength deformed (HYSD) bars of good quality steel are recommended. For masonry buildings, lime mortar or cement mortar with desirable characteristics should be used instead of mud mortar.

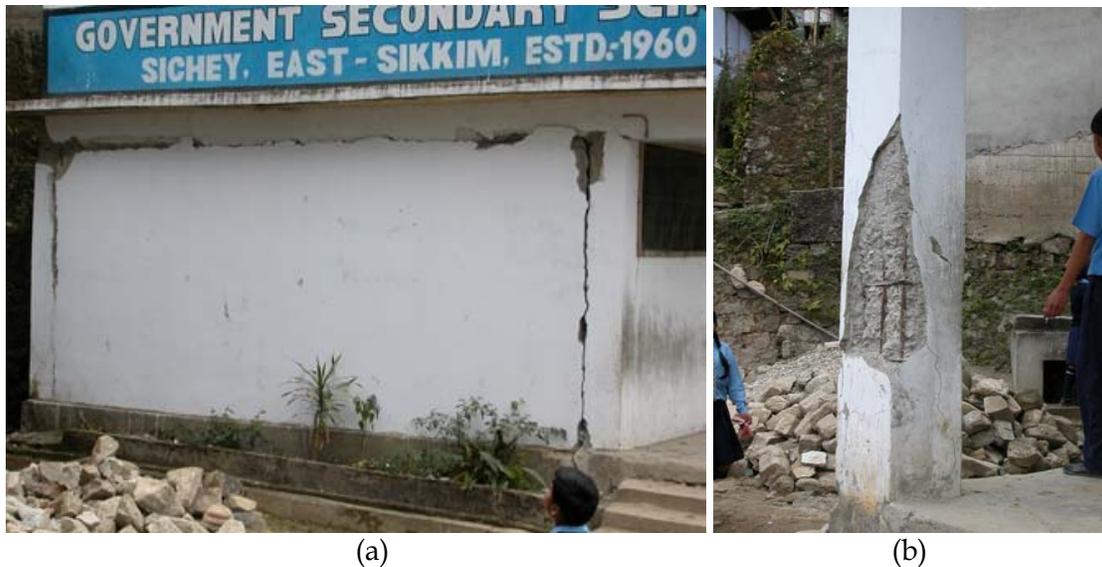
Similar damage to infills and RC members was noticed in several other government and private RC buildings in eastern and southern districts of Sikkim. A part of recently constructed three-storey RC government secondary school building at Sichey was found to be damaged. One masonry infill wall in the first storey tilted out of plane (Figure 9a) along with cracks in several other infills. In several RC columns of the building, spalling of cover concrete due to corrosion of reinforcement bars was observed along with inadequate shear reinforcement (Figure 9b).

Figure 9: Government secondary school building at Sichey suffered moderate damages: (a) out of plane tilting of masonry infill wall, (b) inadequate shear reinforcement in columns, and spalling of cover concrete in columns at several locations due to corrosion.

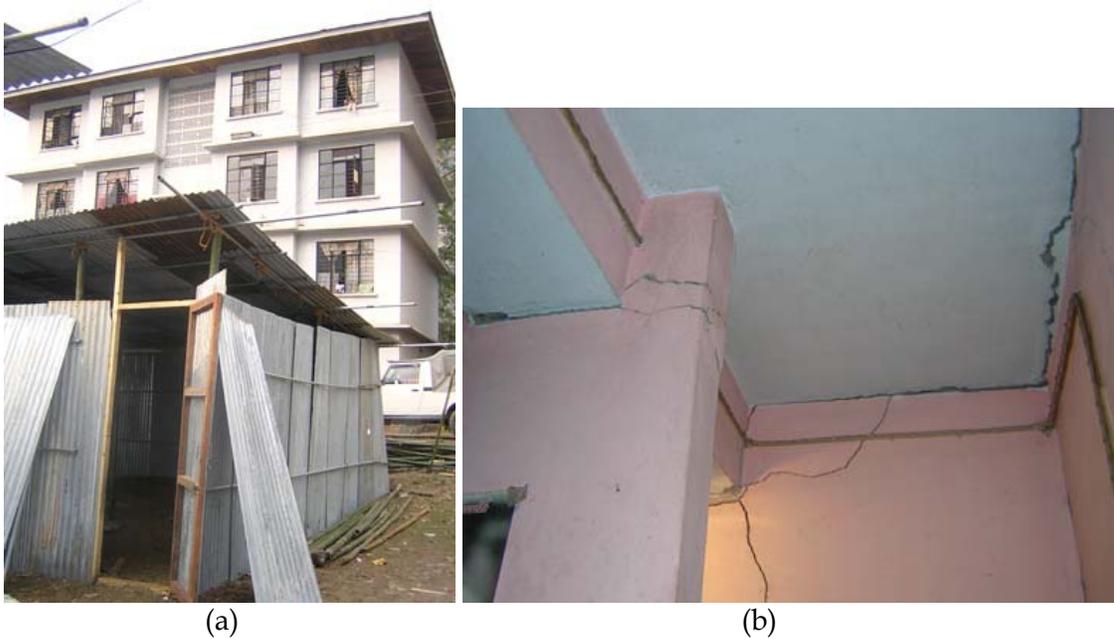
Several RC buildings (up to four-storey high) of Sikkim Nationalized Transport (SNT) colony at Ranipool near Gangtok suffered similar damages (Figure 10a). At least one quarter was severely damaged (Figure 10b), and the government had already given orders of evacuation of several quarters. At the time of reconnaissance visit, temporary relief quarters (~7 m × 7 m) using GI sheets, bamboo posts and GI pipes were being constructed in front of the RC buildings, and residents were instructed to move into them (Figure 10a).

Figure 10: One quarter of four storey government residential buildings (SNT colony) at Ranipool suffered severe damages: (a) temporary shelters constructed using GI sheets in the backdrop of the RC quarters, (b) damaged columns and walls in one of the quarters.

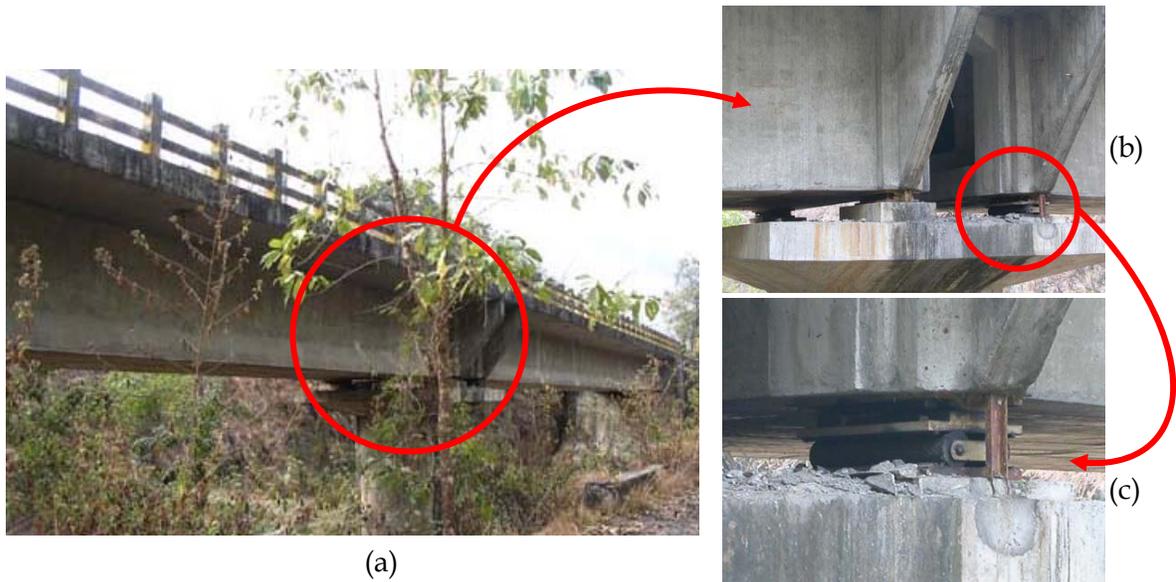
There are several bridges on National Highway 31A, which connects Sikkim to the rest of country. In the Tarkhola Bridge between Melli and Rangpo, spalling of concrete was observed at the top of central pier near bearings (Figure 11). One needs to ascertain if this was caused by the earthquake shaking. Bridge deck lateral restrainers, which can prevent the spans from dislodging off the piers, were observed in most of the bridges along NH 31A. However, these steel lateral restrainers appeared to be insufficient for holding the bridge decks during severe ground shaking expected in seismic zone IV (Figure 11c). An RC pedestrian foot bridge constructed in 1989 near STNM Hospital at Gangtok sustained minor damage in the form of spalling of cover concrete in one RC beam due to corrosion of reinforcement bars. Horizontal cracks were observed in masonry walls of an RC office building of Sanitation Section, Urban Development and Housing Department (UDHD, Sikkim) constructed under the foot bridge at one end.

Figure 11: Two-span RC Tarkhola Bridge between Melli and Rangpo appeared to be slightly damaged at the location of roller bearings on top of central pier: (a) bridge overview, (b) closer view of the central pier cap, and (c) spalling of concrete and insufficient lateral restrainer made of steel at the top of pier.
