2015 GORKHA (NEPAL) EARTHQUAKE

Effects on Built Environment & A Perspective on Growing Seismic Risk in Bihar-Nepal Region

Department of Civil Engineering, Indian Institute of Technology Kanpur

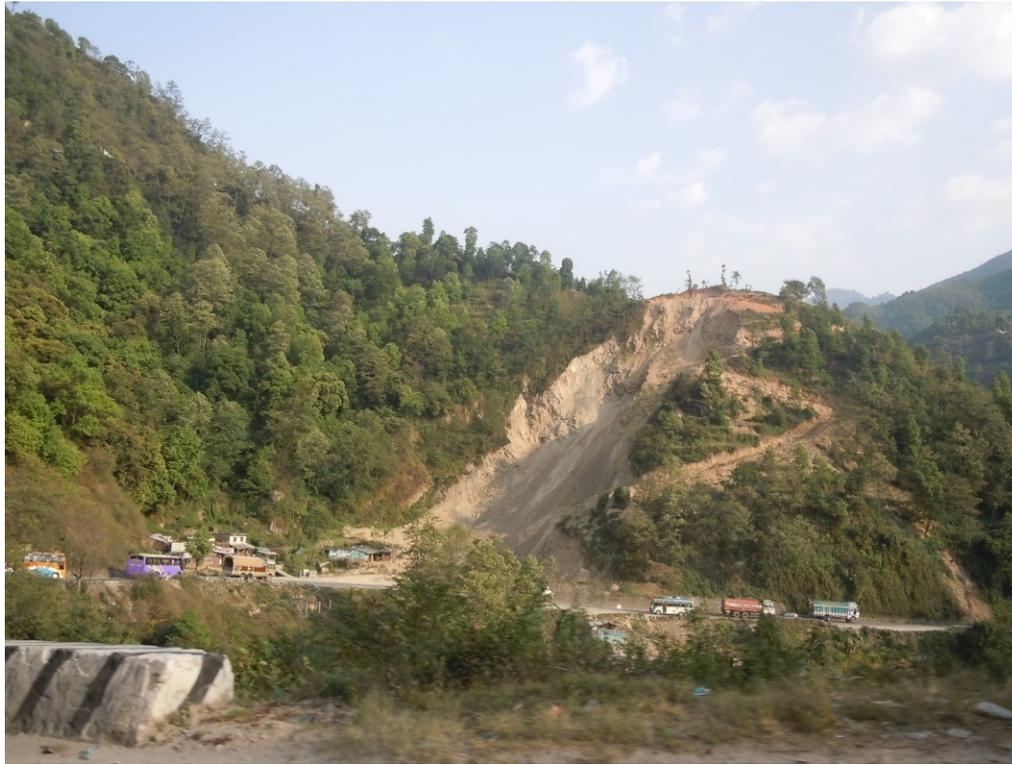
Landslide on road to Kathmandu, Nepal

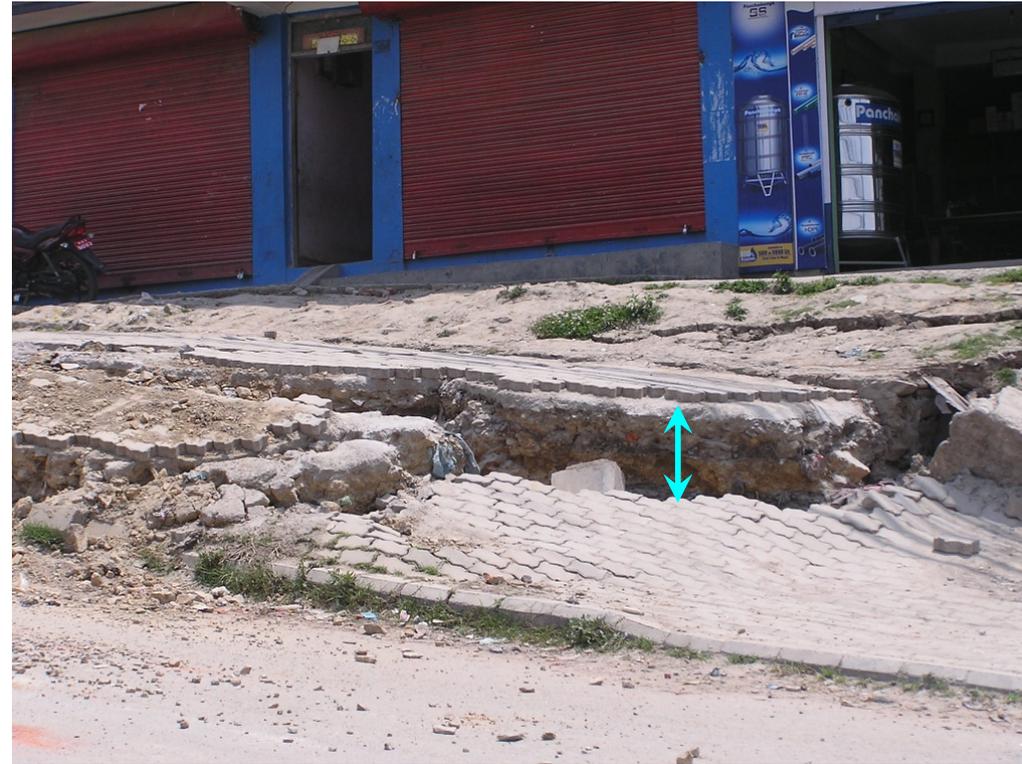
Vertical movement of ground which resulted in severe damages to roads

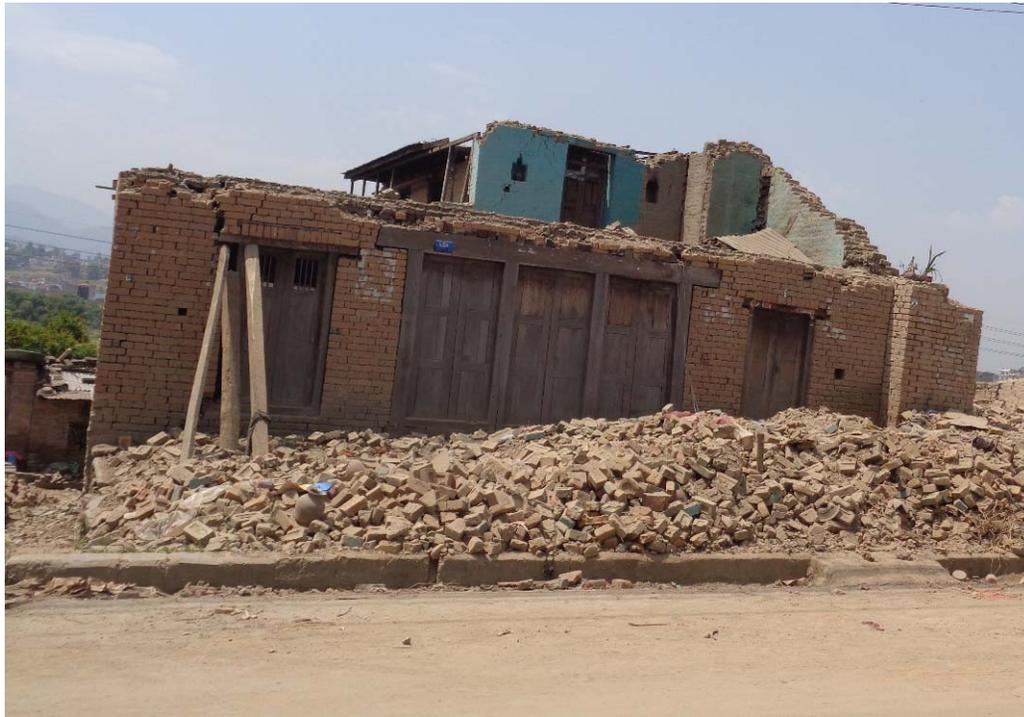
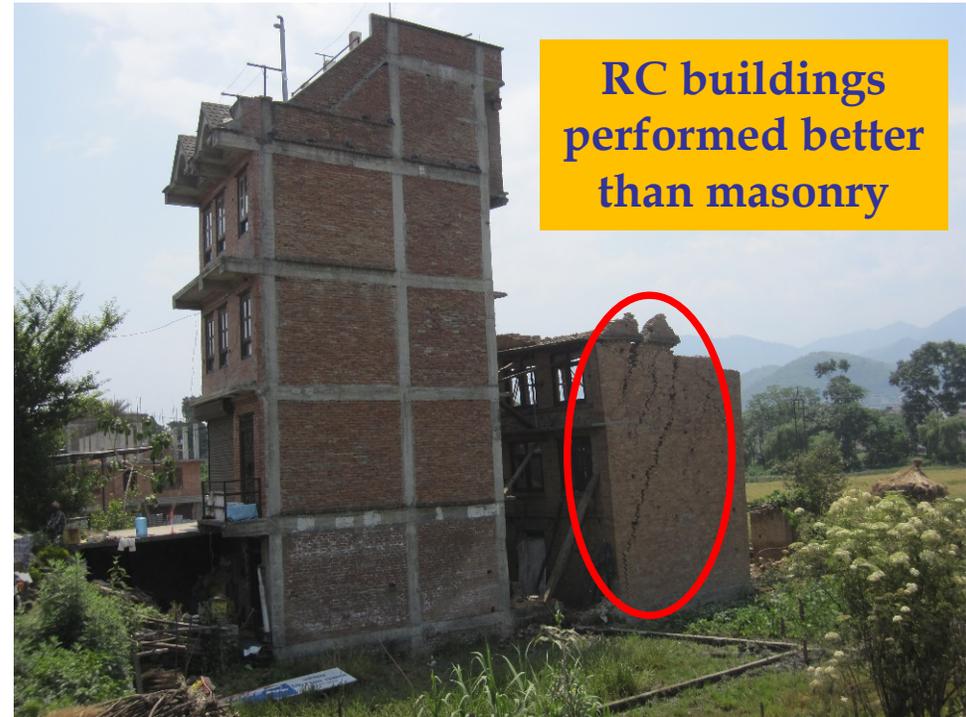
Complete collapse of 50~60 year old URM buildings in Nikoshera (Bhaktapur, Nepal)

Old unreinforced masonry buildings suffered maximum damage during the earthquake due to their deteriorated strength over the years and the absence of concrete members aggravated the level of damage. However, the adjacent RC buildings suffered only minor damage.

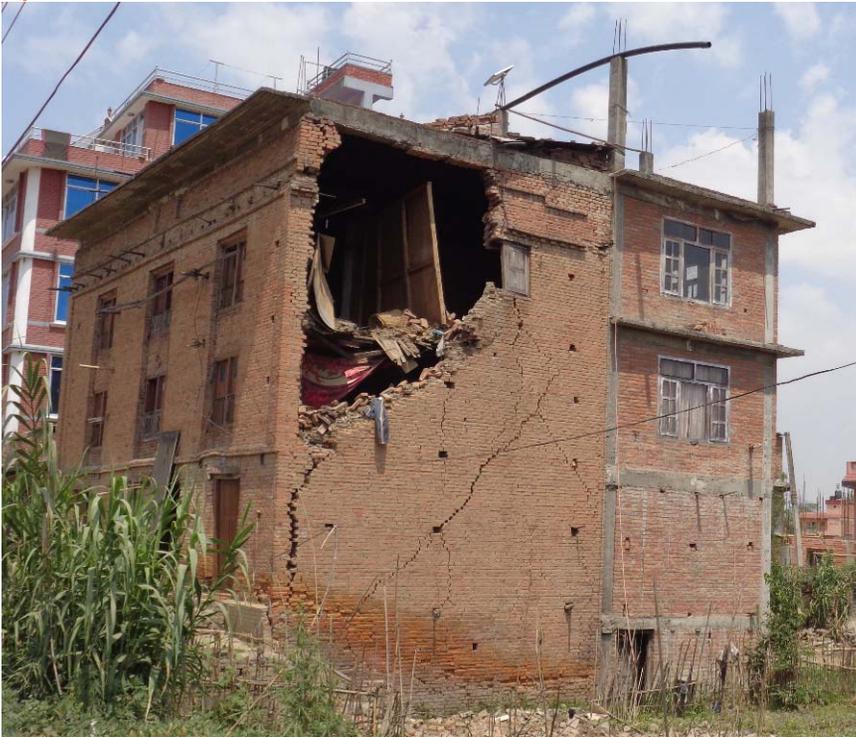
Out-of-plane failure of the wall and step-type diagonal cracks

The old masonry buildings suffered partial to complete collapse due to the inadequate lateral strength of the masonry walls and the poor connection between the wall and diaphragm.

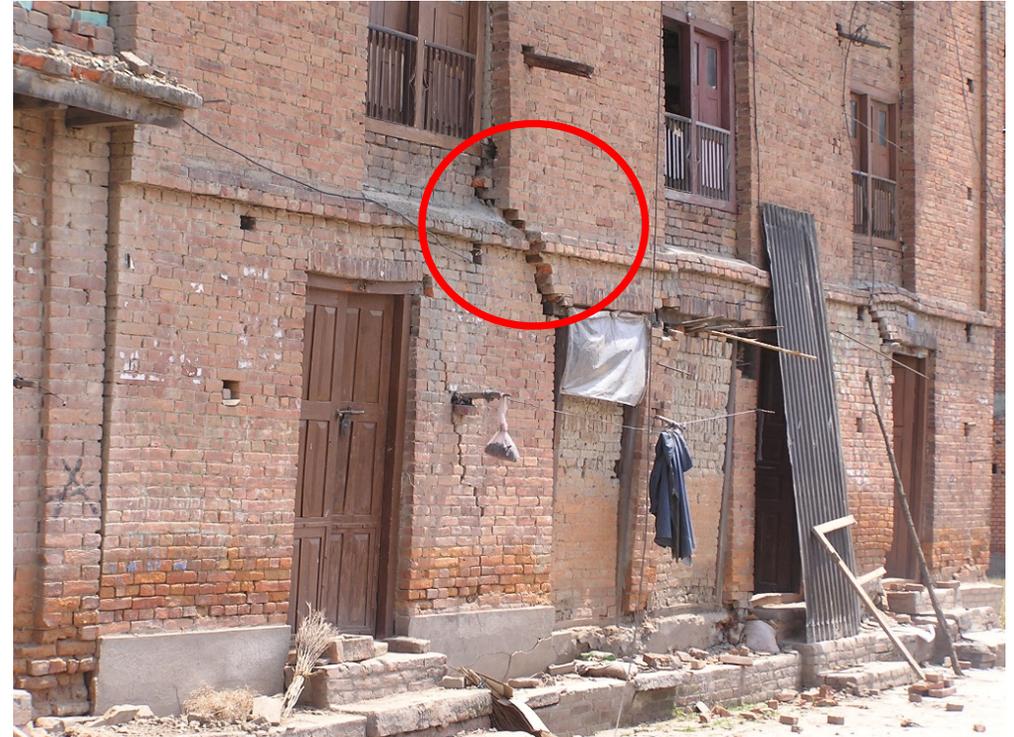
Severe damage to the walls due to the absence of lintel band around openings

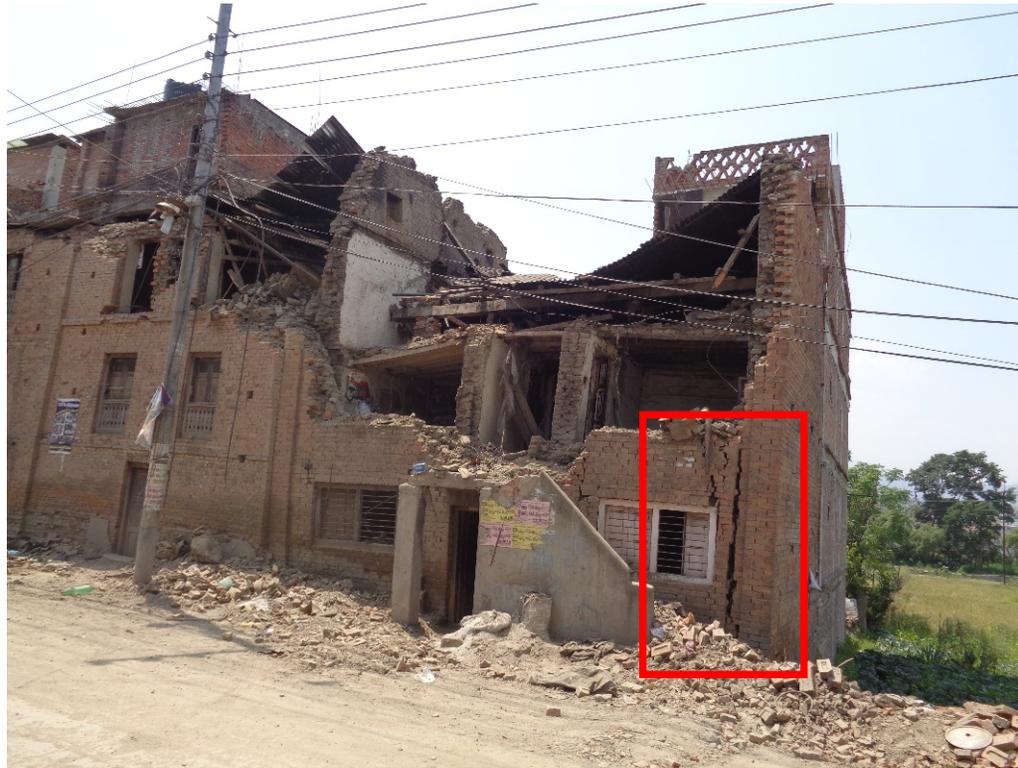
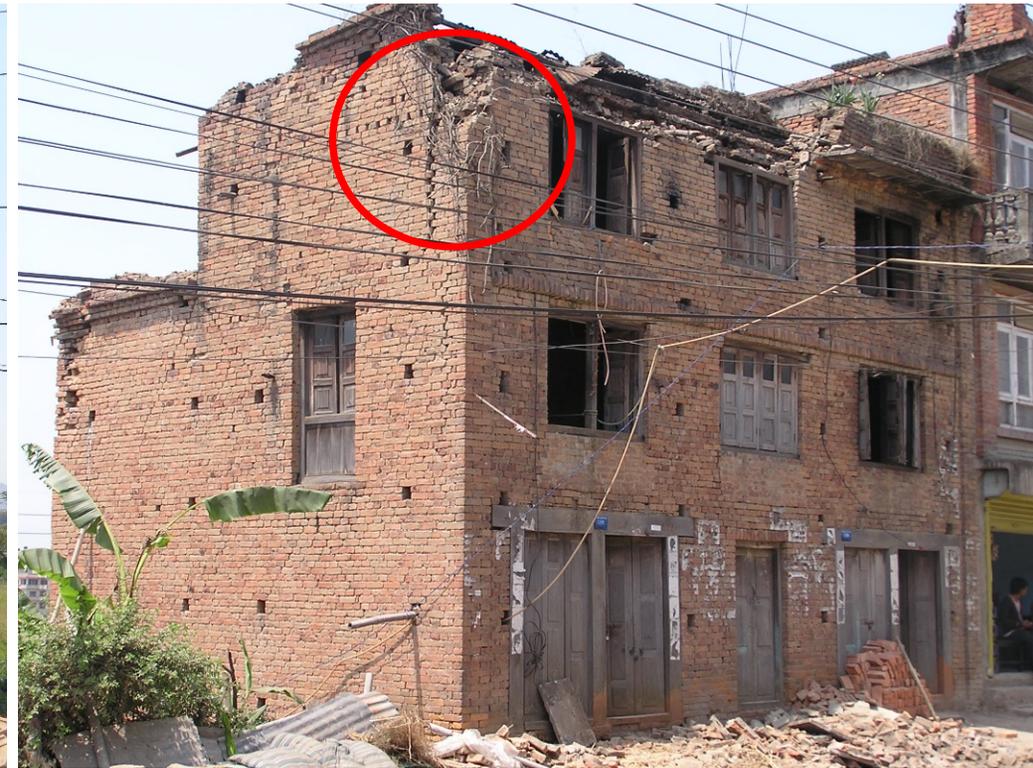
Cracks were formed at the corners of the masonry wall making it vulnerable to collapse under out-of-plane shaking

In most of the URM buildings, the structure lost integrity after formation of cracks at the corners of the wall making it highly vulnerable to out-of-plane collapse

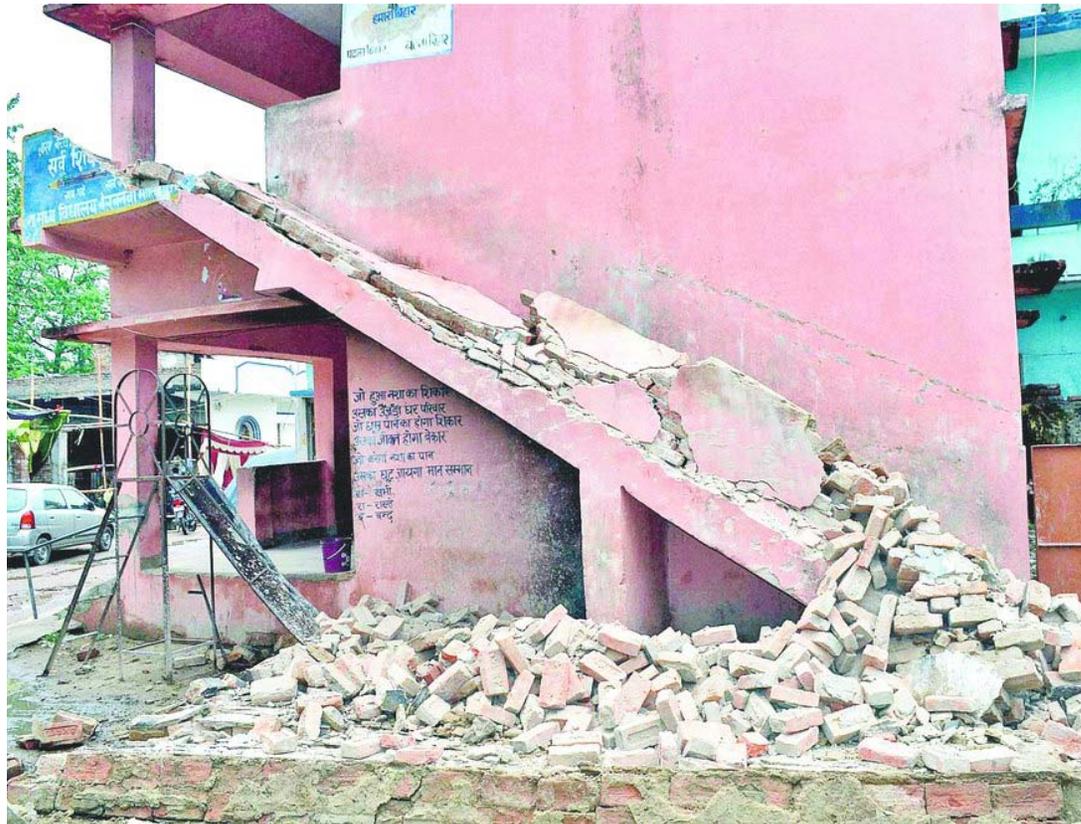
**School building in Motihari, Bihar
(Photo: PTI)**

Some areas of North Bihar experienced a shaking intensity of VI and below. 3 poorly built *kaccha* houses were completely collapsed and 142 buildings were partially damaged.

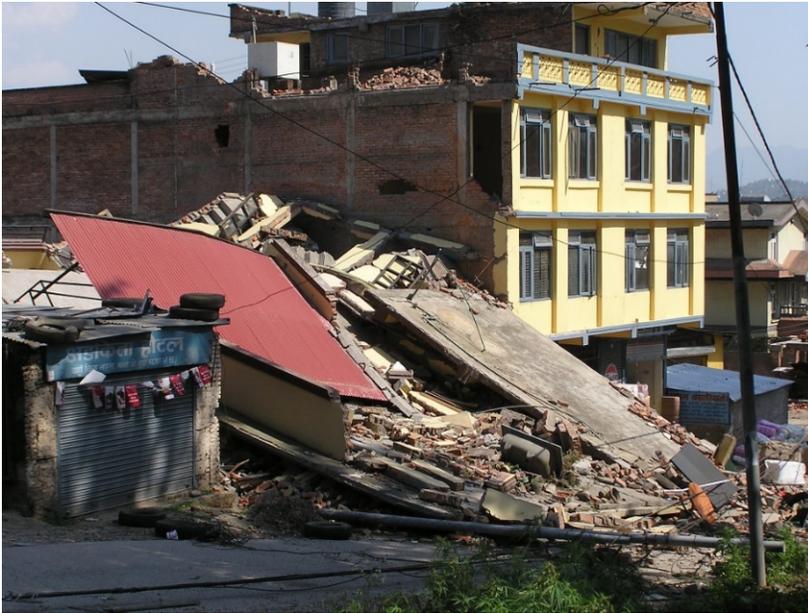
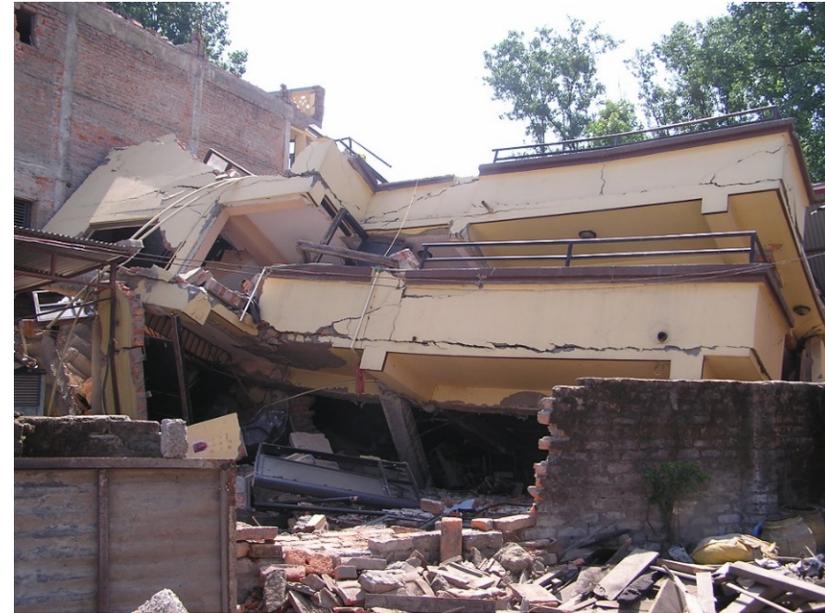
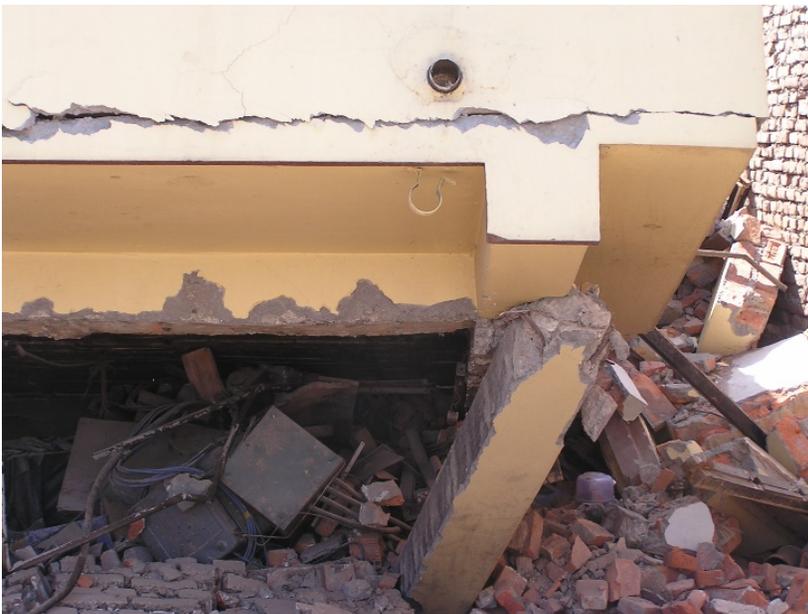
Pancake collapse of four storey building in Kathmandu, Nepal

Collapse of buildings highlighted the structural deficiencies in the RC buildings of the affected region. This includes poor reinforcement detailing, faulty construction practices, poor quality of construction materials and so on.

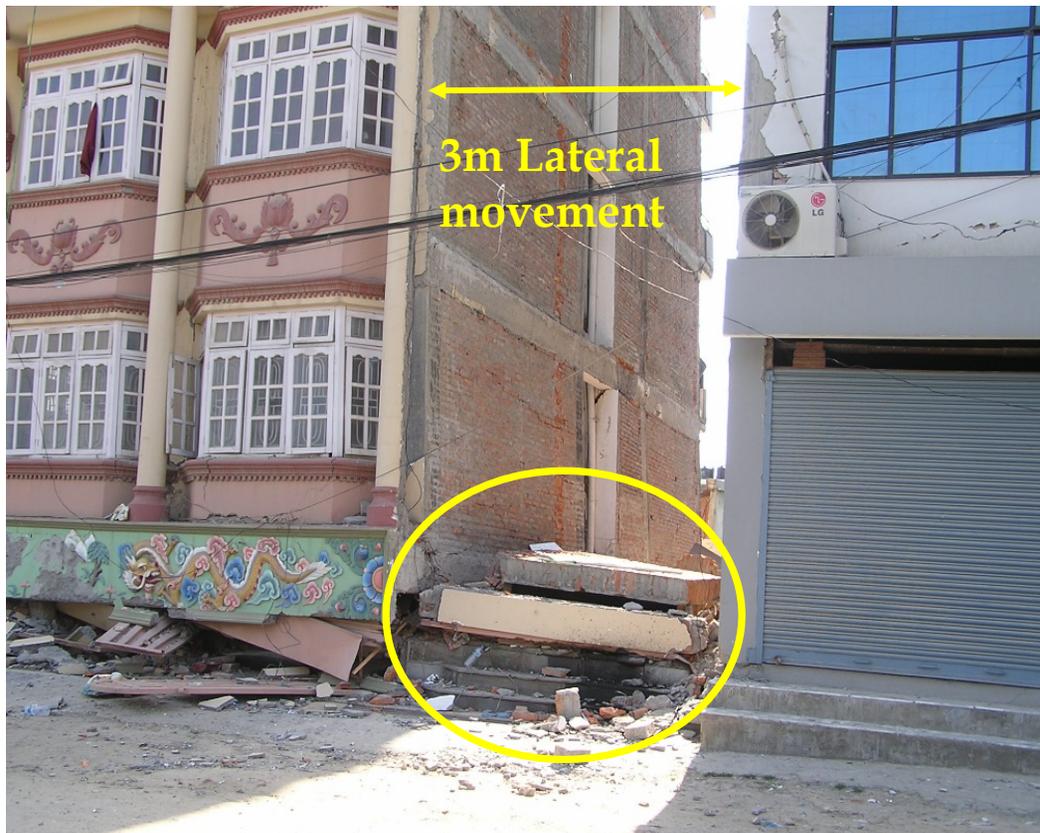
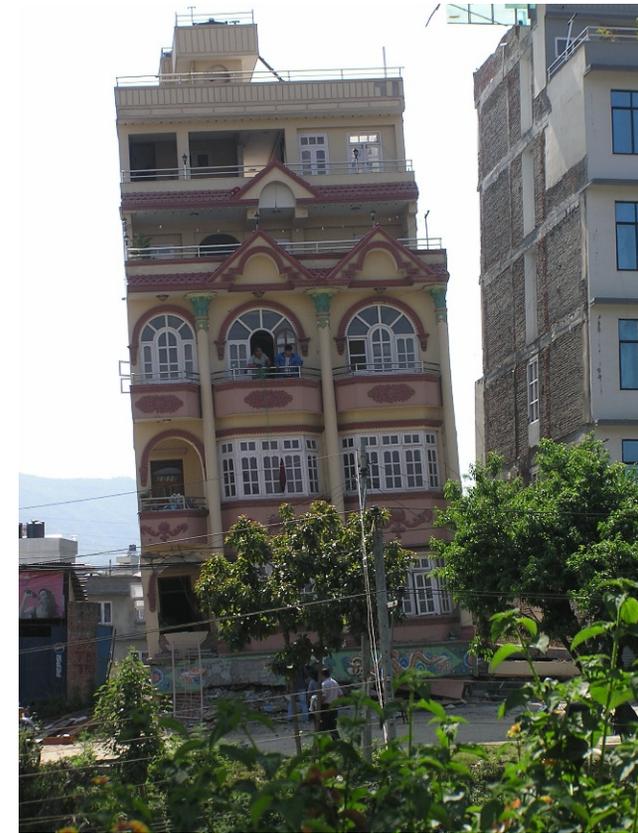
Open ground storey failure of 5 storey building in Kathmandu, Nepal

Some RC buildings the ground storey is left open without infill walls for utility purposes such as parking. This practice makes the ground storey weak with respect to the upper storeys leading to a mechanism known as the weak storey collapse.

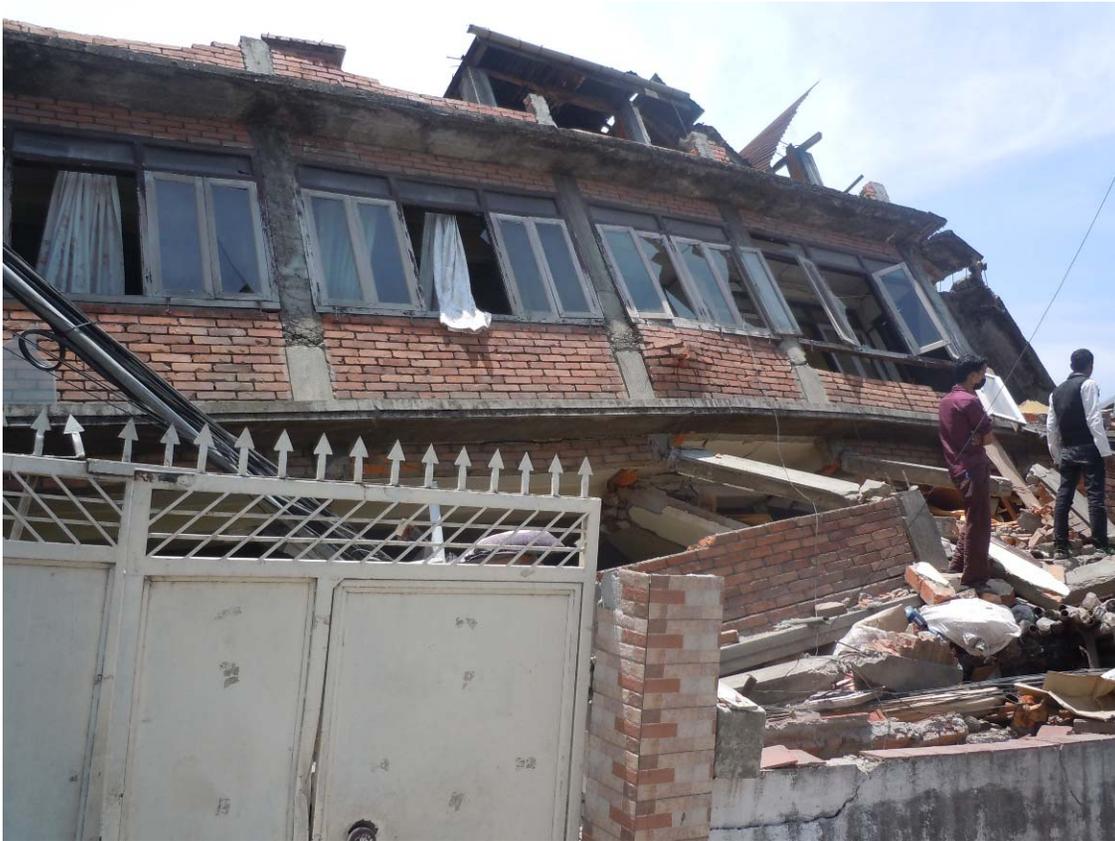
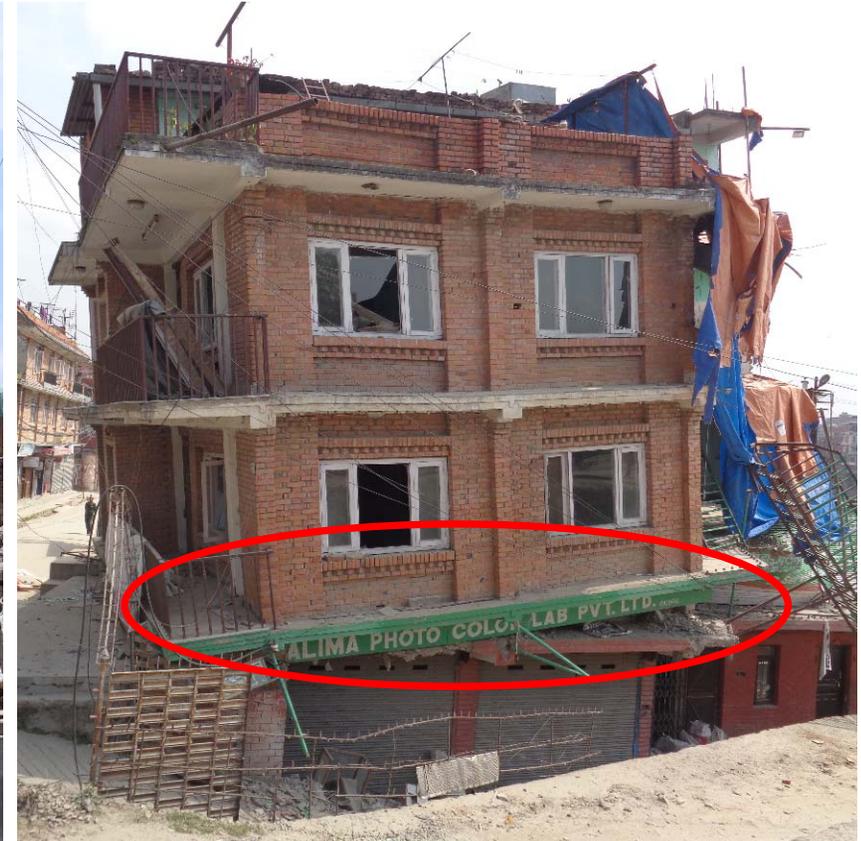
Collapse of intermediate weak storey in buildings of Kathmandu, Nepal

A number of buildings collapsed during the earthquake due to faulty construction practices such as absence of adequate walls led to formation of weak storey mechanism.

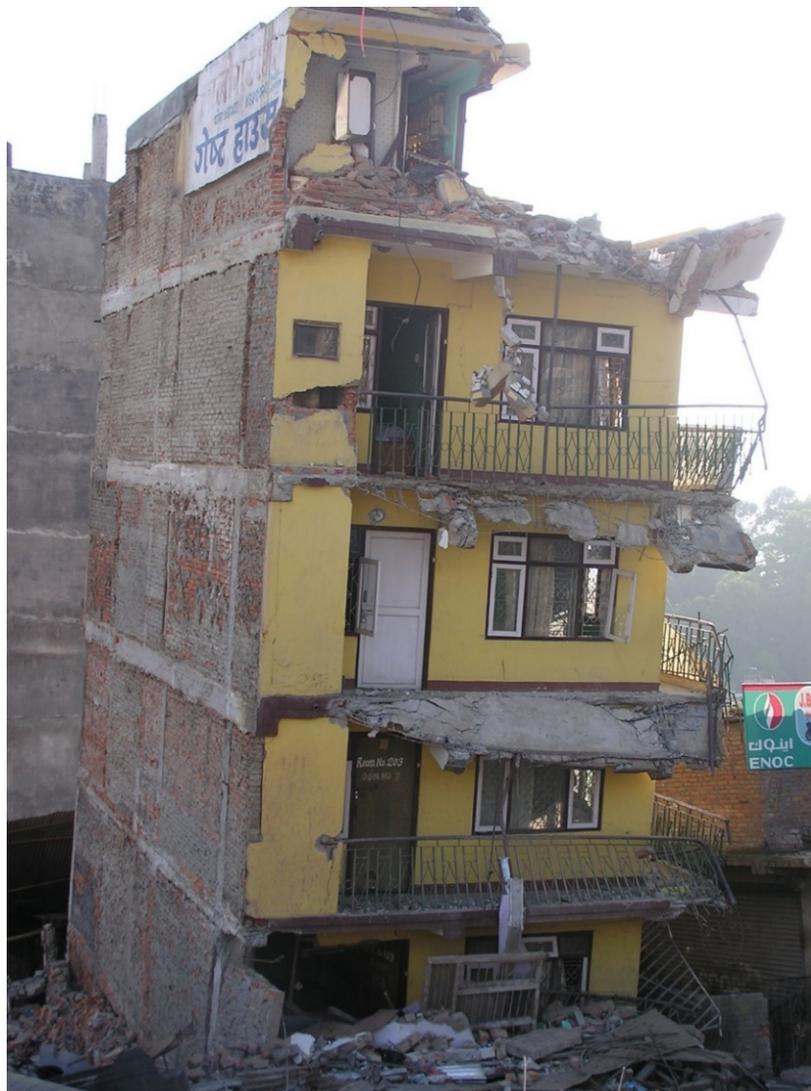
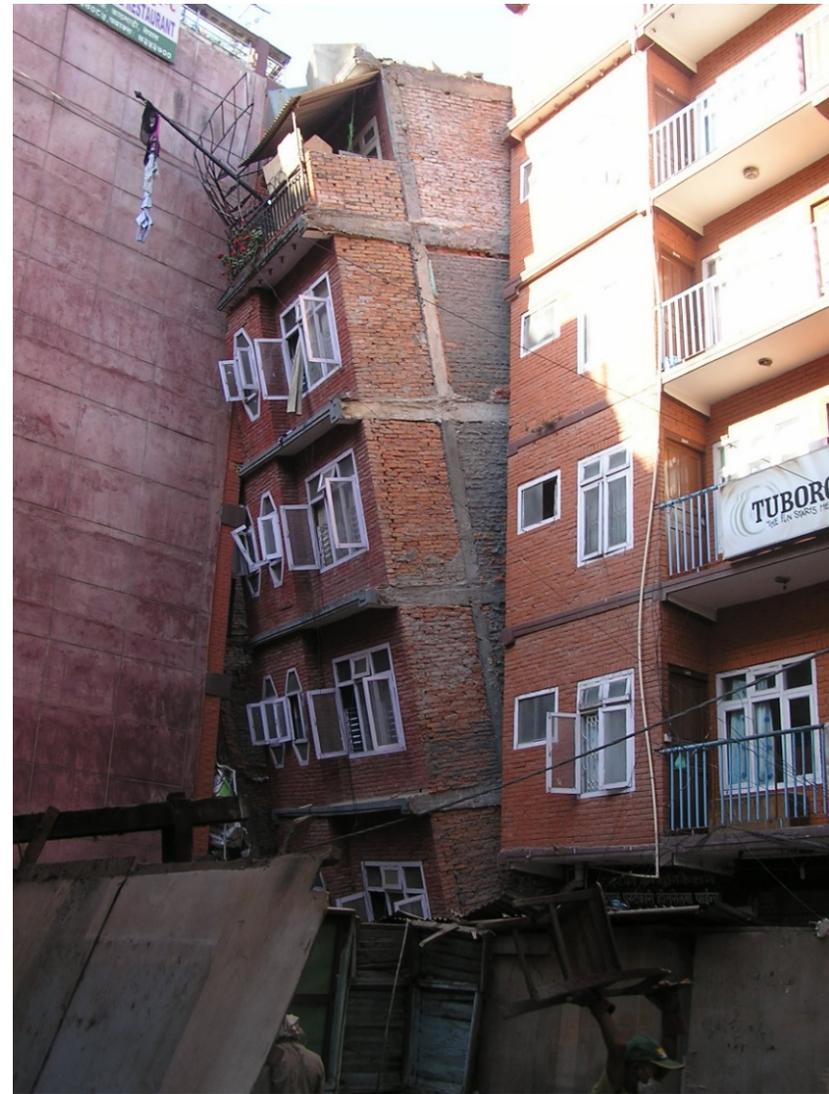
Collapsed buildings having poor geometric configuration (Too long in one direction)

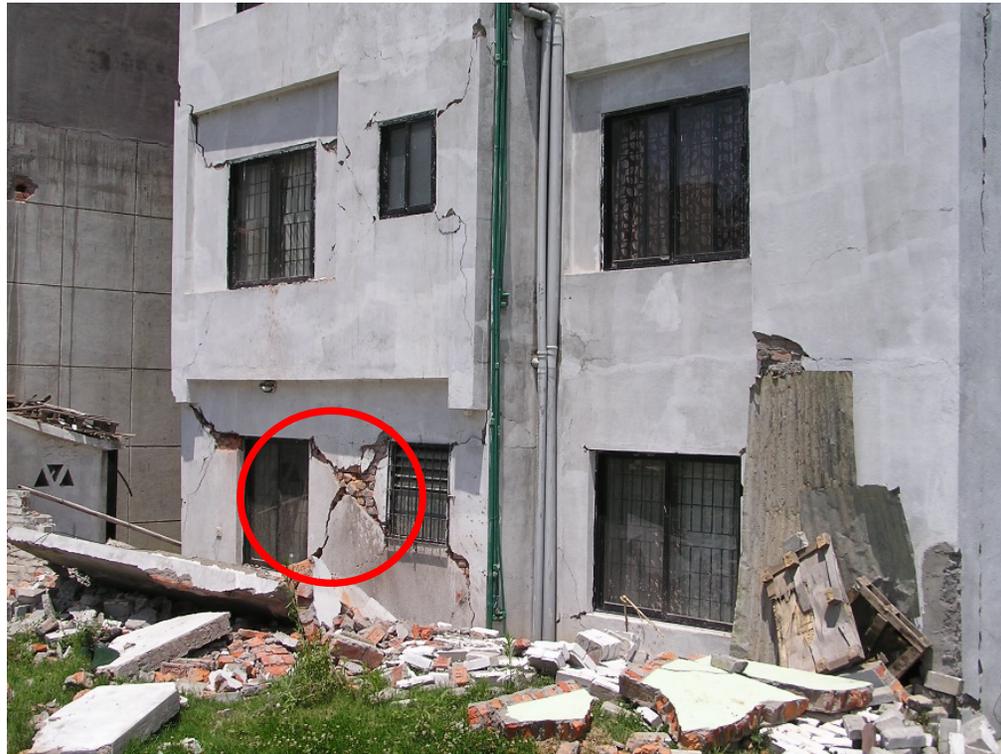
Diagonal cracks in the wall due to lack of confining RC band around openings

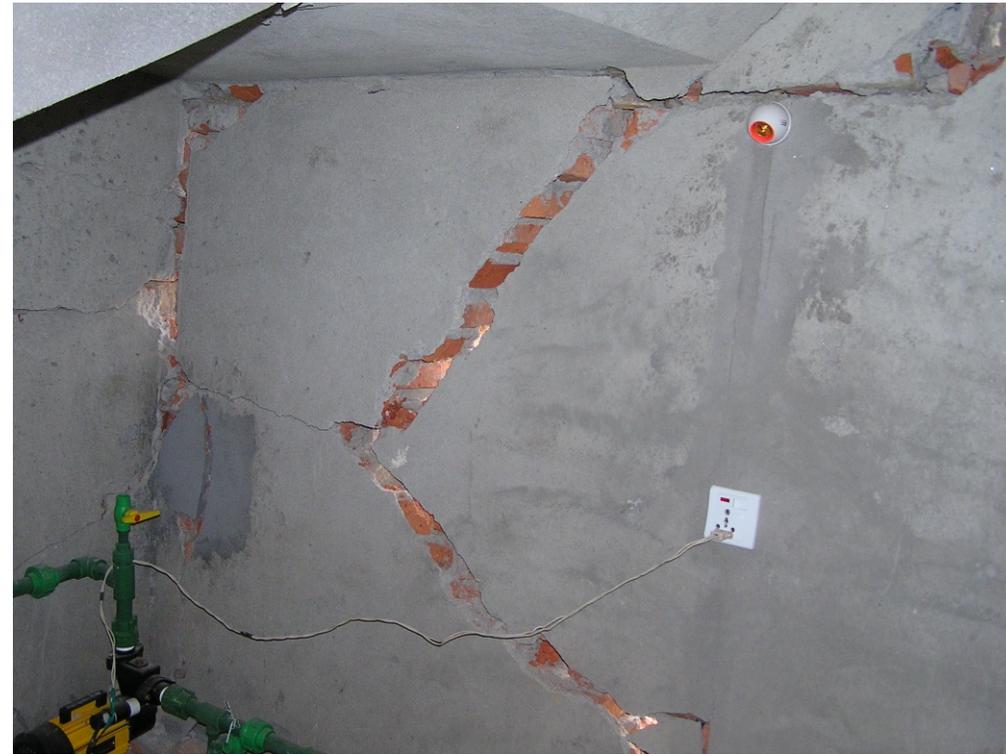
Half-brick thick infill walls severely damaged in a building in Kathmandu

The RC buildings that were partially destroyed had inadequate reinforcement and masonry walls were projecting beyond the columns.

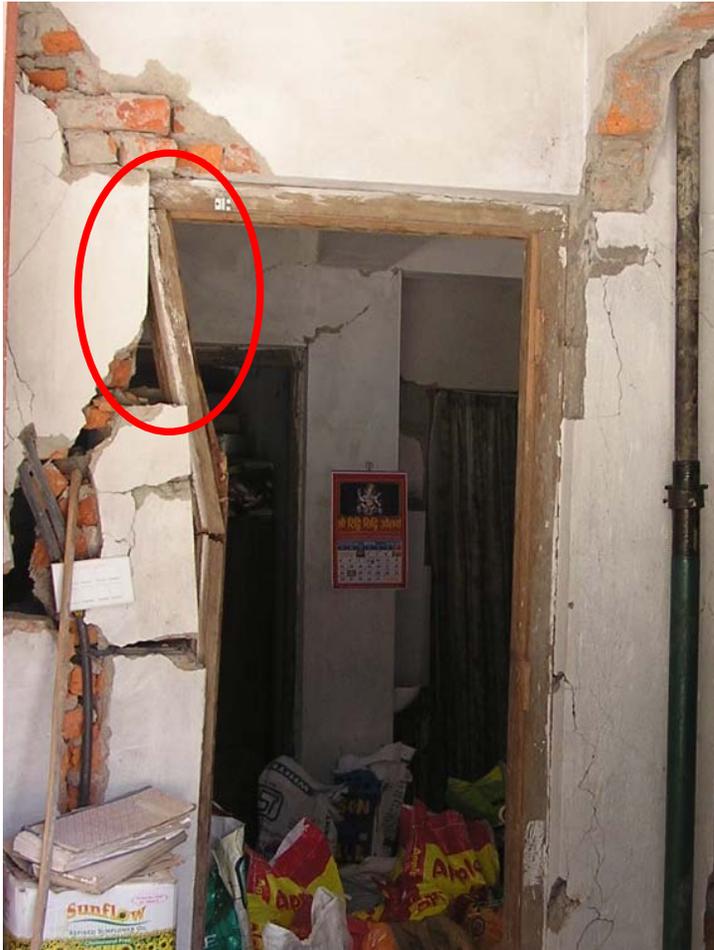
No RC band around opening

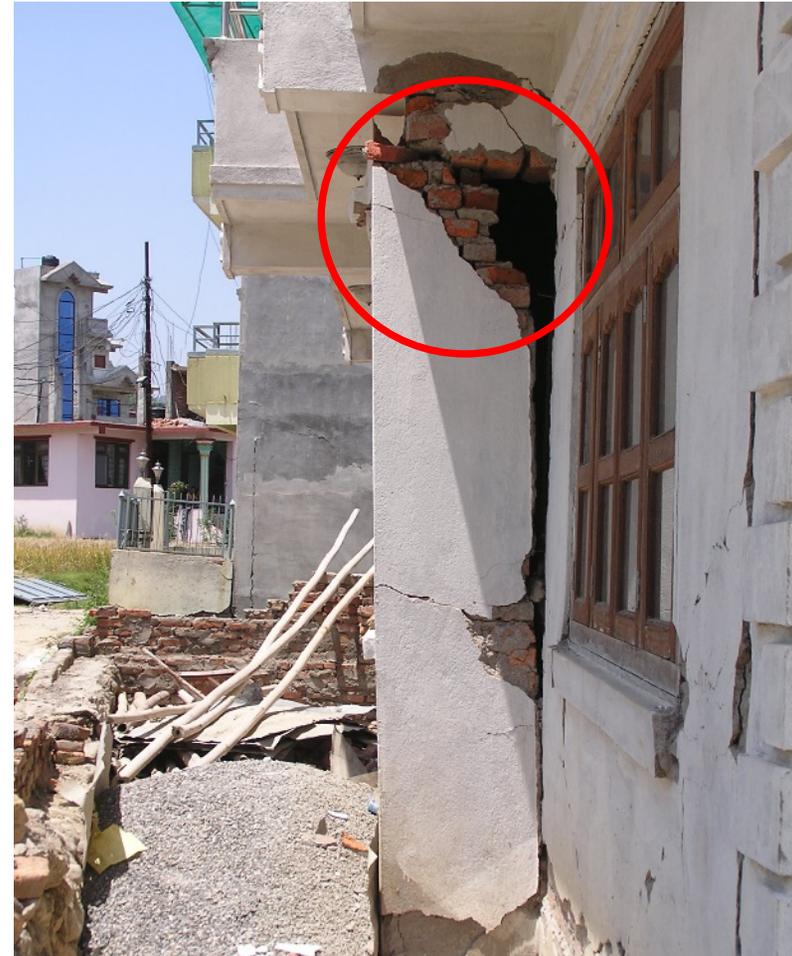
No columns at the corners of building plan

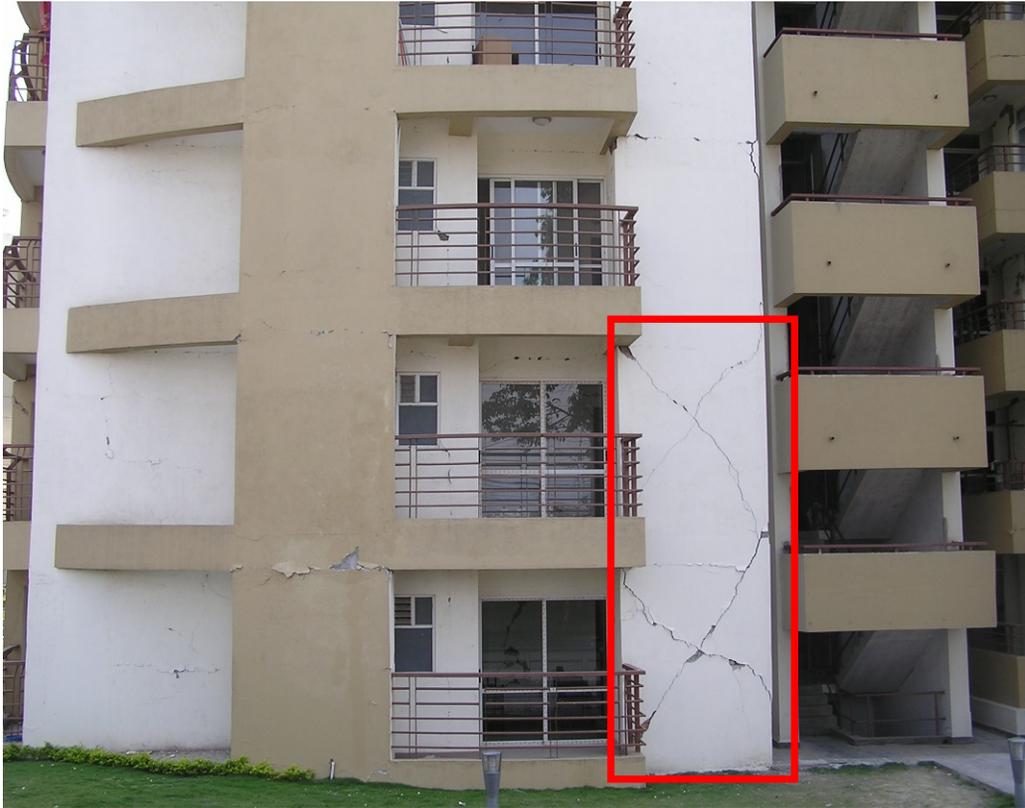
Diagonal cracks in the infill walls of high-rise buildings

Infill walls were severely damaged in tall RC buildings

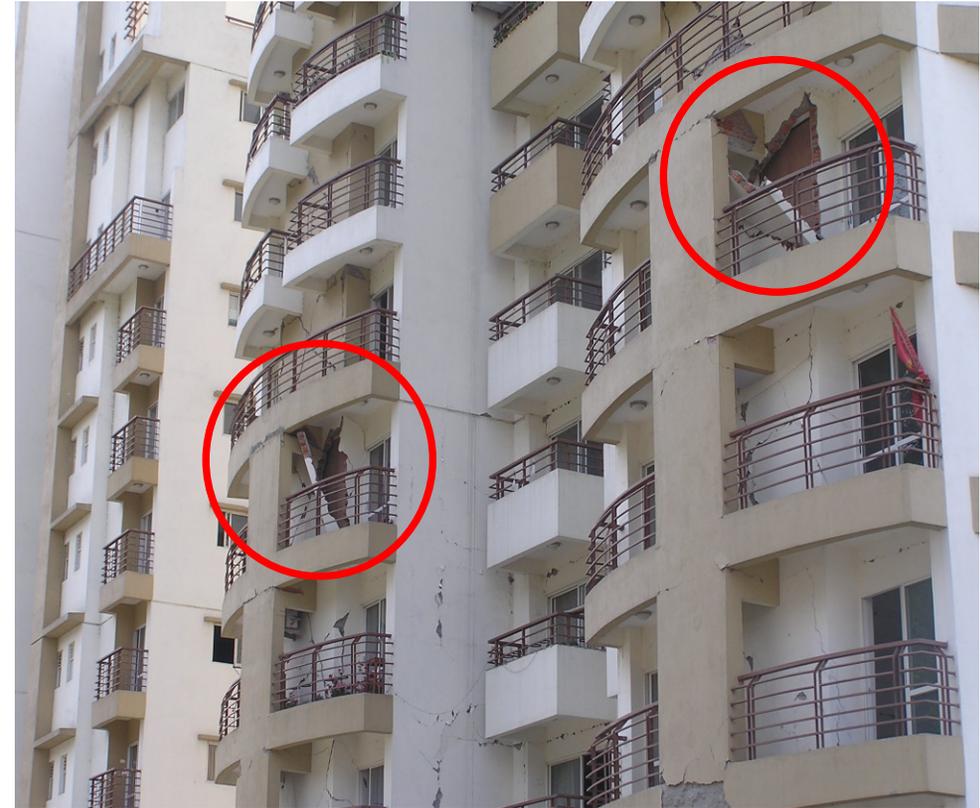
Combined in-plane and out-of-plane failure of infill wall

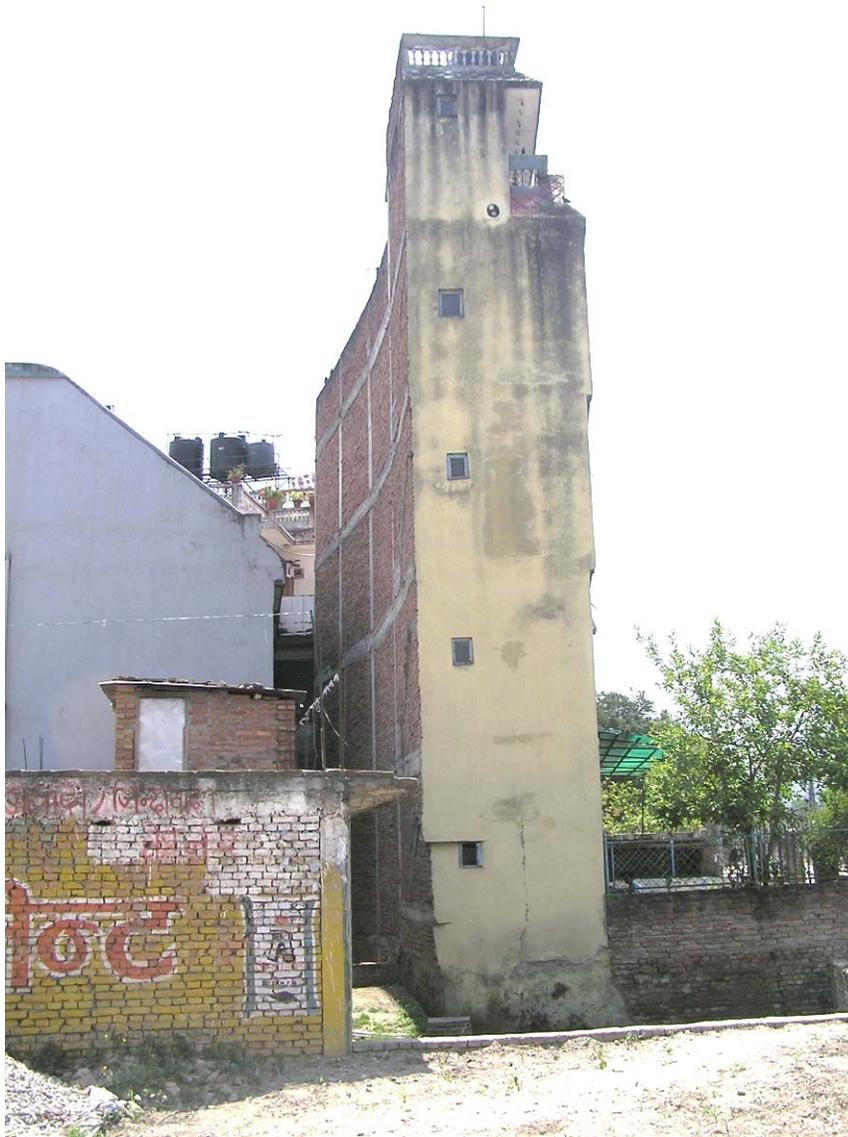
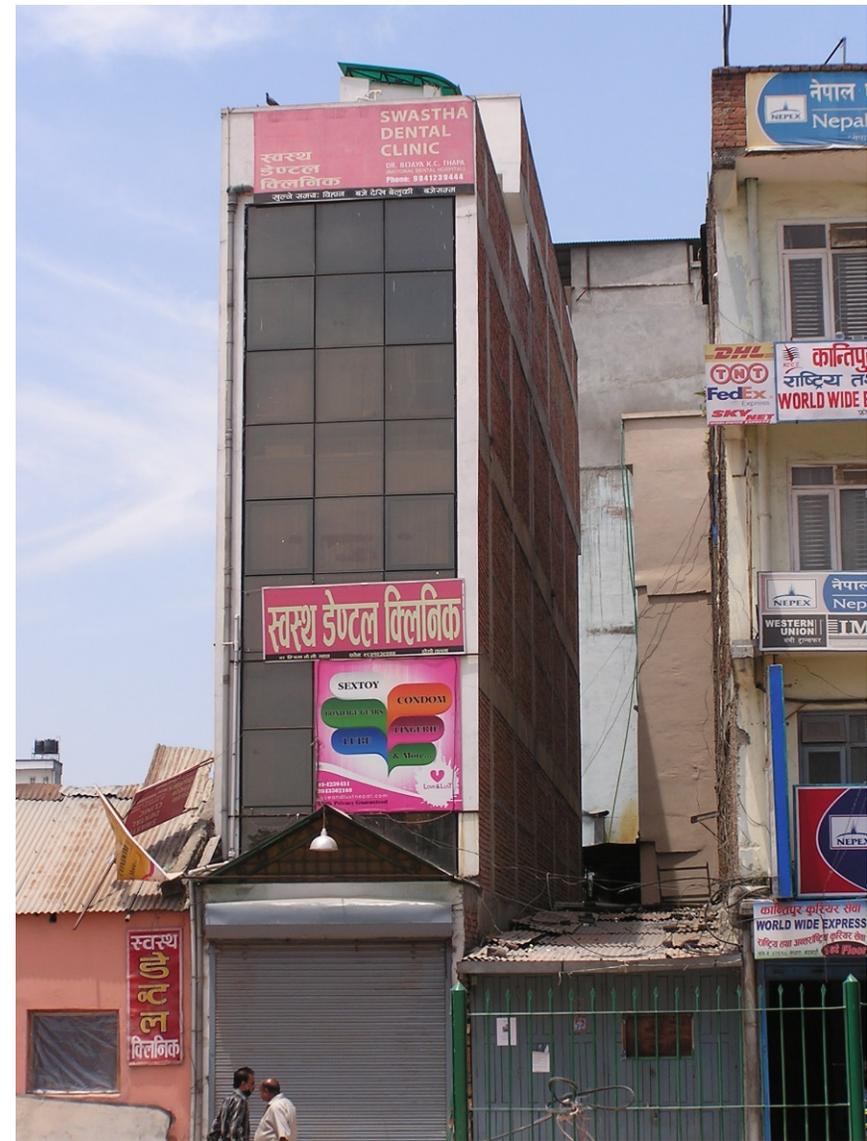
Poor geometric configuration (Too long in one direction)

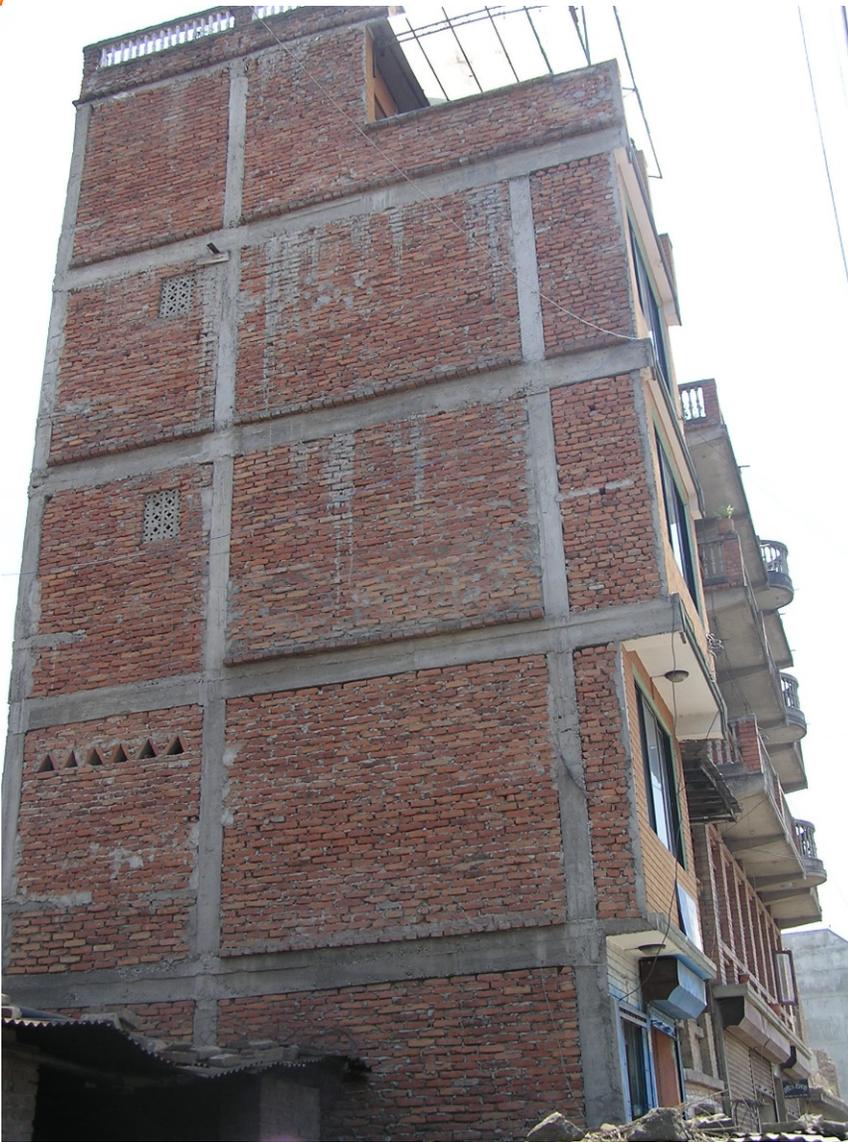
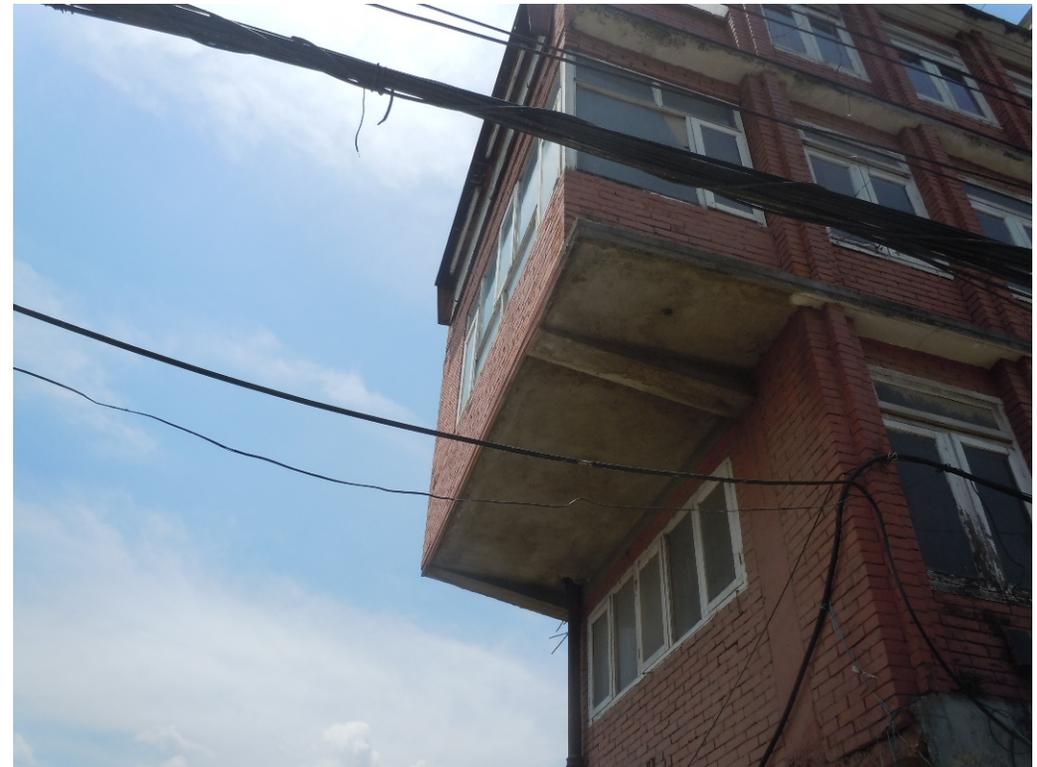
Due to the extension of masonry wall beyond column line, the columns supporting the projection will be overstressed and the outer wall will also be susceptible to damage due to lesser stiffness.

Box type construction: Extension of wall beyond column line
