2015 GORKHA (NEPAL) EARTHQUAKE

Effects on Built Environment & A Perspective on Growing Seismic Risk in Bihar-Nepal Region

Department of Civil Engineering, Indian Institute of Technology Kanpur

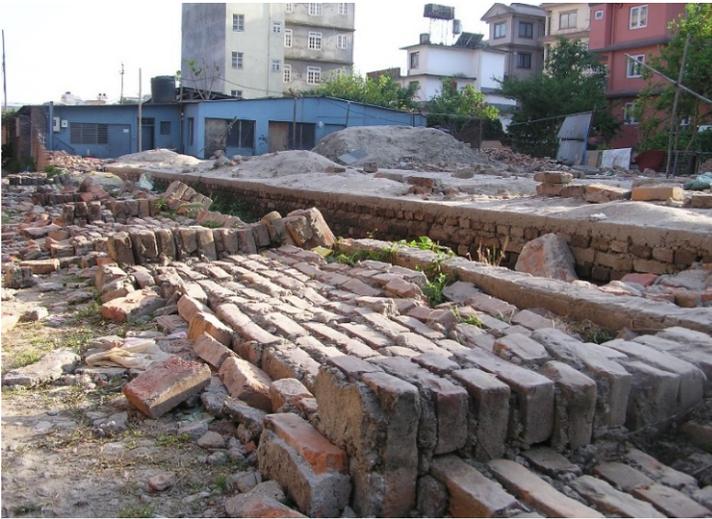
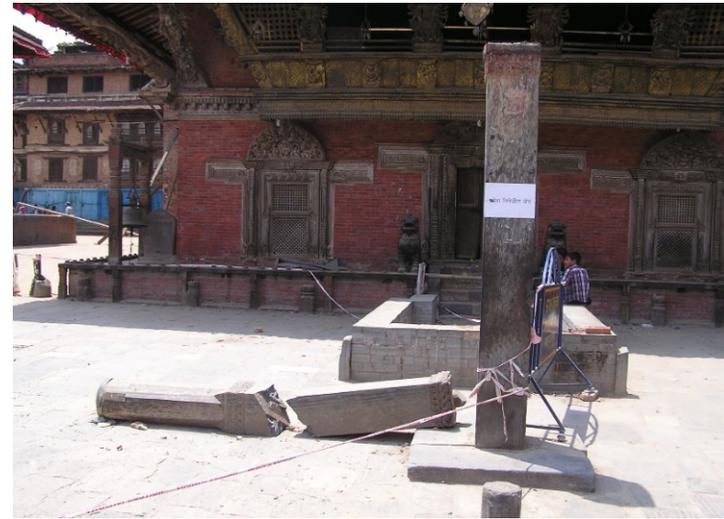
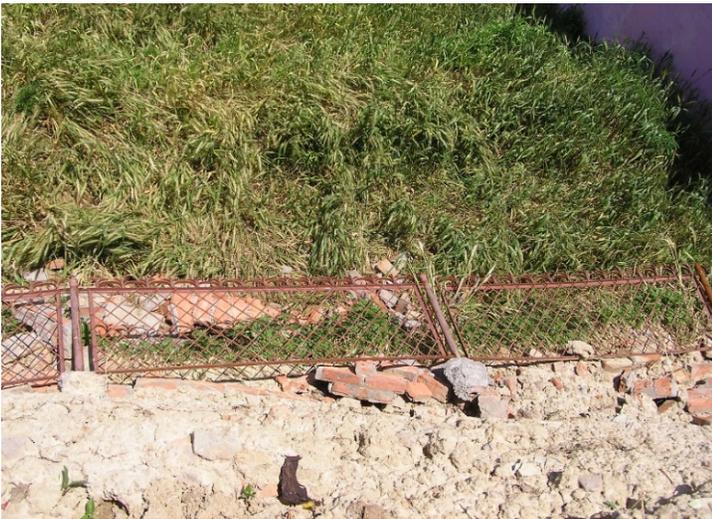
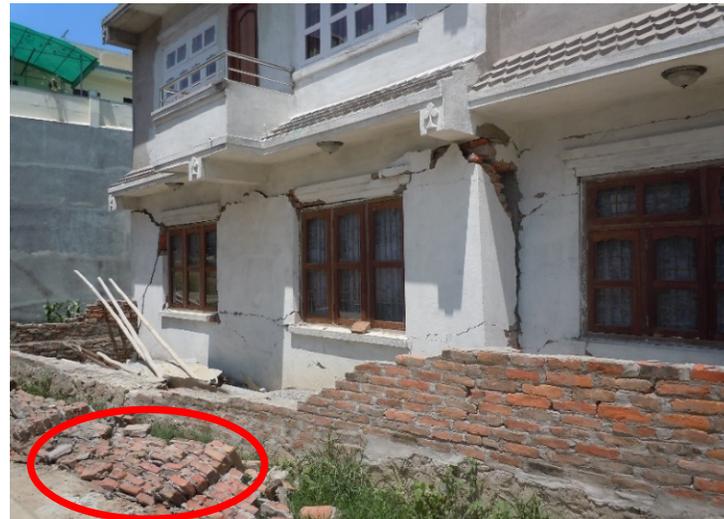
Damage to most of the freestanding structures in and around Kathmandu and some parts of North Bihar was observed

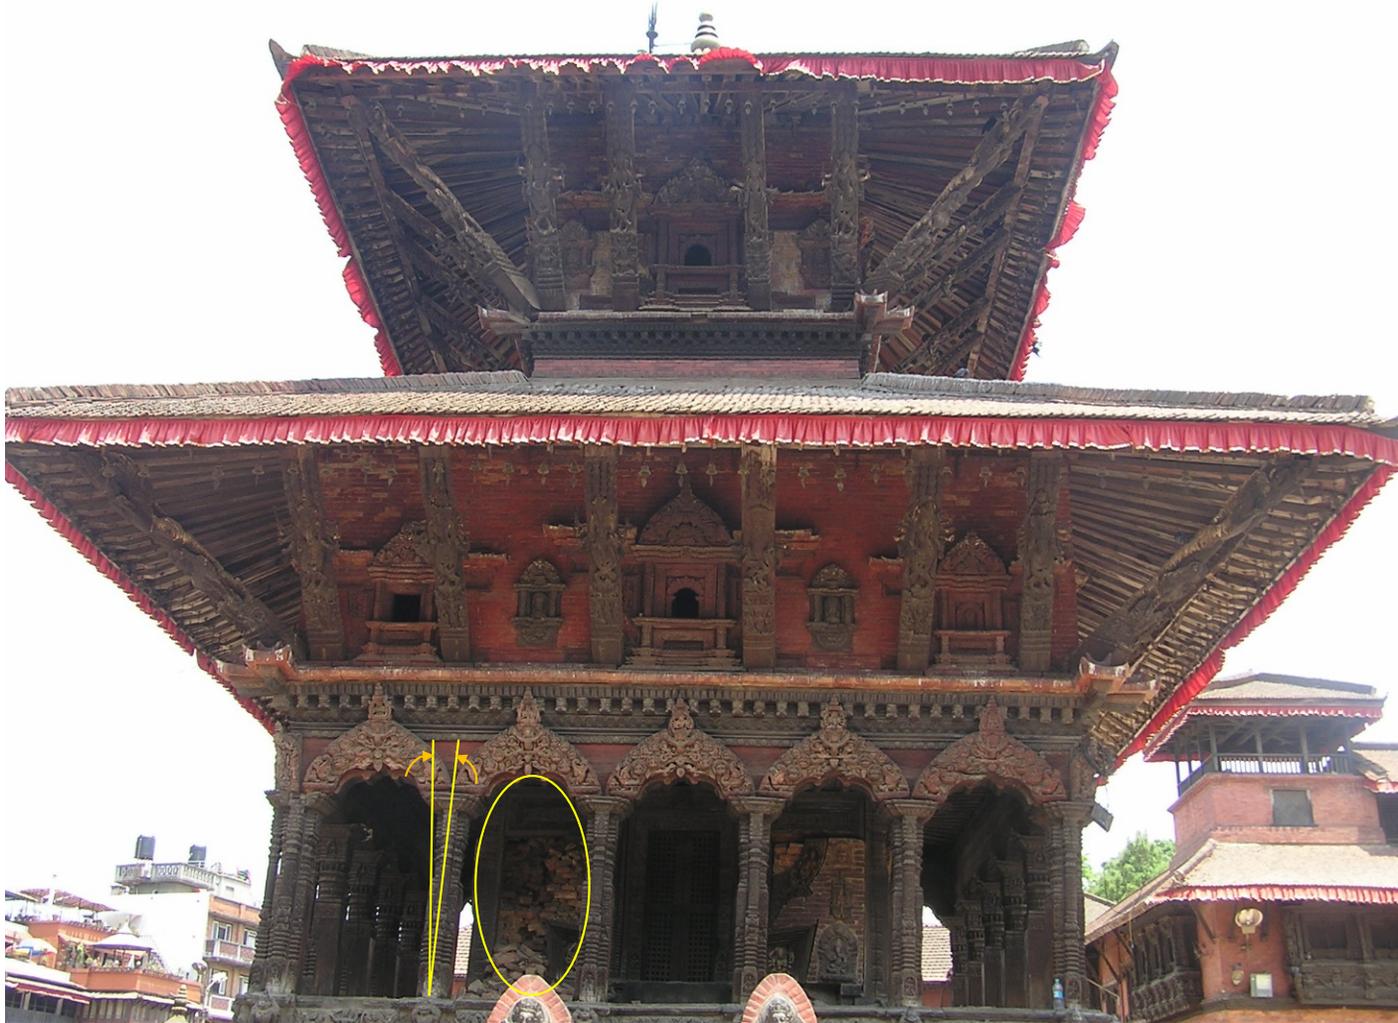
Sway of timber frame and masonry collapse of Temple in Lalitpur

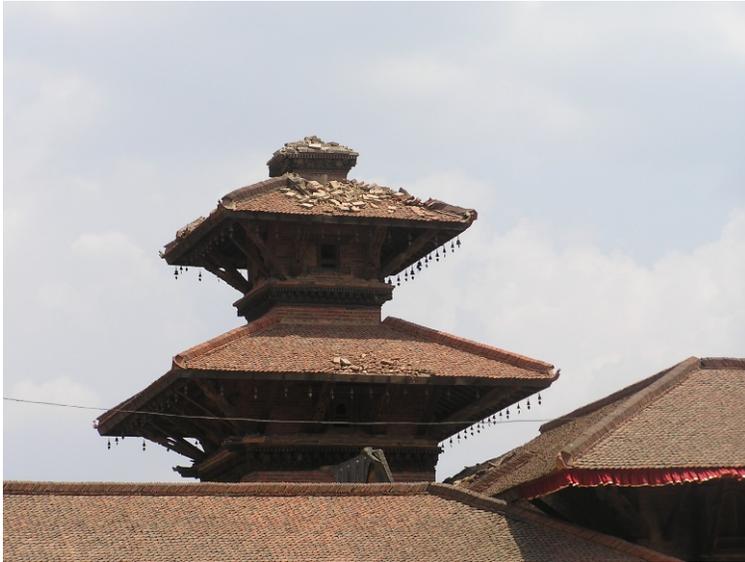
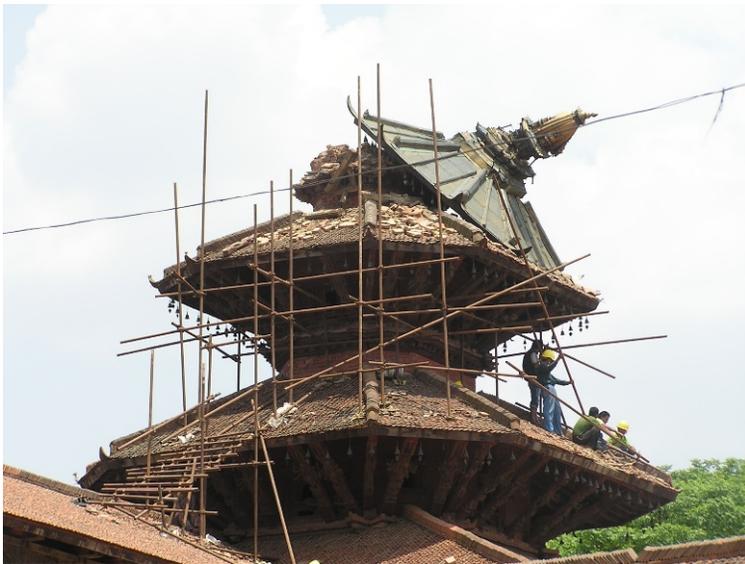
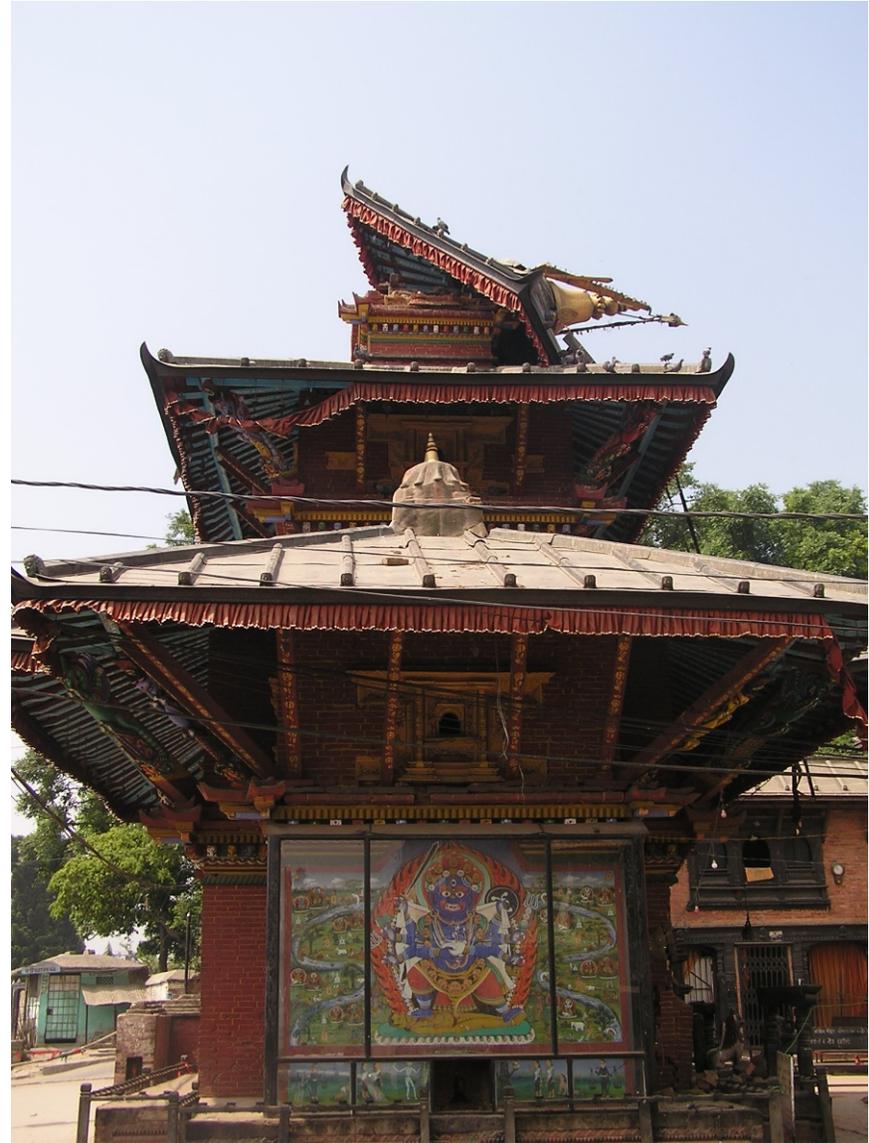
Failure of Pagoda Structures
