## NICEE - IIT KANPUR RECONNAISSANCE SURVEY OF THE 2015 GORKHA (NEPAL) EARTHQUAKE OF APRIL 25, 2015

National Information Center on Earthquake Engineering  
Indian Institute of Technology Kanpur, India

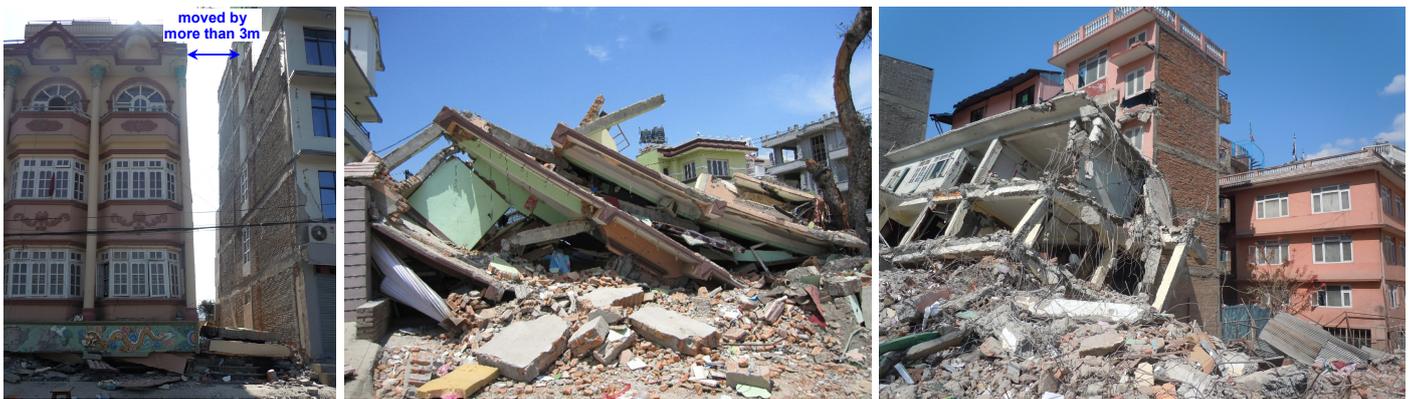
It was rather perplexing to discover that a great majority of buildings seriously lacked earthquake-resistant features which are so essential for a satisfactory seismic performance in the design level shaking. Most of the RC buildings in Kathmandu suffered varying degree of damage, from moderate to complete collapse during this earthquake. Many unique and inherently poor construction features significantly added to the seismic vulnerability of structures. These features include weak and very slender partition walls in brick masonry, extended floor plans in upper stories supported on cantilevered beams and slabs, open ground storey, poor beam-column connection details, large vertical and horizontal plan irregularity, etc. Fig. 1 shows typical example of collapsed multi-story buildings in Kathmandu. In older town of Bhaktapur, several old unreinforced masonry buildings which were still used as residential structures suffered maximum damage due to their deteriorated strength over the years (Fig. 2).

**Fig. 1.** Collapse of multi-storey buildings in Kathmandu

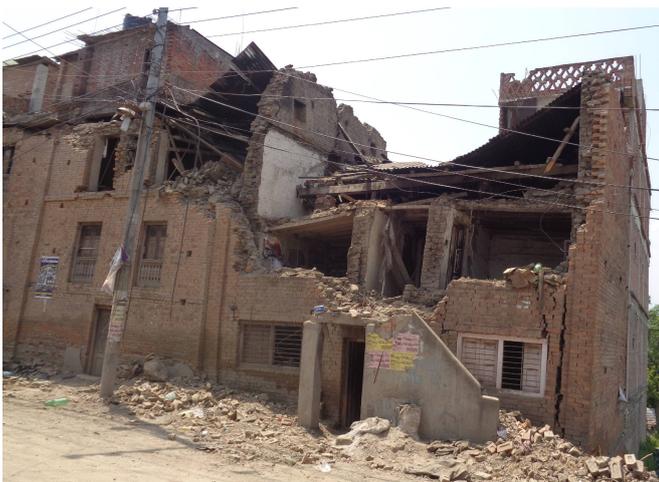
**Fig. 2.** Collapsed unreinforced masonry buildings at Bhaktapur

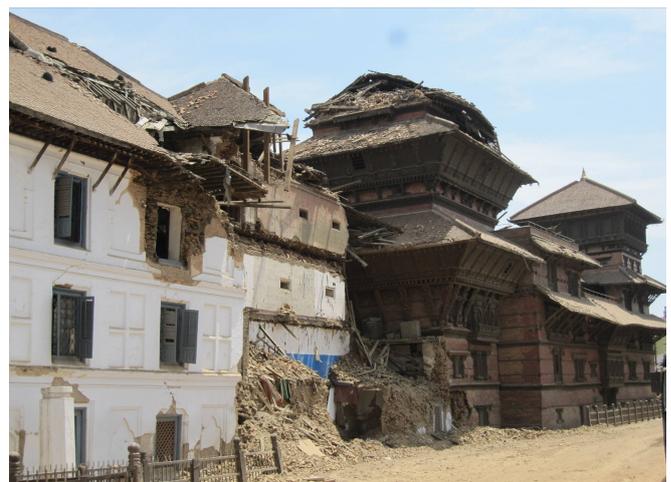
The poor earthquake performance of cultural heritage such as temples and palaces is a source of concern as almost all historic structures suffered varying degree of damages in this earthquake. The exterior walls of these temples are constructed of clay brick or stone masonry while the interior building frame and floor diaphragm is constructed of timber. Heavy damages have been observed to several temples and monuments at Kathmandu and Bhaktapur (Fig. 3).

**Fig. 3.** Severe damages to temples and palaces in Durbar square at Kathmandu
