## Learning from Earthquakes

### M 6.9 Sikkim Earthquake of September 19, 2011

*This report was contributed by EERI members C.V.R. Murty, Indian Institute of Technology (IIT) Madras; Alpa Sheth, VMS Consultants, Mumbai; and Durgesh Rai, IIT Kanpur.*

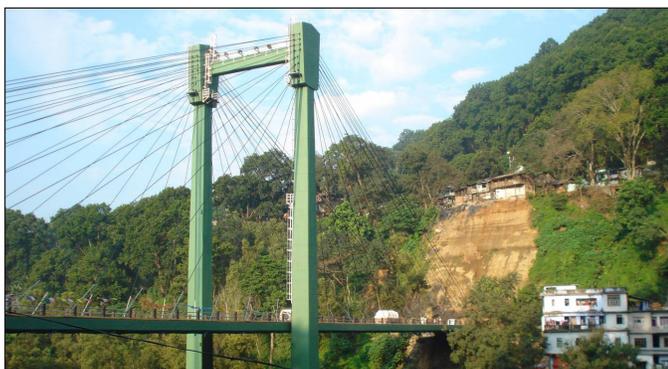
**Figure 2.** Landslide near the cable-stayed bridge at Nayabazar (South Sikkim District) restricted the use of the bridge for relief work after the earthquake (photo: C.V.R. Murty).

As the region is mountainous and rains preceded the earthquake, the event triggered massive landslides. Damage to buildings and infrastructure caused by landslides was more severe than damage due to direct ground shaking in some regions (Figures 2 and 3). Landslides cut off the severely affected areas, especially at higher altitudes, hampered rescue and relief work, and required the help of Army helicopters.

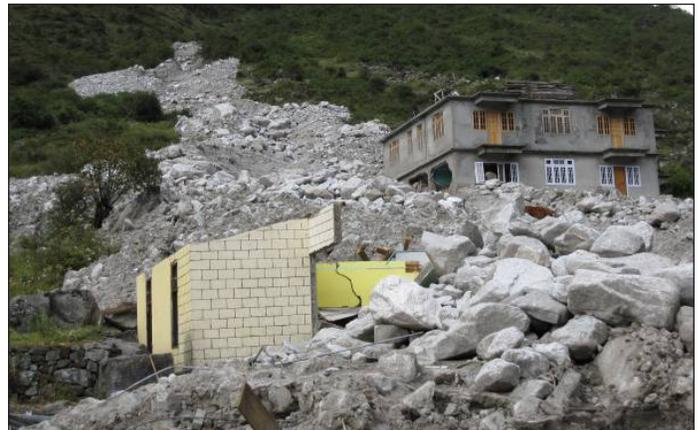
**Figure 3.** Damage due to rockslide and mudslide at Lachung (photo: D. Rai).

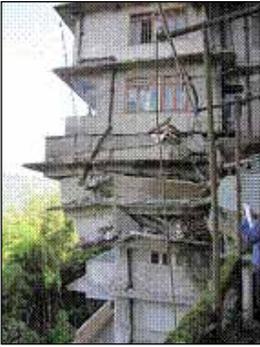
**Figure 4.** Pancaking of middle two stories in a nine-story building at Gangtok, East Sikkim (photo: D. Rai).

had a symmetric and uniform grid of beams and columns. Some buildings that had open stories collapsed, usually at mid-height (Figure 4), or had severe structural damage. Likewise, buildings with asymmetry in placement of URM infill walls, causing torsion, also were severely punished. Single RC buildings collapsed far from the meizoseismal area; e.g., at Jorethang in South Sikkim district about 80 km from Gangtok (Figure 5). Traditional *Ekra* housing made of bamboo or wood framing with lightweight infill panels of straw and plaster behaved exceptionally well.

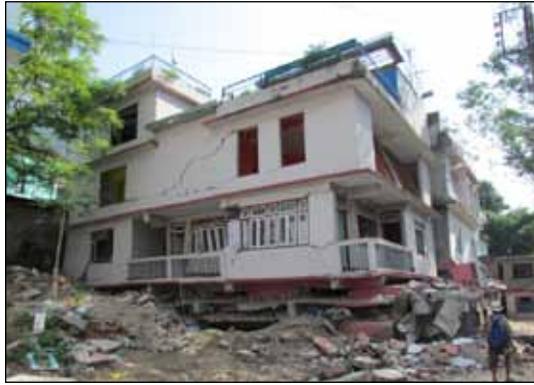
**Figure 5.** Pancaking of three stories in five-story house in Jorethang, South Sikkim (photo: A. Sheth).

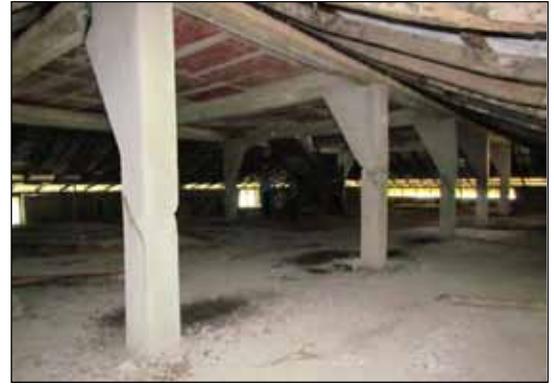
**Figure 6.** All columns supporting roof of Phudong Monastery, North Sikkim, failed. (photo: A. Sheth).

Heavy damage has occurred to temple structures (shrine halls) of various Buddhist monasteries (Figure 6). Historic monastery temples are made of thick (two to five feet thick at base) external load-bearing rubble masonry wall in mud mortar. The internal framing was of wooden posts and beams. Monastery build-

ings of the past few decades include those made in RC, with beams and columns infilled with URM infill walls. In this RC construction, there is no frame action; the RC construction mimicked the historic wooden construction. Both sets of monasteries were damaged; some had partially collapsed, and others showed extensive structural damage. Few monasteries escaped with minor nonstructural damage, such
