Effects of the 2005 Muzaffarabad (Kashmir) earthquake on built environment

DURGESH C. RAI*
C. V. R. MURTY

*Department of Civil Engineering,
Indian Institute of Technology,
Kanpur 208 016, India*

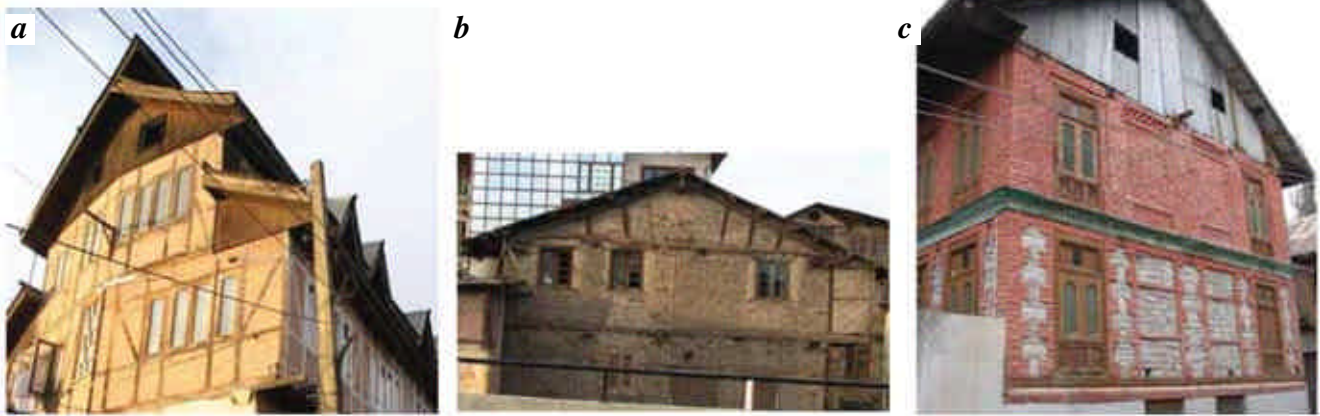
ing masonry is quite different from typical brick masonry and their performance in this earthquake has been once again shown to be superior with no or very little damage. No collapse was observed in such masonry even in the areas of higher shaking. This timber-lacing of masonry, which is locally referred as *dhajji-dewari* (meaning patch quilt wall) has excellent earthquake-resistant features. Presence of timber studs, which subdivides the infill, arrests the loss of the portion or all of several masonry panels and resisted progressive destruction of the rest of the wall (Figure 2). Moreover, the closely spaced studs prevent propagation of diagonal shear cracks within any single panel, and reduce the possibility of out-of-plane failure of masonry of thin half-brick walls even in higher stories and gable portion of the walls. *Dhajji-dewari* system is often used for walls of upper stories, especially for the gable portion of the wall, even when the walls in bottom stories could be made of brick or stone masonry (Figure 2 a).

In older constructions, another form of timber-laced masonry, known as *Taq* has been practiced in which large pieces of wood have been used as horizontal runners embedded in the heavy masonry walls, which add to the lateral load resisting ability of the structure (Figure 2 b). The concept of *Dhajji-dewari* has also been extended to develop a mixed construction in which stones are used as filler hard material in wall panels created by a series of piers in softer coursed brick masonry of greater integrity under lateral loads (Figure 2 c). The masonry walls with stones confined in such a manner have performed quite satisfactorily, in contrast to usual brick or stone masonry.

Figure 2. Traditional masonry for proven earthquake resistance. *a*, *Dhajji-dewari* system of timber laced masonry for confining masonry in small panels; *b*, *Taq* system of embedding timber thick walls; *c*, Brick masonry piers for timbers in stone infilled wall.

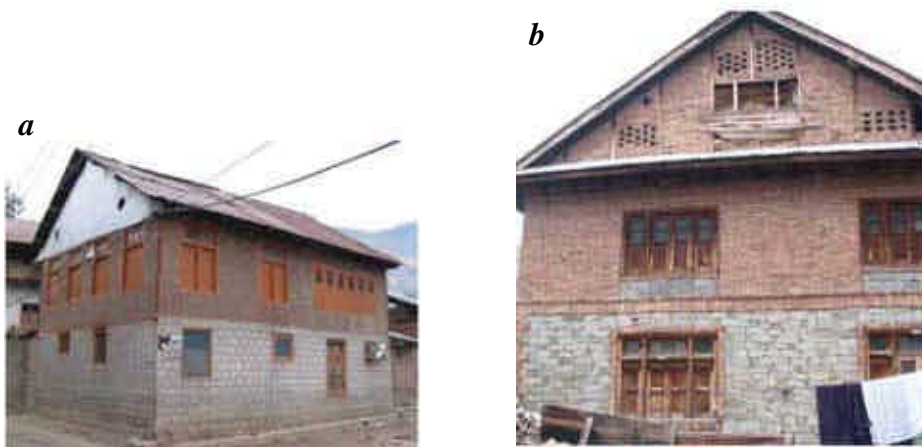
In the upper reaches of North Kashmir Himalayas, majority of houses use stone masonry in mud mortar for walls and flexible diaphragms for floors and roofs consisting of timber. Stone masonry is produced from a wide range of materials and constructed in many different forms that have shown varying degree of performance in this earthquake. Unreinforced stone masonry is very durable even in the hostile environment and can accommodate movements and resist natural forces without becoming unstable and falling apart, especially when they are laid in even courses after proper dressing (Figure 3).

Figure 3. Examples of mixed construction involving *dhajji-dewari* and dressed/undressed stone masonry and brick masonry.
