Performance of structures during the Sikkim earthquake of 14 February 2006

Hemant B. Kaushik*, Kaustubh Dasgupta, Dipti R. Sahoo and Gayatri Kharel

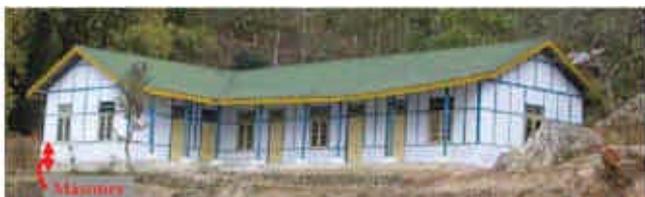
Figure 2. Traditionally constructed typical Ikra structure in Sikkim (school building at Nandok, East Sikkim).

Traditional construction in Sikkim consists mostly of typical bamboo houses, known locally as ‘Ikra’, and also known as Assam-type housing. Ikra houses are single-storey structures consisting of brick or stone masonry walls up to about 1 m above the plinth (Figure 2). This masonry supports the walls consisting of bamboo woven together with a wooden frame, and plastered with cement or mud plaster. The roof generally consists of GI sheets supported on wood/bamboo trusses, which laterally connect the parallel walls. Bamboo superstructure is connected to the masonry foundation walls using steel angles, and flats with

bolts and nails. There were no reports of any significant damages to Ikra structures during this earthquake.
