National Information Center on Earthquake Engineering

# 2011 SIKKIM EARTHQUAKE

## Effects on Built Environment & A Perspective on Growing Seismic Risk

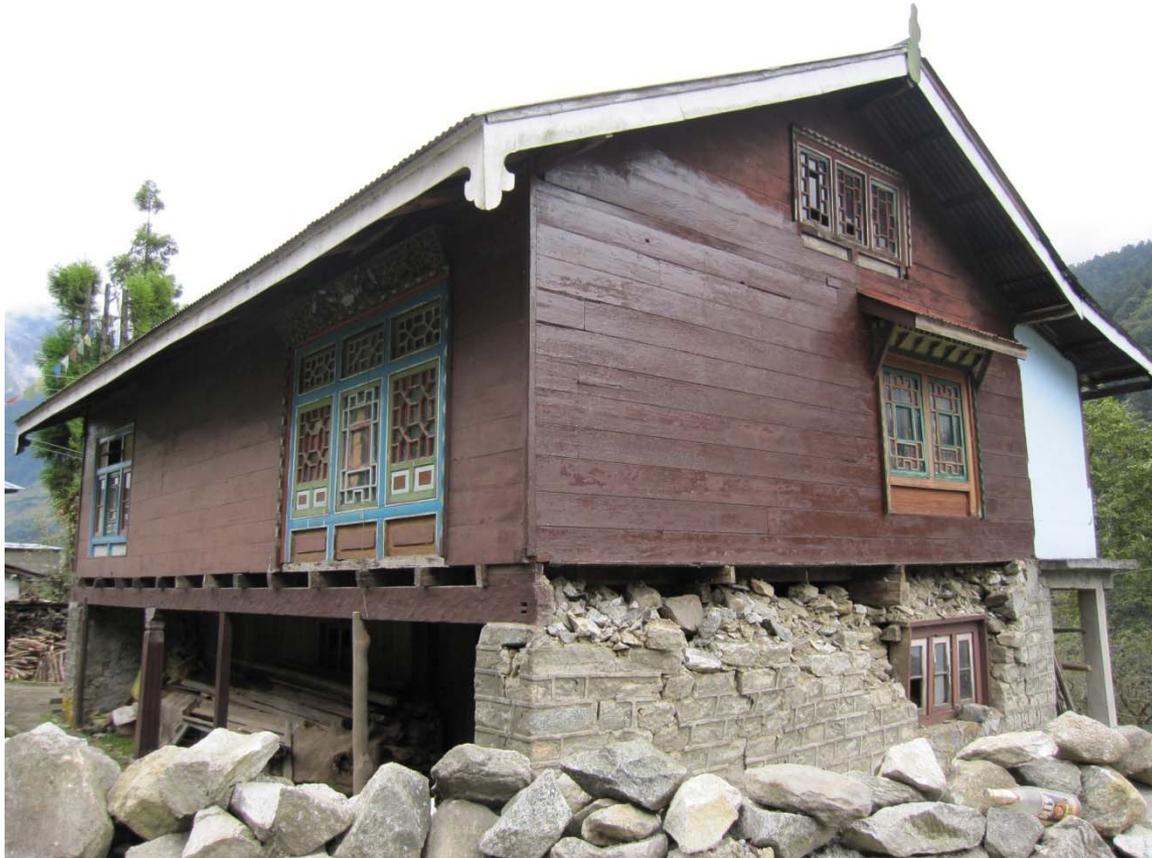
*Shee-Khim houses*

*Shee-Khim* house is one of the traditional construction practiced in upper reaches of Sikkim. It is made of wooden frame and planks and supported on wooden posts. Houses are provided with random-rubble (R/R) masonry wall as basement enclosure.

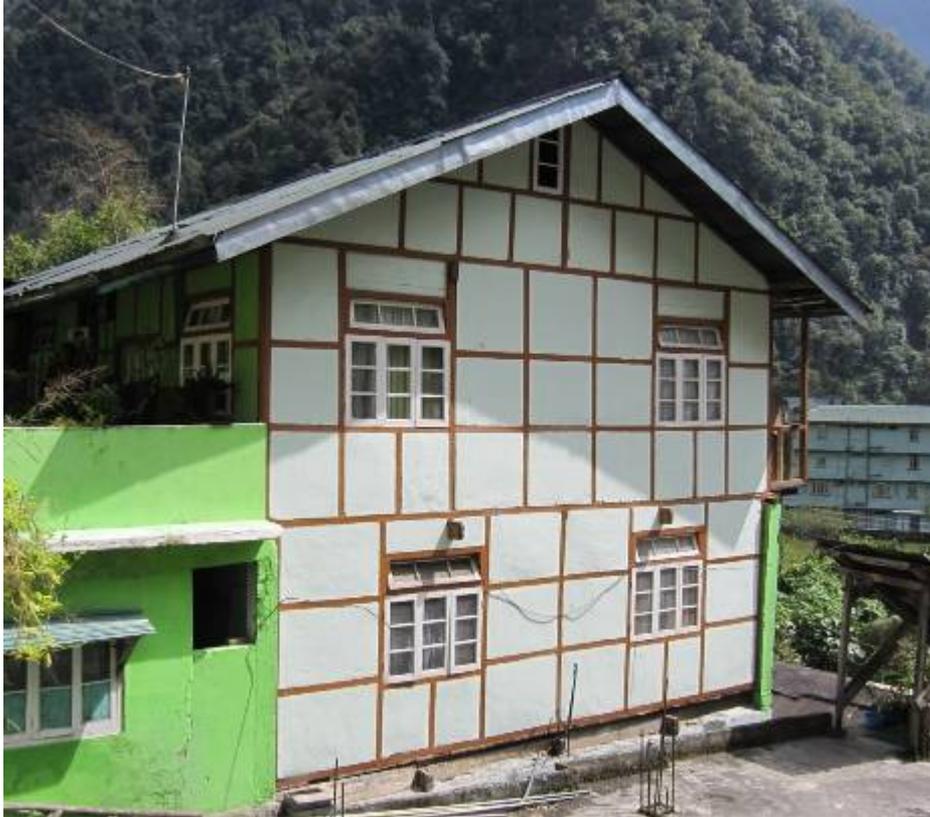
*Ikra house*

Another type of traditional housing practice in Sikkim is *Ikra* house. Walls are made up of bamboo panels fitted inside the wooden frames and plastered with cement/mud mortar. These are also supported on wooden posts.

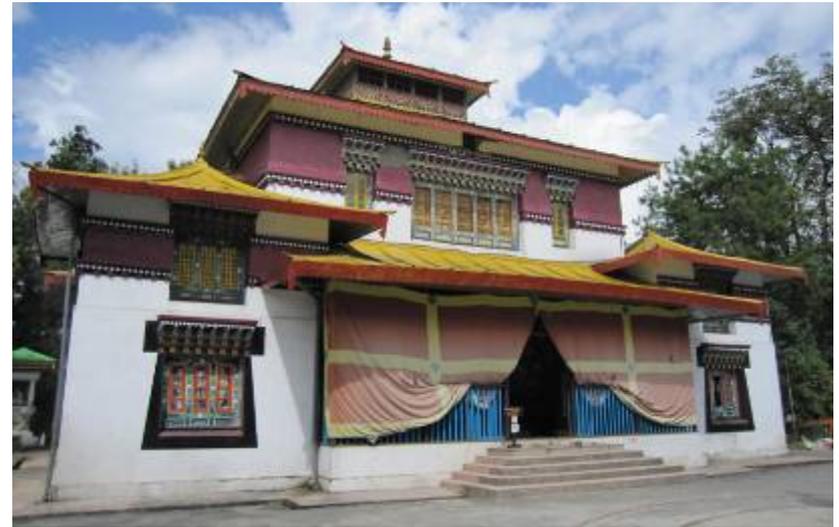
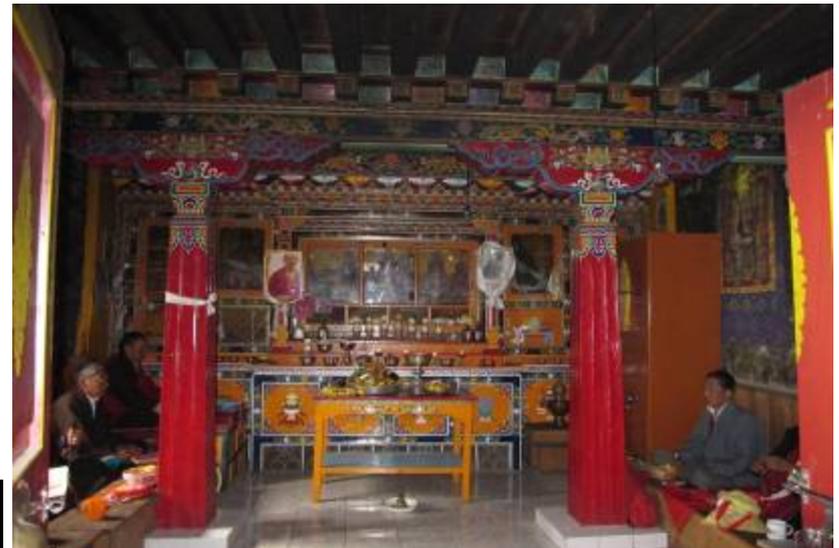
**Typical monastery temple**

The interior timber frames are intricately carved, while the interior wall surfaces are diligently painted with life-like imageries.
