Reconnaissance Report

North Andaman (Diglipur) Earthquake of 14 September 2002

by
Durgesh C. Rai
C. V. R. Murty

April 2003

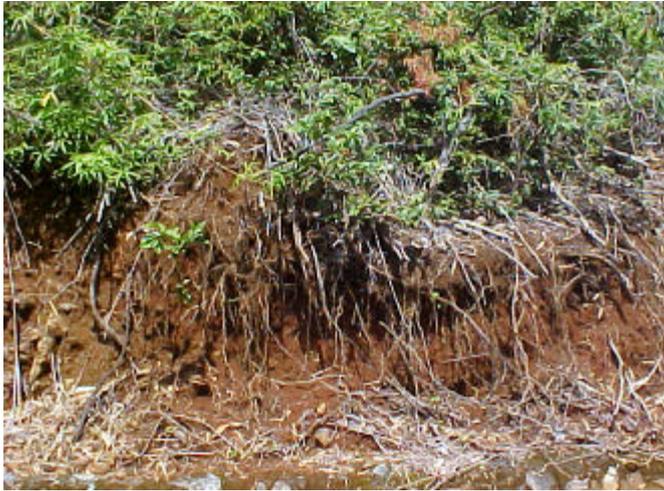
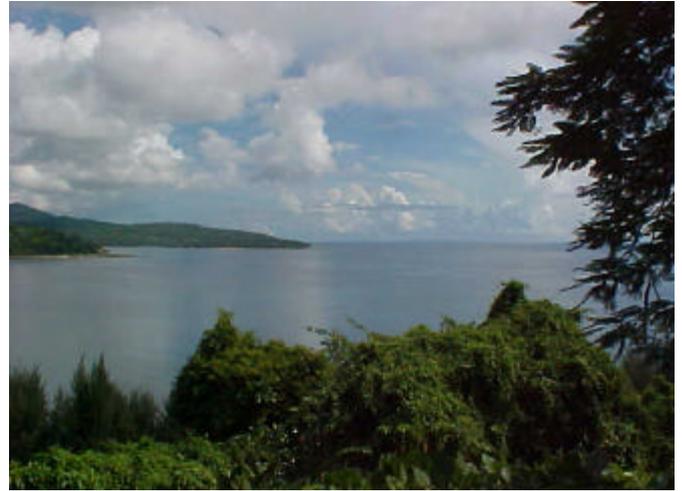
Figure 8: *Soil strata in the Andaman & Nicobar Islands has two dominant features, namely (a) soft disintegrated murrum or silty soil along the hill slopes, and (b) high water table due to extensive water body around the low-lying islands. Both these contribute to making the hill slopes vulnerable to the expected strong seismic shaking in the region.*

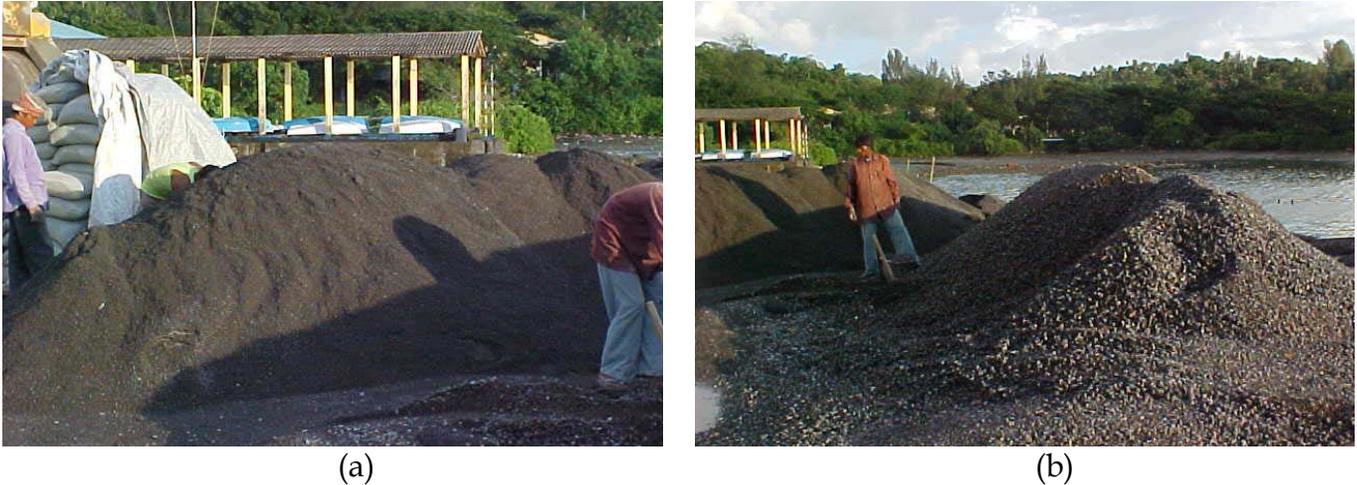
Figure 10: Fine and Coarse Aggregates obtained from crushing the sedimentary and basalt rocks available in the region.

locally available sedimentary and basalt rocks, which have very high water absorption capacity. Thus, the concrete obtained from these aggregates also has very high permeability.

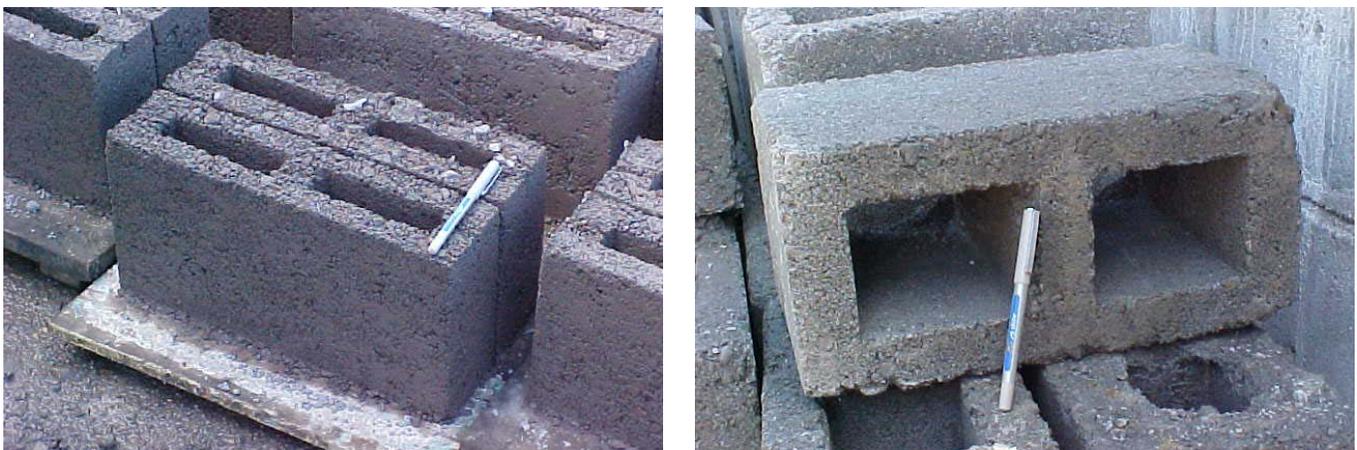
Burnt-clay bricks are non-existent in the Andaman and Nicobar Island region primarily because of the non-availability of good clayey earth and the difficulty to manufacture because of less sunshine and almost daily drizzles/showers. Instead, concrete blocks are widely used for masonry in the region. Two sizes of hollow concrete blocks are normally used; namely: (a) 200 mm thick block with nominal plan dimensions of 400 mm length and 200 mm width, in exterior walls and (b) 100 mm thick block with the same nominal plan dimensions, in interior partition walls (Figure 11). They are made by mixing Portland cement, sea sand and 12 mm stone chips in the proportion of 1:3:6 by volume. Usually, they are not adequately compacted and cured, and therefore their compressive strengths are usually as low as 3 MPa. These low strengths do not meet requirements of the relevant Indian Standards. Solid concrete blocks were used in place of hollow concrete blocks, where higher compressive loads were anticipated. Cement-sand mortar is used for the masonry; the mortar mixes vary from 1:3 to 1:6.

Figure 11: Hollow concrete blocks used for masonry wall are characterized with a very low compressive strength due to poor compaction, curing, etc.

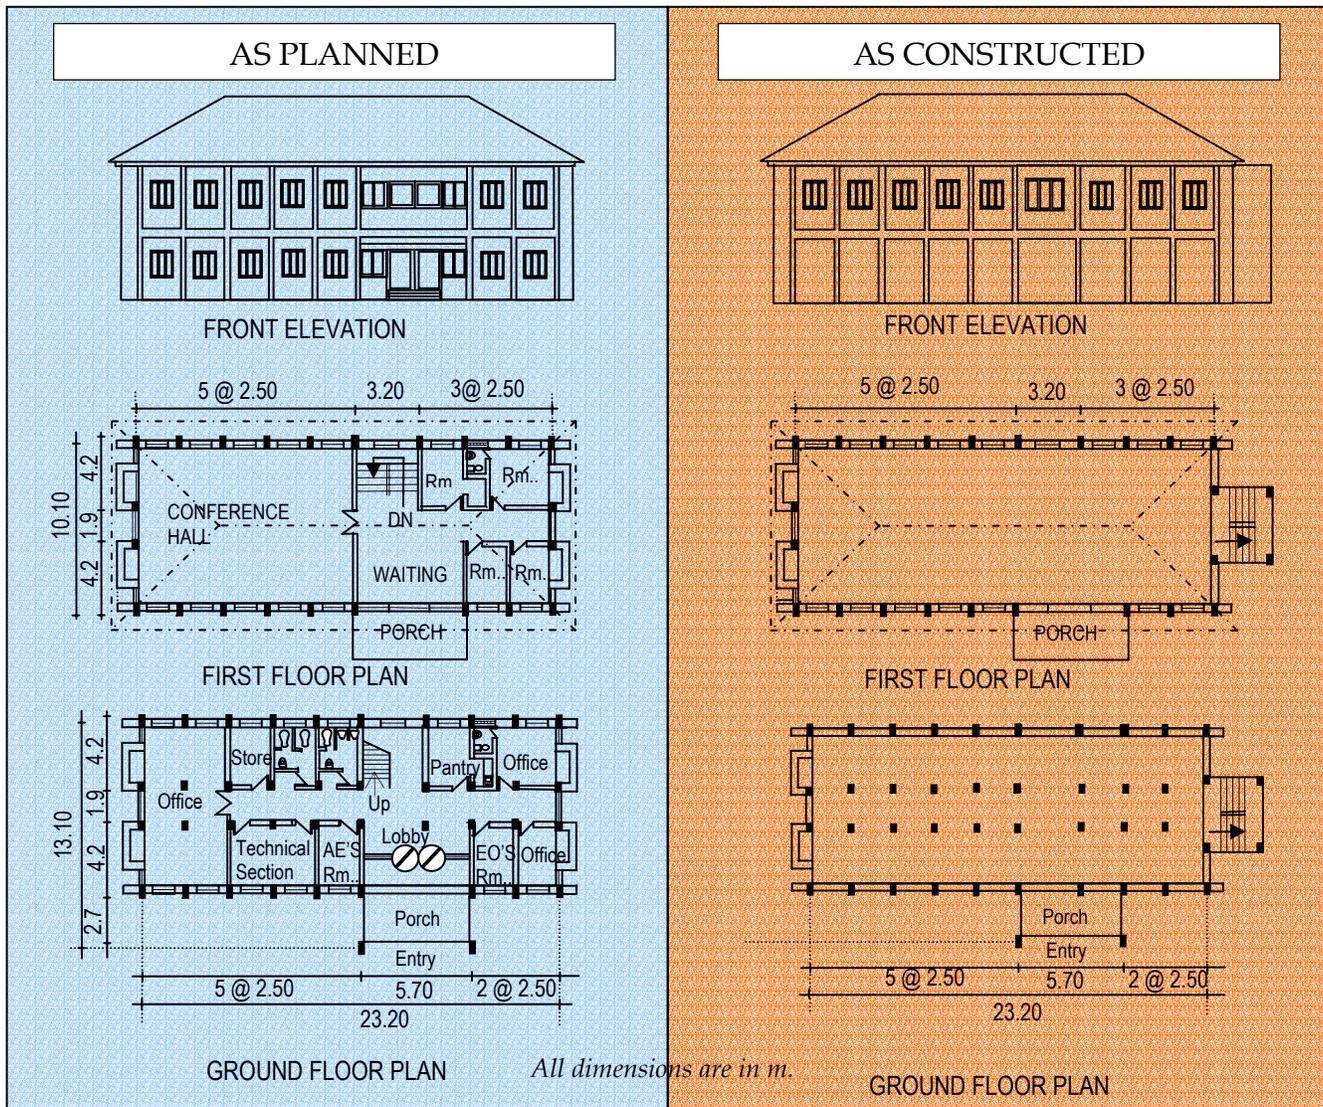
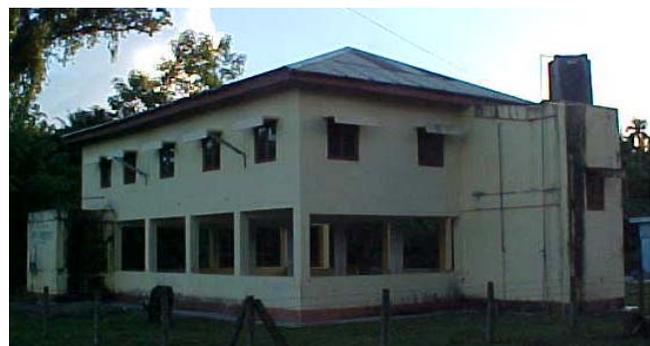
In the last few years, many Panchayat buildings have been constructed in the region based on the type design developed by the Andaman Public Works Department (APWD). A typical plan and elevation of such a building is shown in Figure 16. However, significant variations from the approved drawings were noticed, such as creation of open ground story for meeting assemblies by not raising masonry walls to the full story height. The first story becomes heavy and stiff due to presence of large amount of masonry wall to create office space. Obviously, this top-heavy-bottom-flexible structure would result in large seismic demands on the column members for which they might not have been designed.

Figure 16: Typical plan and elevation of Panchayat buildings in the region. The 23.2 m by 13.1 m building in the plan was originally designed with office spaces on the ground floor, which was altered when built. Also, the stair case block was relocated at the end of the building.

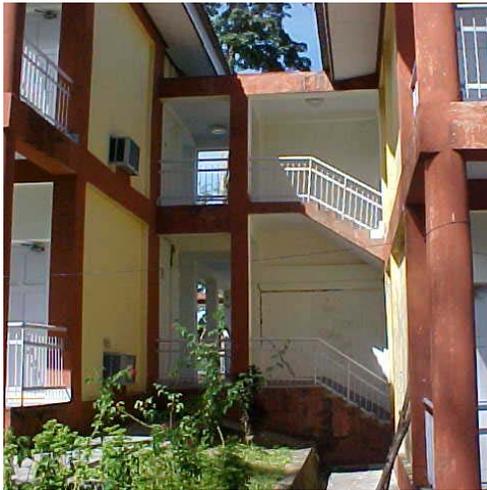
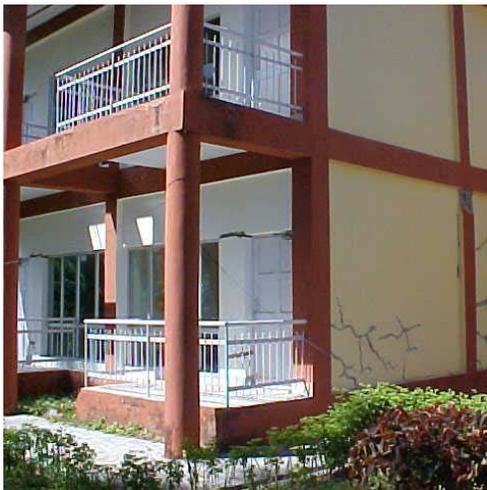
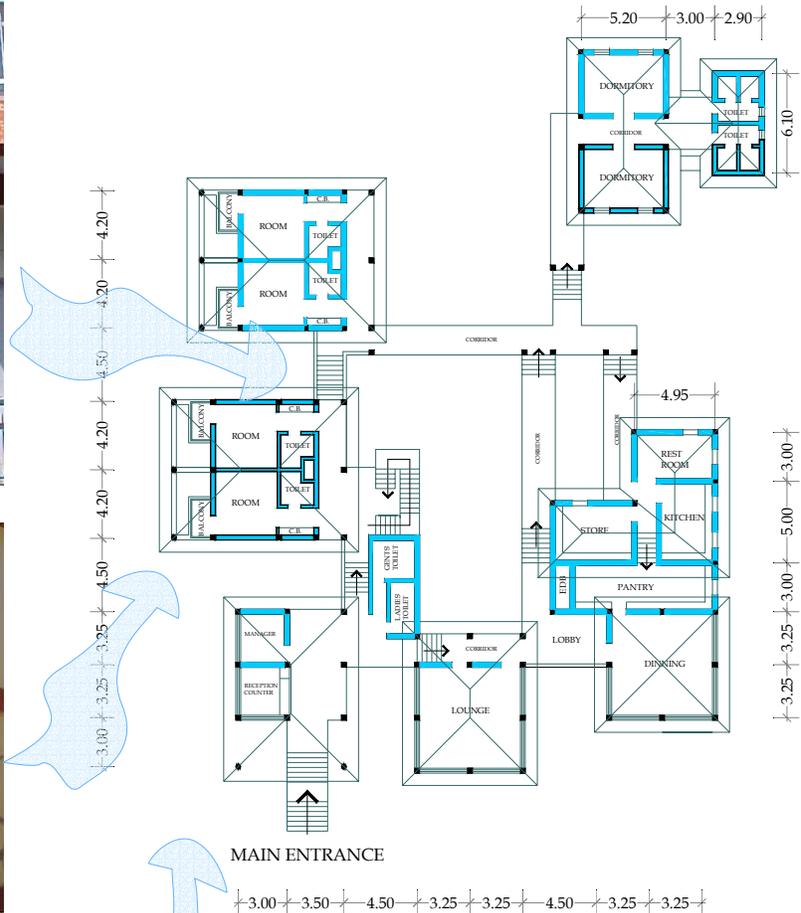
Similar omissions in reinforcement detailing and serious errors on part of architectural layout and planning of structures in high seismic zones was vividly illustrated in recently completed Turtle Resort building at Shibpur, near Diglipur. The building is a two-storey RC frame building with concrete block masonry infills, as well as load bearing one in some parts of the building. The building is highly irregular not only in the plan but also vertically with floors at various levels connected through lobbies and walkways (Figure 19). The building developed cracks in columns and in the large number of partition and bearing walls. The cracking near the column tops were primarily due to absence of transverse stirrups over a length greater than

two times the column width. The building suffered damage disproportionate to the observed shaking primarily due to poor layout of structural elements causing additional forces, irregularities in strength and stiffness, discontinuities in the load path, and absence of column ties (Figure 20). The seismic vulnerability of this building was sufficiently illustrated during this earthquake and its performance provides enough clues to predict its behaviour in the event of greater shaking.

Figure 20: Damage to columns, which reveal absence of transverse ties over a length of about 450 mm from the beam soffit. This omission during the construction compounded with poor architectural planning and configuration resulted in significant damage in an area that sustained less than moderate shaking.

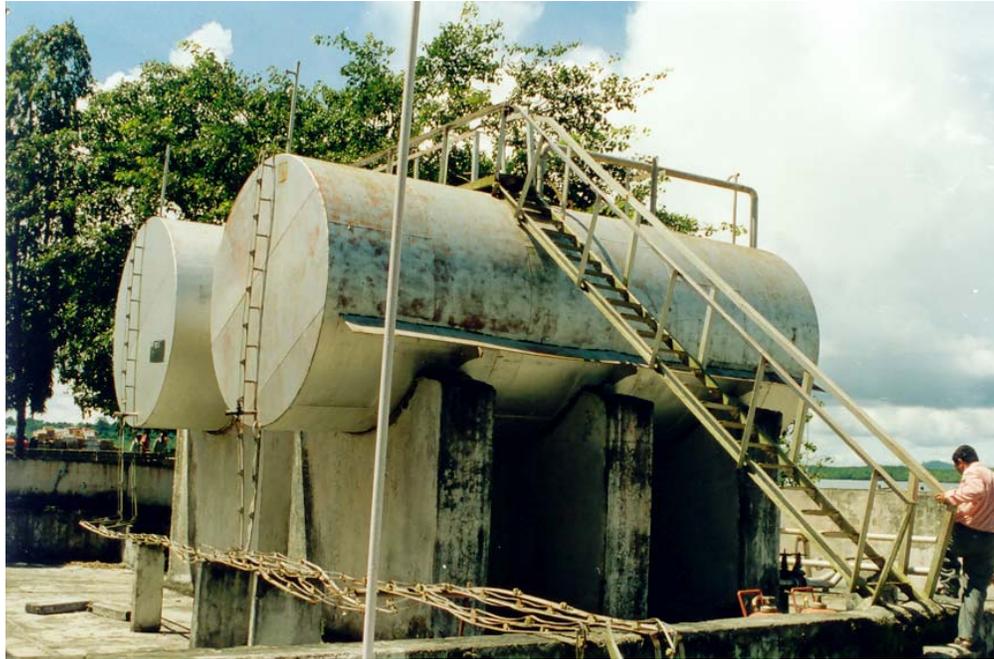
At the Arial Bay, there are two POL (petrol oil and lubricants) tanks (Figure 28). These cylindrical tanks are made of welded mild steel plates of diameter 3m and length 7.5 m supported horizontally on masonry pedestals performed satisfactorily. They contained only 50% of the 50kl capacity of the High Speed Diesel oil.

Figure 28: Cylindrical tanks for Petrol, Lubricants and Oil (POL) at Diglipur harbour.

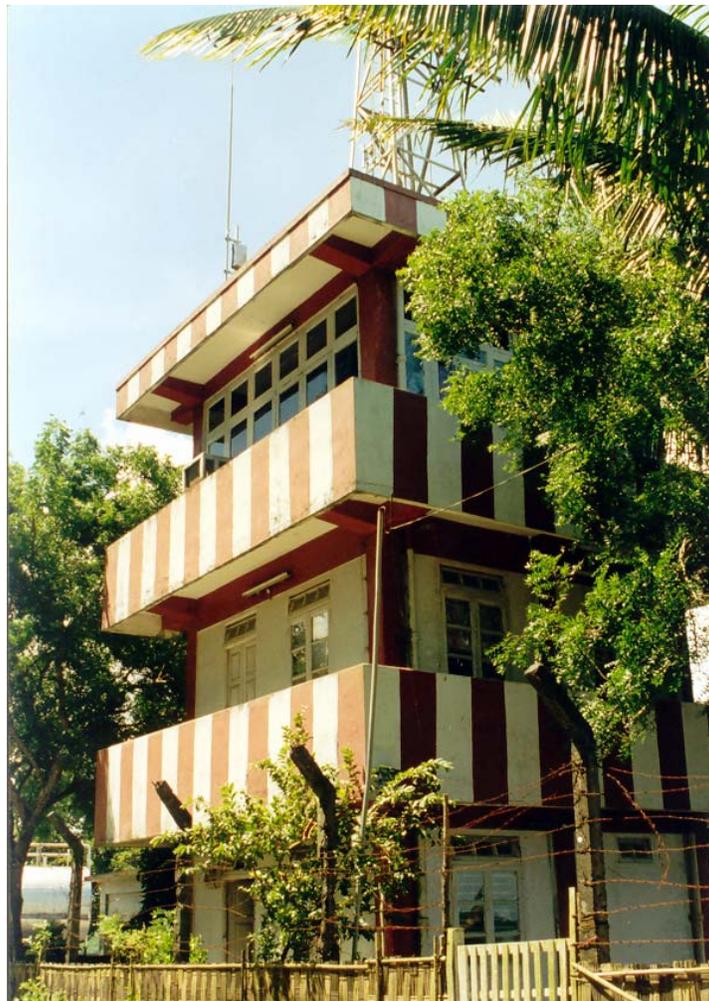
The control tower of the Arial Bay is a three-storey RC frame structure with a 10m high steel mast (Figure 29). In the lower portion, it has a single room of 5mX5m plan with eight columns along the perimeter. It has no major damage. Only the infill was separated from the frame in the ground storey of the RC frame building. Similar minor cosmetic damage was noted in other masonry structures of canteen, passenger waiting hall and cargo shed.

Figure 29: Three-storeyed RC frame structure for Control Tower building at Diglipur harbour.
