The September 29, 1993, M6.4 Killari, Maharashtra Earthquake in Central India.

EERI Special Earthquake Report, EERI Newsletter, Vol. 28, No. 1, January 1994

Sudhir K. Jain, C.V.R.Murty and Navin Chandak
Department of Civil Engineering
Indian Institute of Technology Kanpur

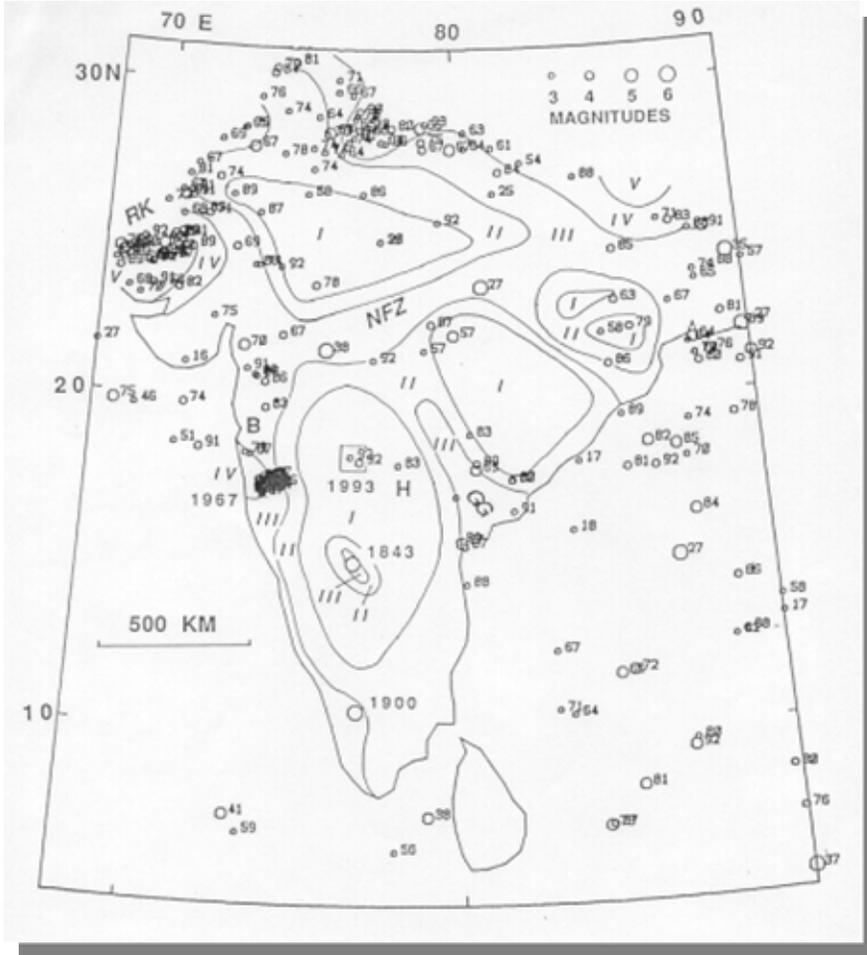
Figure 1: Seismicity (ISC catalog, 1901-1992; epicenters indicated by a circle and last two digits of the year; epicenters along the Himalayan and Baluchistan arcs omitted to avoid clutter) and earthquake hazard zonation in five categories (I to V is lowest to highest, respectively, Geological Survey of India, 1992). The 1993 Killari epicentral area is indicated by a box; the two epicenters within this area are the largest representatives of the very active precursory swarm felt in Killari in 1992. Large and destructive earthquakes near Bellary, 1843, and near Coimbatore, 1900, are also plotted (years indicated in full). 1967 is the year of the largest earthquake from the very active reservoir-induced source zone near Koyna. RK = 1819 Rann of Kutch earthquake; NFZ = Narabada fault zone; GG = Godavari Graben; B = Bombay; H = Hyderabad.

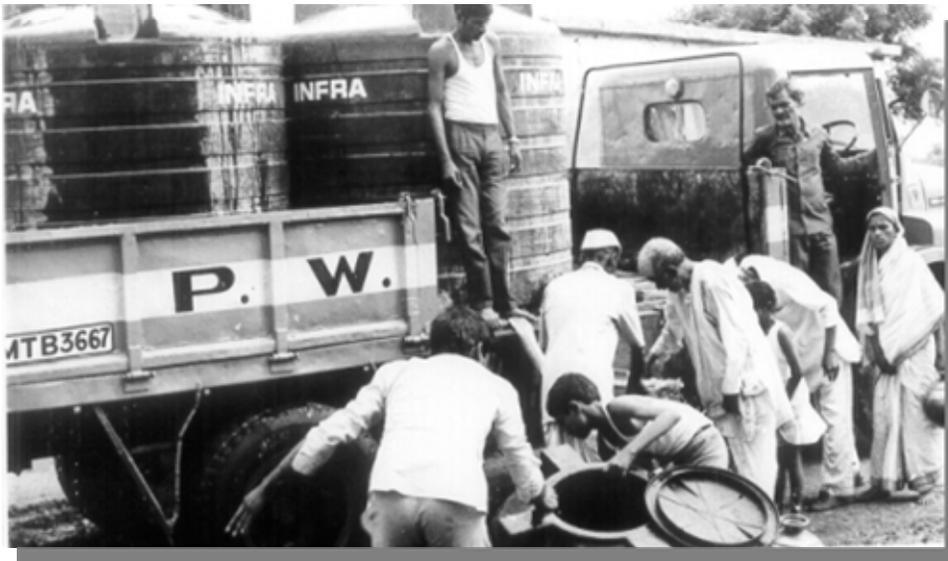
Figure 7: After the earthquake, water was trucked into the region. Generally, each village was assigned a truck requisitioned from unaffected neighbouring districts

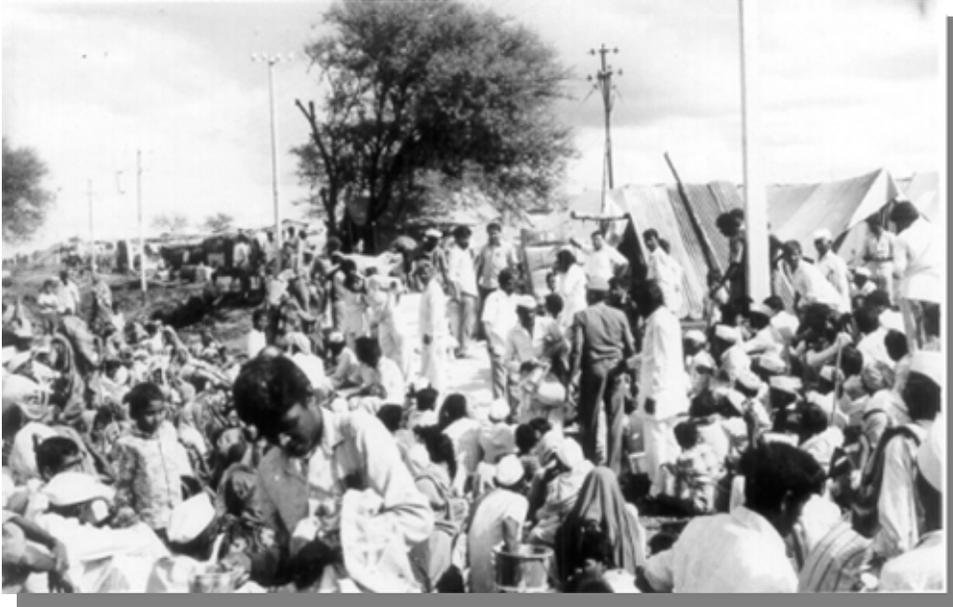
Figure 8: Distribution of relief supplies was systematized through the issuance of 'family cards' and 'individual cards' to residents of the affected areas

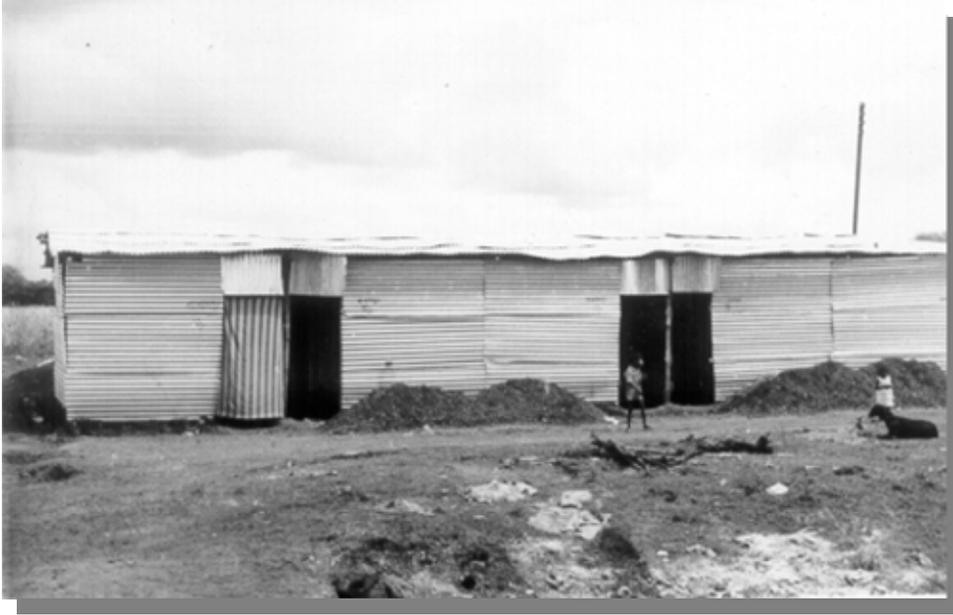
Figure 9: Temporary shelters of galvanized iron sheet were rapidly erected. Each provides shelter for five families

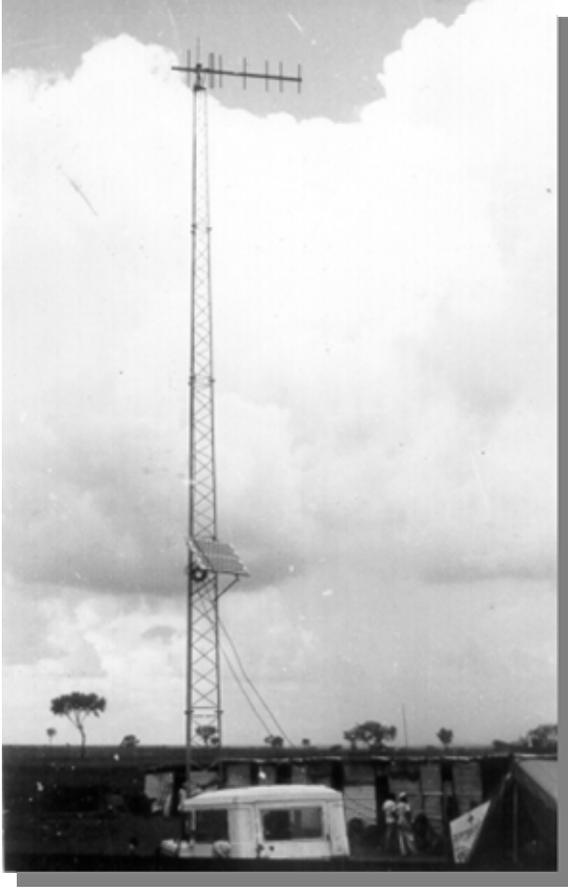
Figure 10: Solar Powered Satellite Communication Towers were brought in to connect the larger villages to the outside world
