RECONNAISSANCE REPORT
SIKKIM EARTHQUAKE OF 14 FEBRUARY 2006

Hemant B Kaushik
Kaustubh Dasgupta
Dipti R Sahoo
Gayatri Kharel

NATIONAL INFORMATION CENTER OF EARTHQUAKE ENGINEERING
INDIAN INSTITUTE OF TECHNOLOGY KANPUR
KANPUR 208016 (INDIA)

April 2006

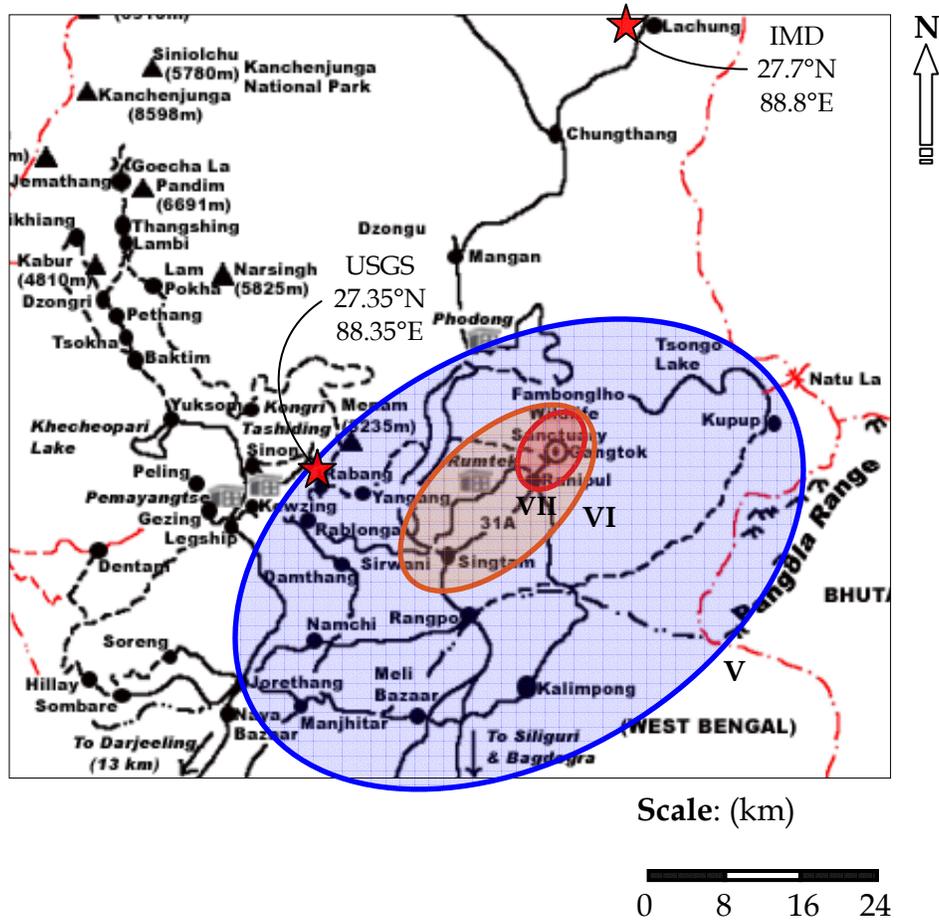
Figure 1: Epicentral locations and proposed iso-seismal map of 14 February 2006 Sikkim earthquake.

Most of the structural damage was observed in and around the state capital Gangtok with the maximum intensity of shaking as VII on MSK scale (Figure 1). Damages observed in buildings in and around Singtam (East Sikkim) towards the south-west of Gangtok, suggested an intensity level of VI. It is interesting to note in Figure 1 that the epicentral location as per USGS and IMD lies well outside the area of maximum damage (25 km west of Gangtok as per USGS and 44 km North of Gangtok as per IMD). This may be due to inaccurate estimation of the epicenter.
