2015 GORKHA (NEPAL) EARTHQUAKE

Effects on Built Environment & A Perspective on Growing Seismic Risk in Bihar-Nepal Region

Department of Civil Engineering, Indian Institute of Technology Kanpur

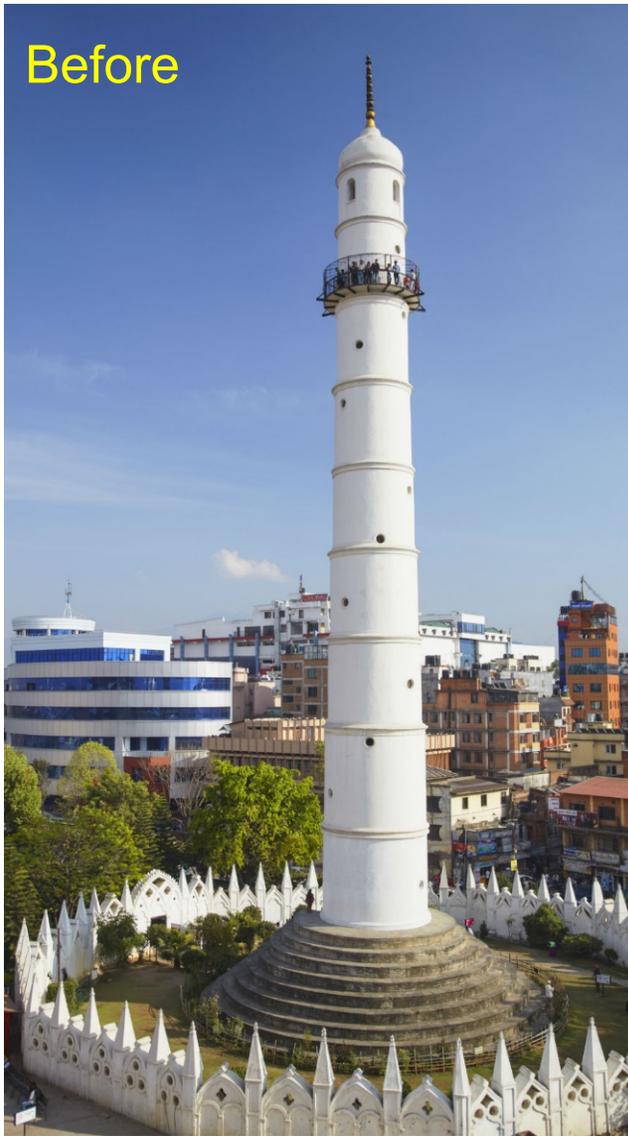
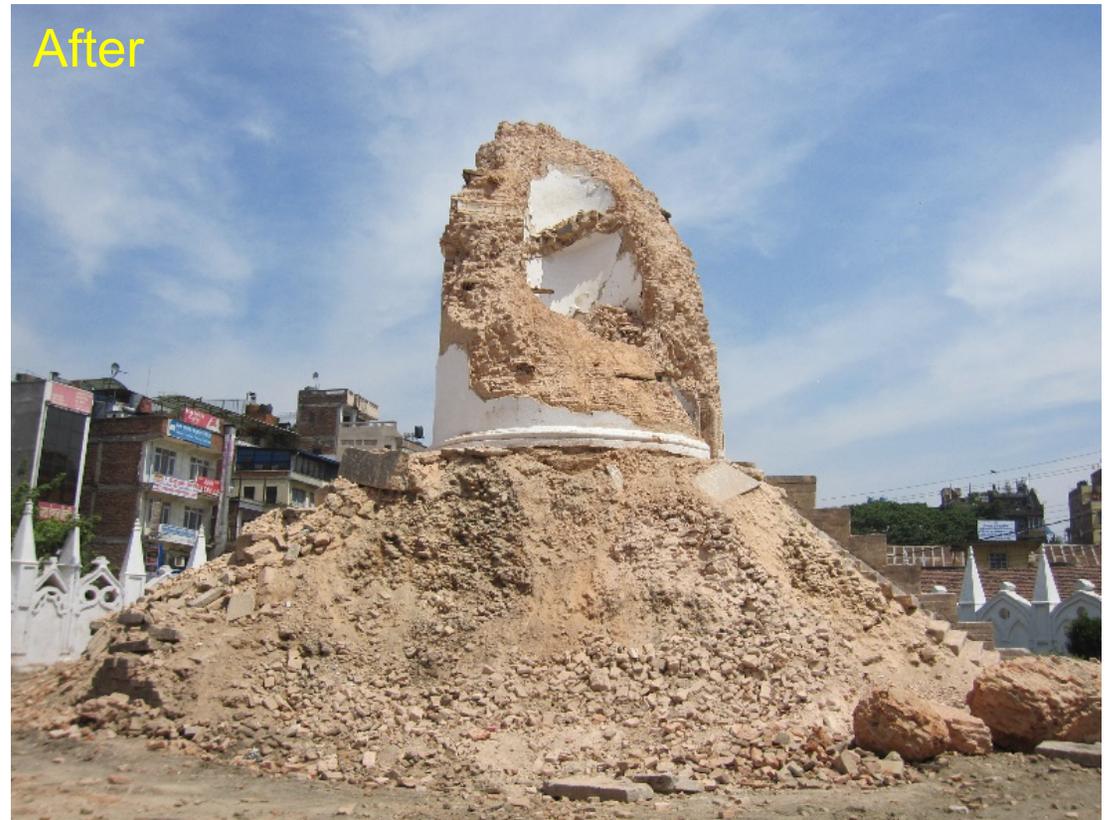
Dharahara Tower

- The cultural heritage structures, being old and weak were unable to resist the seismic forces and were damaged seriously.
- Landslides were observed, and vertical movement of soil led to damage of roads and pedestrian bridges at some places.
