# Documentation of Procedures, Evaluation, and Monitoring Tools

## Disbursement of Entitlements

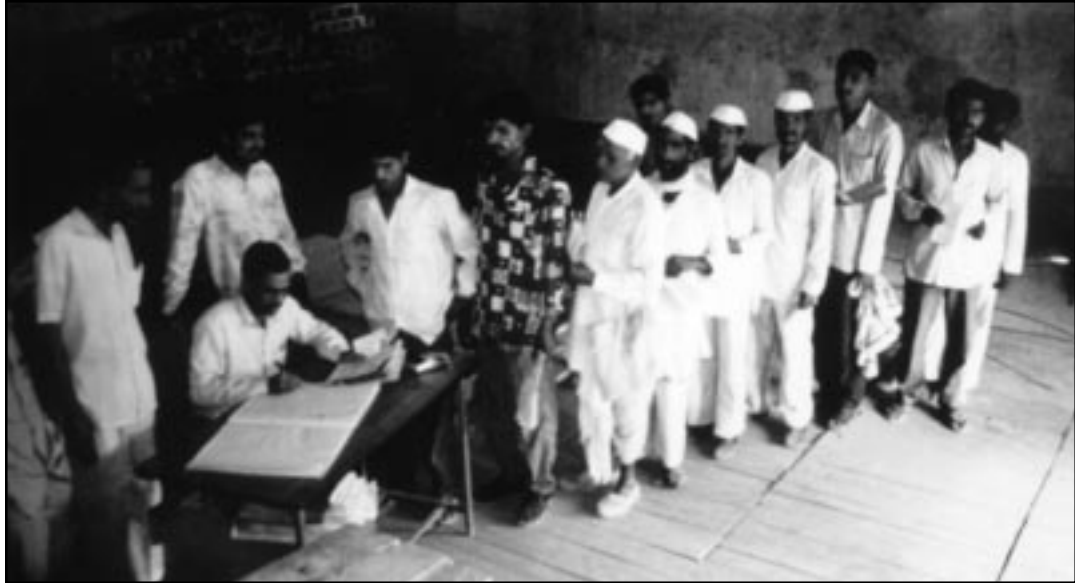
**Figure 43**  
Beneficiaries  
collecting  
materials from  
the government  
depots.

beneficiary collects the necessary building materials from stores established by the PMU (Figure 43).

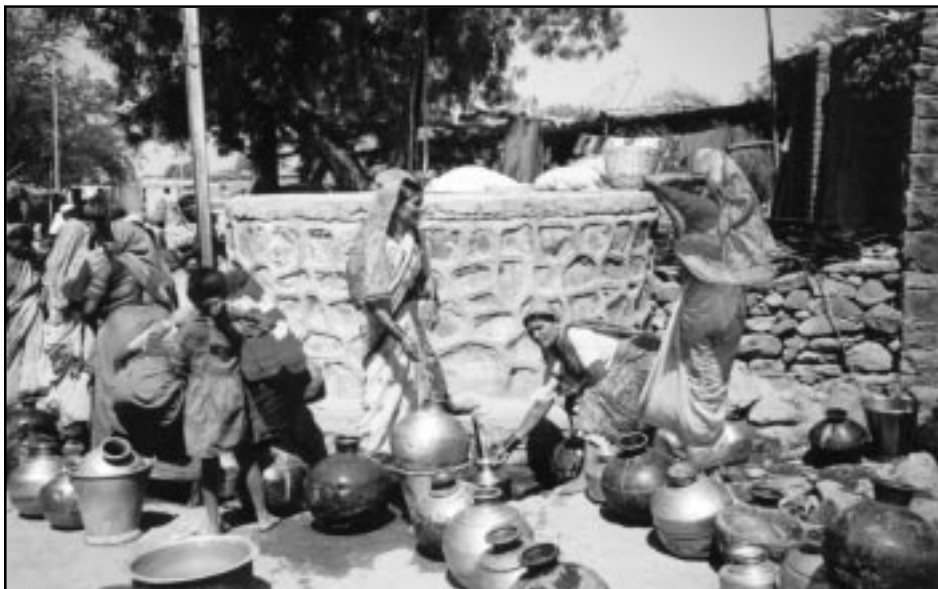
**Figure 44** A case of acute water shortage in a village undergoing in-situ rehabilitation.

1. The consultants believe that “when the project involves construction of about 30,000 houses against time in a difficult environment where temperatures reach 45° C (113° F), there is acute water shortage for three to four months a year (Figure 44), local sand is coarse with a high silt content, and the experience of the masons is poor but the requirements large, the problem of maintaining quality is an enormous one...” (LASA, 1998). According to the LASA report, a major source of construction quality problems was the extensive use of concrete technology,

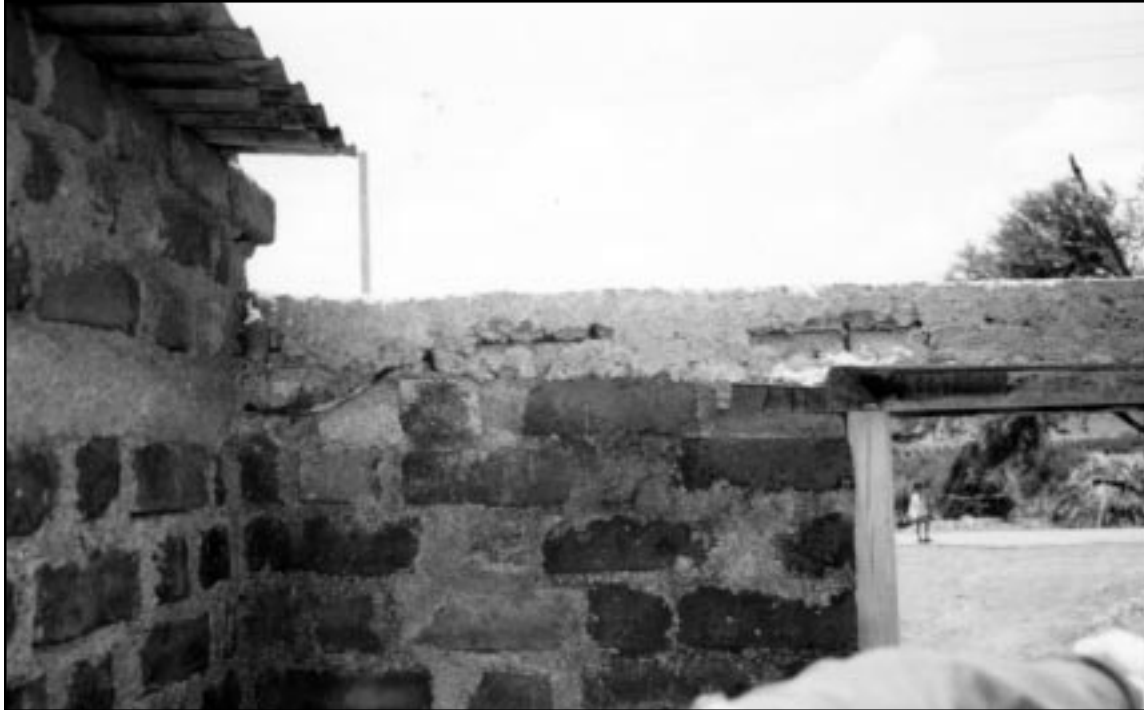
**Figure 45** An example of poor construction of a concrete lintel band showing exposed rebar and the change in the level between the two walls.

- Some of the houses constructed in the RRSP had a number of technical defects, including discontinuous bands, especially at the lintel/roof levels (Figure 45); inadequate concrete covers leading to exposed reinforcement bars and chances for the corrosion; CGI sheets that were not attached to the roof by hooks (as required), but instead were held in place by stone boulders; excessively large or inappropriately located openings in the walls.
